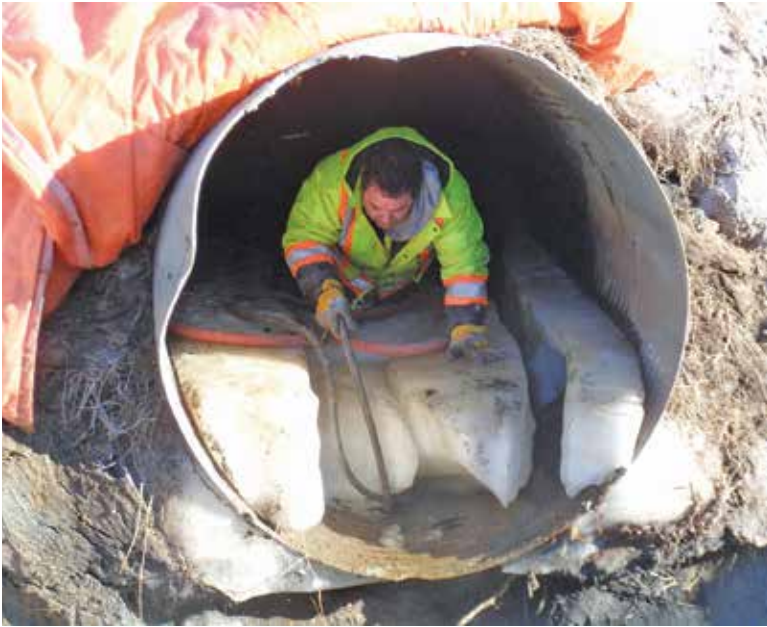
In January and February 2014, one of the coldest winters in history, the Saskatchewan Department of Highways and Infrastructure contracted with Winnipeg-based MuddRuckers Inc. to complete a culvert rehabilitation project. The project consisted of four large culverts in separate locations. One is a round, 5-foot-diameter, 130-foot-long pipe. The other three are arched, about 80 feet long, with one 72 inches wide and 42 inches tall, and two that are 102 inches wide and 72 inches tall. All were corrugated metal and the two largest had deep indentations. All were failing; they were badly rusted, some sections of invert were rotting out and some culvert sections were misaligned.

MuddRuckers' bid was based on a **Centripipe** centrifugally cast pipe rehabilitation system from **AP/M PERMAFORM** the department had used for previous culvert rehabilitation projects. The cost-effective process utilizes a precisely controlled spincaster to apply multiple thin layers of high strength cementitious grout, creating a brand-new concrete pipe within the old pipe or sewer, while minimizing impact on flow capacity. The challenge was completing the work in arctic-cold temperatures. A week before rehabilitation began, 350,000 Btu heaters were brought to the sites, along with ground thaw heaters, to gradually raise culvert temperatures to about 68 degrees F, the optimum temperature for curing.

After rehabilitation was complete, the heaters were kept in place for a week to facilitate proper curing. By rotating the heaters from site to site, and working on multiple sites, the entire project was successfully completed in six weeks. **800/662-6465; www.centripipe.com.**

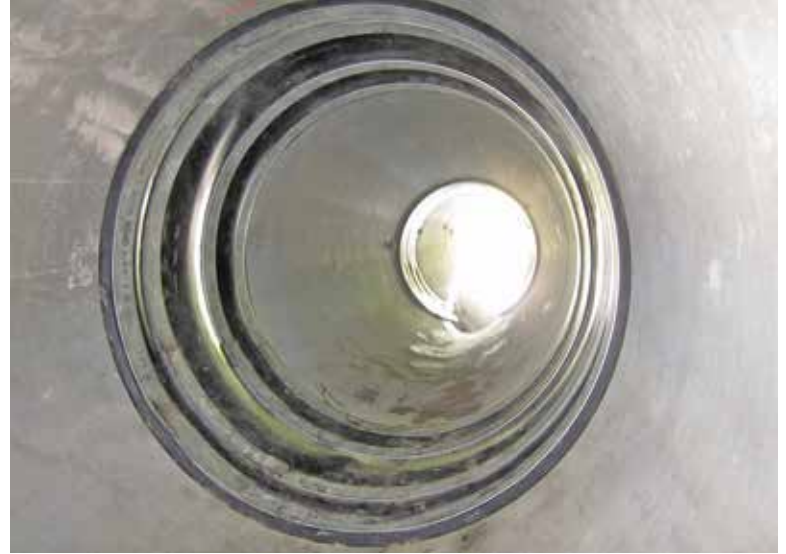
A 2013 Wisconsin DOT project to reconstruct a stretch of Hwy. 164 in Racine County was completed by late in the year. In a wetland area, there were settlement issues where twin 30-inch RCP stormwater culverts crossed under the roadway. The settlement caused the RCP culvert to move, and some joints opened up, allowing soil to migrate in.

The DOT contacted a local rehab contractor, Visu-Sewer Inc., who contacted **Cretex Specialty Products** and inquired about the **Cretex/HydraT-ite Internal Joint Seal**. The seals were chosen because they could be installed at the defective joints without digging and with easy man entry on the open-ended culverts. A total of four (two in each RCP culvert) 30-inch seals were installed and the contractor performed injection grouting to stabilize the soil around the outside of the joints.

The joints have remained sealed according to specifications. **800/345-3764; www.cretexseals.com.**

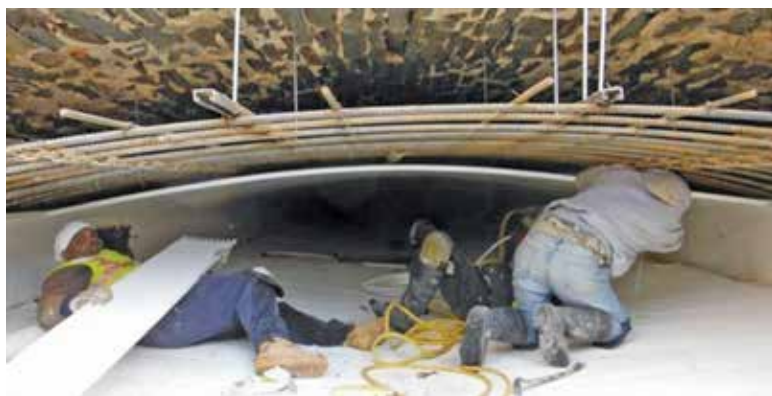
The City of Baltimore, Md., planned to rebuild Central Avenue, which included a structural rehabilitation of 3,275 feet of 100-year-old brick/stone storm drain that ranged in width between 9 to 20 feet and heights from 3.8 to 6.5 feet before lining. Low headroom posed challenges working in tight, confined spaces. Because there were areas of structural deficiency in the culvert, the storm drain rehab had to be completed before excavating the old street pavement and putting any new loads on top of it.

The city chose **Grout-In-Place-Liner** from **Danby**, installing 1-inch PL-III panels, extensive reinforcing steel and grout with thicknesses averaging 12 to 24 inches. A total of 4,400 cubic yards of grout was used for the project. The 28-day test cubes consistently broke at 9,000 to 10,000 psi. The

contractor, Boyer Inc., had the reinforced steel, liner, numerous service connections and grout successfully installed ahead of schedule.

The storm culvert continues to support traffic loads. The corrosion-resistant pipe has an increased hydraulic capacity in spite of the reduced cross-section due to the smooth surface and is expected to function for another 100 years. Design engineers and the construction manager were pleased with the final product. **281/598-1126; www.danbyrehab.com.**

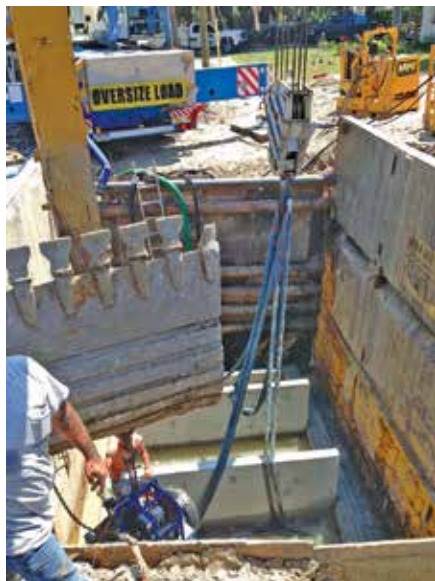
Contractor Keystone Excavators was low bidder to install a heavy precast stormwater filtration vault for the city of Dunedin, Fla., as part of the city's President Street Drainage Project. Throughout the project, groundwater in the excavation was an ongoing problem that had to be managed. Keystone employed a 4-inch submersible hydraulic pump and then a second 6-inch pump to keep the water manageable in the bottom of the hole.

Keystone used a 349 CAT Excavator to excavate a 28- by

16- by 16-foot-deep pit and set three stacked 6- by 2-foot **Efficiency Production** trench boxes to shore the excavation. The trench boxes were manufactured HT8 steel trench shields with 8-inch sidewalls. Keystone also rented road plate from Efficiency, which they used to shore the ends of the pit.

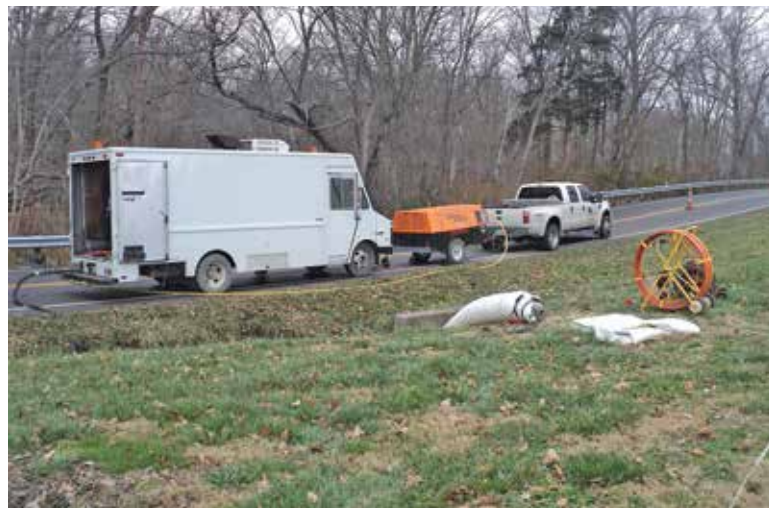
The Ohio Department of Transportation had an 18-inch galvanized culvert, approximately 87 feet long, running under a state highway located in Warren County. The culvert had several holes as a result of deterioration and was washing out. Due to its location under a highway, replacement would have involved removal of asphalt and closure of the highway for an extended period of time.

A certified **Flow-Liner Systems** installer prepared the culvert and installed a CIPP lining system in the 18-inch culvert.

The culvert was successfully lined in one day with minimal disruption to traffic. **800/348-0020; www.flow-liner.com.**

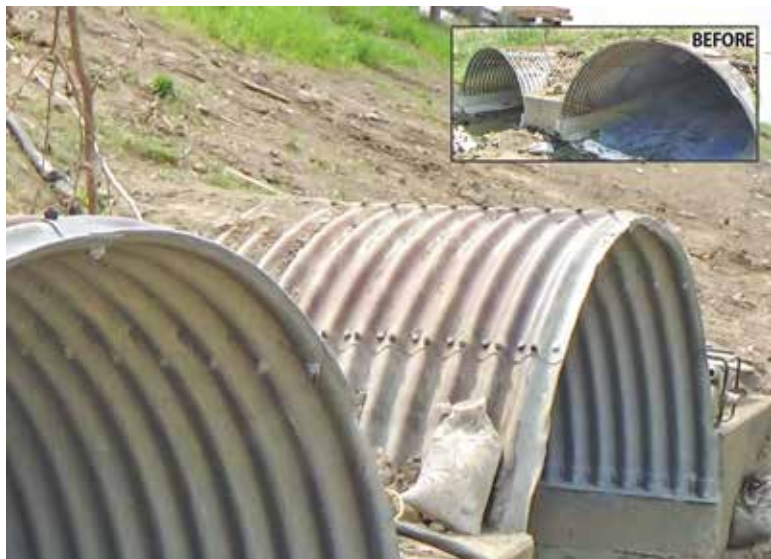
Two culverts under I-280 near Toledo, Ohio, were showing signs of deterioration after decades in service. Though the concrete bottoms and corrugated, galvanized steel arches were still structurally sound, seam bolts on top of the arches had corroded and some steel was rusted. Advanced Rehabilitation Technology won the Ohio Department of Transportation subcontract to repair the damage. As the culverts were large (11 feet wide, 7 feet

tall and approximately 132 feet long), a dig-and-replace solution would have been prohibitively costly, time-consuming and disruptive to traffic.

Instead, ODOT specified lining the culverts with **PolySpray SS100** from **HydraTech Engineered Products**, a spray-applied polyurea-based system that is impervious to chemicals and abrasion. Preparations included dewatering each pipe, diverting the water flow and pressure blasting the surfaces with grit and water to remove debris and old coatings. The contractor then lined the inside of each pipe with a 300-mil layer of PolySpray. The project took less than two weeks to complete and the culverts were returned to service the day after.

In 13 calendar days, for a fraction of the cost of replacement, the department of transportation added 50 years to the serviceable life of two culverts under a busy highway. **513/827-9169; www.hydratechllc.com.**

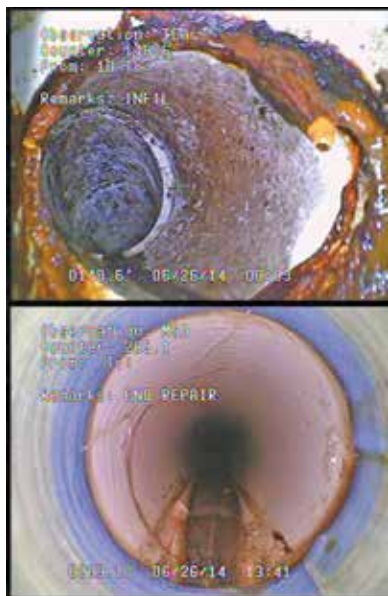
In June 2014, Mid-Mo Environmental of Jefferson City, Mo., cleaned and televised sewer mains in the nearby Callaway County town of New Bloomfield. Many of these lines are under the streets and buried in excess of 10 feet deep. While televising one such line, they assessed a lateral crack, an abandoned tap and a bad joint all within a 6-foot-2-inch span, causing severe inflow and infiltration issues. The

pipe was an 8-inch reinforced truss pipe installed in the 1970s.

Mid-Mo decided to use a trenchless point repair system from **Infrastructure Repair Systems** to restore the three damaged areas with a single 7-foot spot repair. Since the repair was within 24 feet of the near end of the manhole, owner Shawn York devised a 3/4-inch PVC pushrod to push the Logiball carrier and liner into place.

The pushrod saved the time of jetting and stringing the entire 375-foot line and pushed the carrier with the resin-soaked fiberglass and felt liner in position to cover all three damaged areas. This single repair saved the town a significant amount of money by covering three areas with one long point repair, without digging or repaving the street. The installation was completed in less than three hours without any disruption of service to customers or the environment. **877/327-4216; www.irsi.net.**

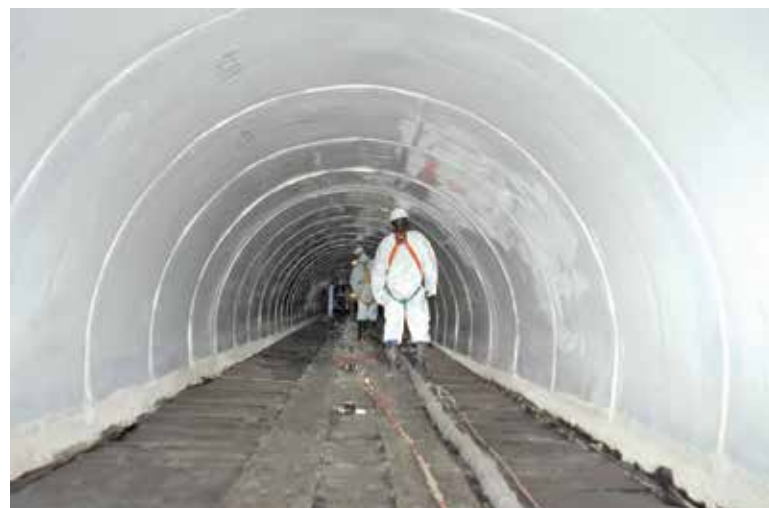
The SD342 Wood Street, Phase II Project from the East Bay Municipal Utility District (EBMUD) in Oakland, Calif., included rehabilitating approximately 6,200 feet of a severely corroded 105-inch-diameter concrete pipe, which had lost structural integrity. This pipeline conveys most of the influent flow into the 168 mgd treatment plant, which serves approximately 650,000 residents along the eastern shore of San Francisco Bay. It is also used as wastewater storage for flow equalization purposes.

Due to budget, risk and schedule concerns, the work had to be performed at night, during low flows and without bypassing. Since the pipeline runs under a residential area, the installation had to proceed without disturbing the neighbors, keep noise levels at or below 65 dB and keep hydrogen sulfide emissions undetectable. EBMUD and their consulting engineer, Brown and Caldwell, chose to continue the rehabilitation with the same fast-curing **Pipeline Structural Polymer Co-Lining System** from **Linabond** that was used successfully in 2000 for Phase I.

The Phase II Project was awarded to J.R. Pipeline, which completed the first section, achieving liner installation rates of up to 1 linear foot per minute. The remainder of the project is to be completed later this year. [805/484-7373](tel:8054847373); www.linabond.com.

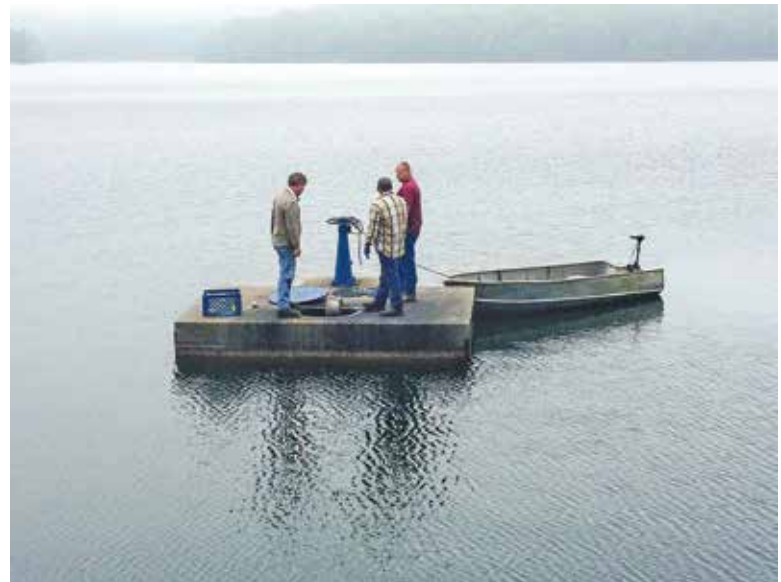
Alpine Lake Resort in Terra Alta, W.Va., needed to rehabilitate a leaking overflow joint. The top of the flowing pipe was compromised due to a failed leaking overflow joint, allowing water to infiltrate the overflow pipe continuously. Thus, the lake was losing water every day beyond desired levels.

The **PipePatch** cured-in-place pipe process from **Source One Environmental** was chosen. A Flow-Thru Packer was used because of its range within a pipe and precise alignment for the repair. On the day of the repair, the

dam's flow levels made it impossible to retrieve measurements for the packer's placement. Additionally, the overflow pipe access point could only be reached by boat and the team navigated to the repair area with equipment. Limited sandbags and makeshift water bags were designed out of packer protective sleeves, utilized to slow the cascading water from entering the drainpipe and control water flow.

A post-repair inspection revealed that the infiltration was completely sealed off. PipePatch cured the leaking joint without excavating, pre-grouting, DEQ permitting or causing disruption within the resort and because of the trenchless technology, the resort was able to maintain their water level and defer negative impacts. [877/450-3701](tel:8774503701); www.sleonline.com. ♦
