## HydraTite® Internal Joint Seal

*Power*

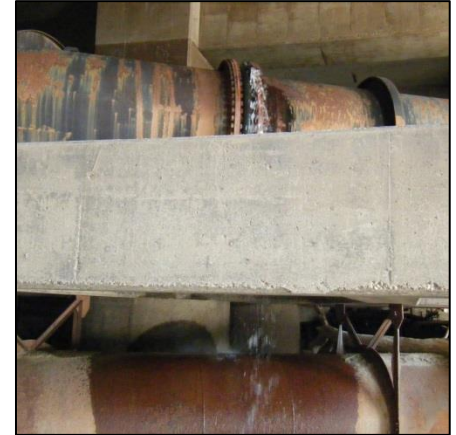
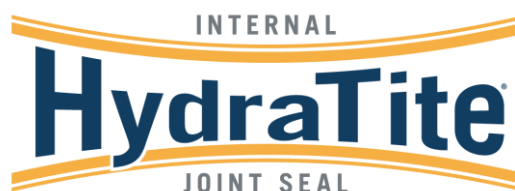
External crack to a 78-in circulating water pump expansion joint caused extensive leakage and forced the power station to shut down.

The solution utilized the HydraTite seal consisting of three two-piece 304 stainless steel bands, a double wide EPDM seal and a 16 gauge stainless steel backing plate to provide an internal slip joint repair.

The crew and all materials entered through an opening provided by the client and were able to complete the HydraTite system installation safely and within one day.

Once the HydraTite internal seal was installed, the leak was isolated and the circulation system was operational. This saved the power company extended downtime.
