INTERNAL PIPE

HydraTite®

JOINT SEAL

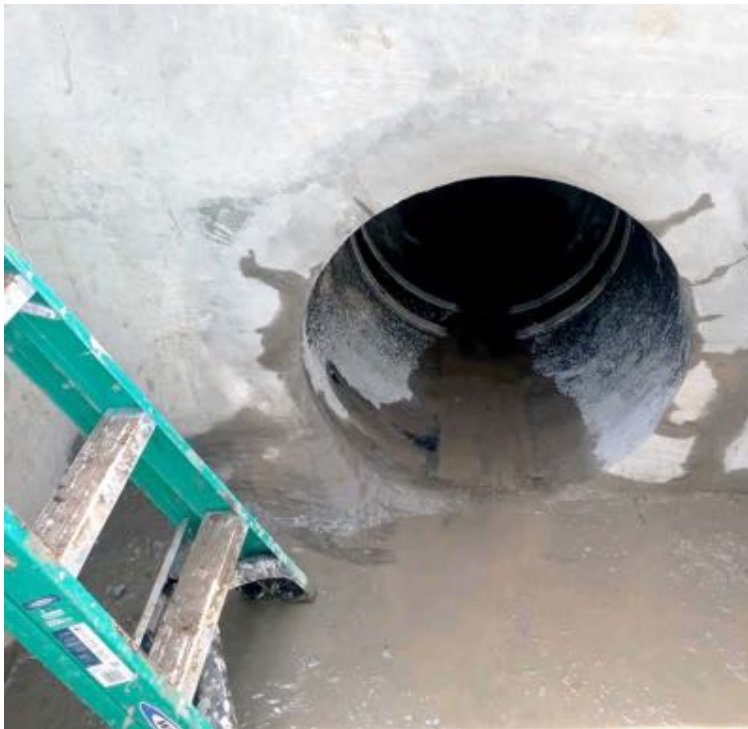
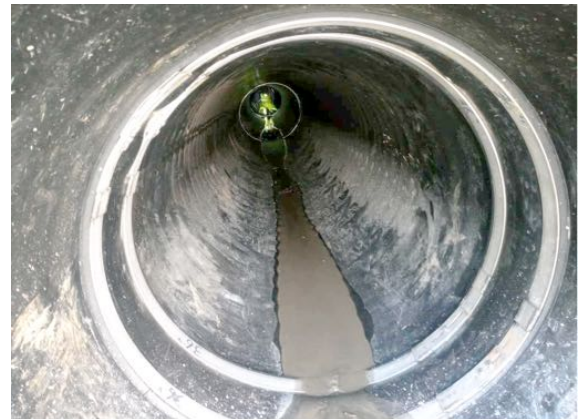
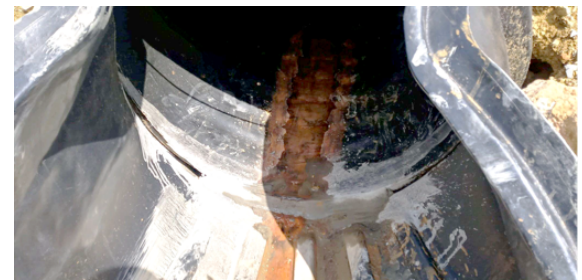
The joints of a 36 inch corrugated polyethylene outfall pipe had become separated due to increasing soil and live loads. Eliminating the infiltration without disrupting the traffic flow raised concerns. The preferred method of repair was to eliminate the infiltration without interrupting traffic flow.

Standard wide HydraTite Internal Pipe Joint Seals were used at the disconnecting joints to prevent infiltration.

11 HydraTite seals were used to repair the joints that had shifted apart. The headwall was fixed with Hydraulic cement. All repairs were completed in 2 days.
