MARINE HYDRAWRAP

STRUCTURAL COMPOSITE REPAIR SYSTEM

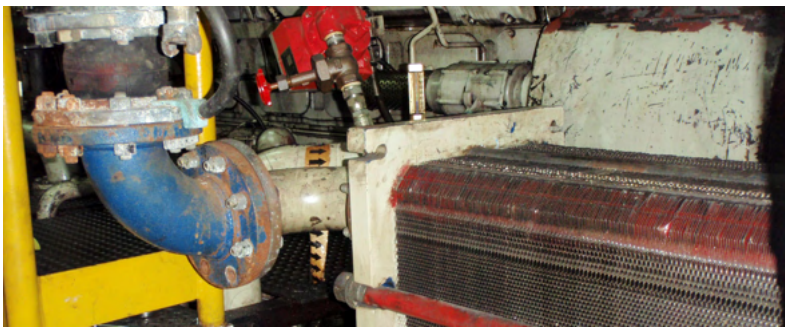
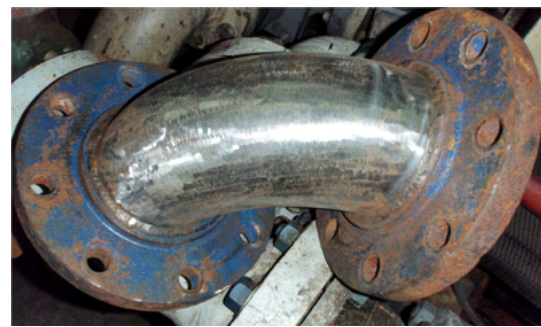
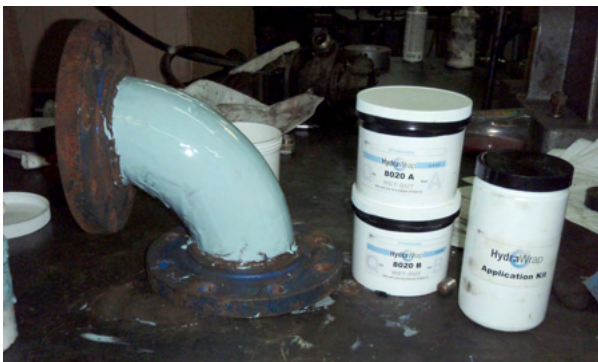
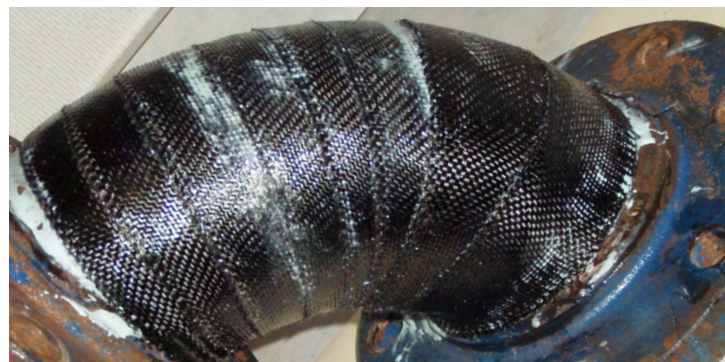
A pipe failure occurred onboard the MODU Quantum 4000 on the No. 5 main generator cooling water system. The leak, caused by corrosion, occurred on a carbon steel 4" SCH 80 short radius flanged elbow which is part of the saltwater discharge from a titanium plate heat exchanger. The system pressure is 40PSIG (2.75 bar) and the temperature is 105 F° (40 C°).

The Chief Engineer decided to repair the failed pipe elbow utilizing a 4" Marine HydraWrap elbow kit, a Design Approved by the American Bureau of Shipping for shipboard piping repairs.

The surface of the pipe elbow was surfaced prepped to achieve a mechanical profile. The HydraWrap FRP repair system was then applied in accordance with design standards.

The leak was quickly sealed and the pipe was returned to service. The crew was pleased with how easy it was to follow the directions for application. The repair will extend the service life of this pipe for years to come.
