**Market**  
*Water & Utilities*

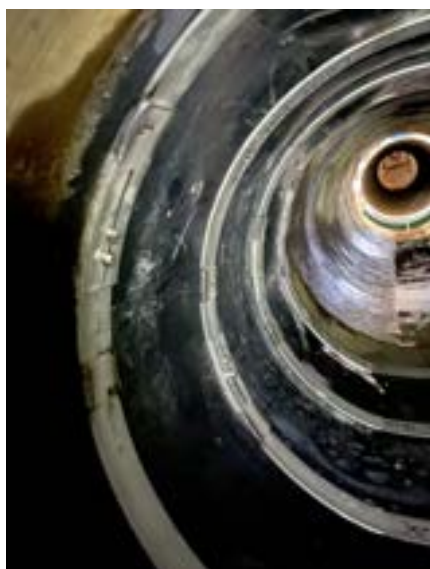
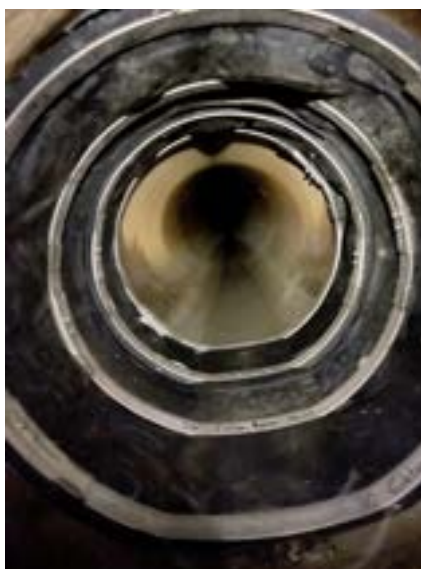
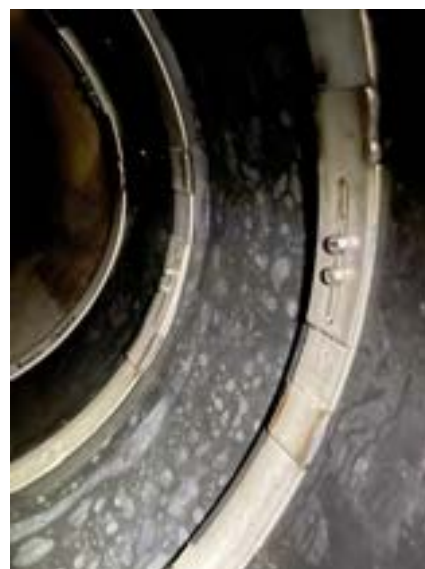
A four-inch crack had formed in a reinforced concrete pipe (RCP) near a joint where this pipe connected to a steel pipe. As a result, there was an active leak in this 30" pipe that raised concerns of the crack growing, contaminating the potable water, and creating voids around the pipe leading to eventual total system failure.

The chosen solution was to isolate the crack by sealing it with three interlocked Standard-Wide HydraTite Internal Pipe Joint Seals.

Before the installation, the facility lowered the reservoir and shut off all valves to the affected pipe to ensure the field crew's safety. In only seven hours the three seals were installed over the RCP's crack.
