HYDRAWRAP

STRUCTURAL COMPOSITE REPAIR SYSTEM

Market
Municipal

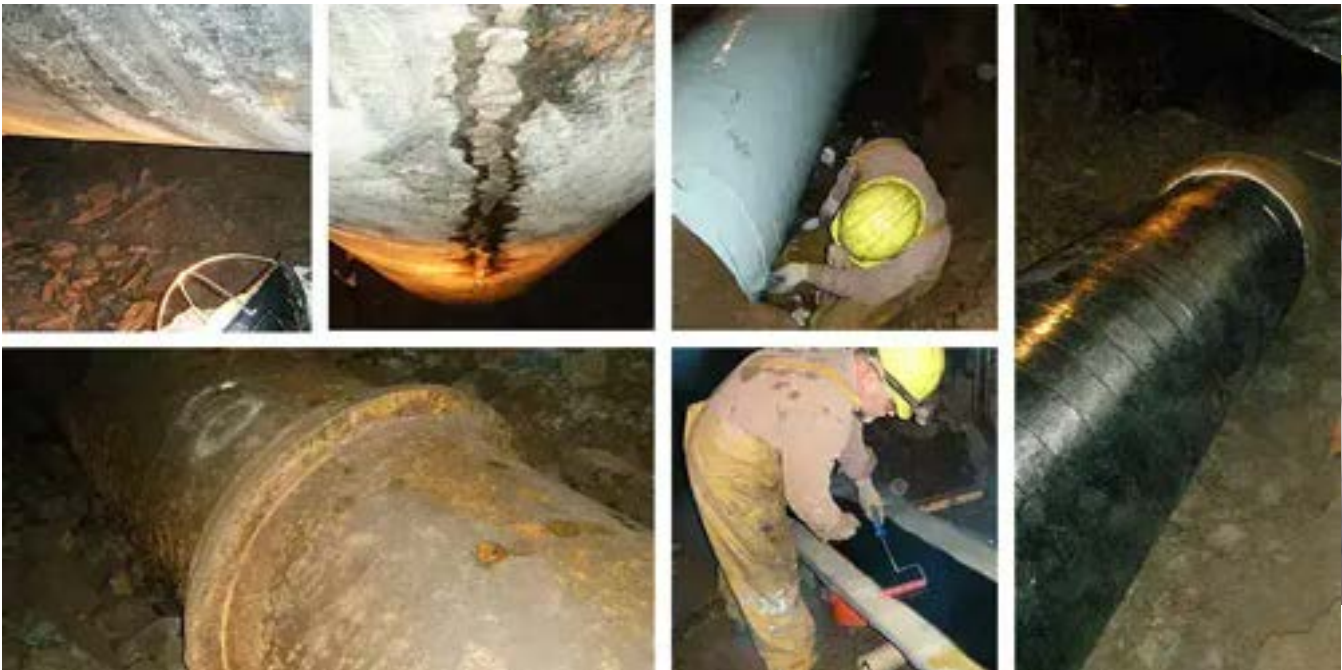
A 36" cast iron supply line pipe located in a tunnel had visible corrosion. A thru-wall defect was causing a 12-foot section between the bell and spigot to leak. A repair method was needed that could guard against corrosion as well as eliminate the leaking.

To eliminate the leak quickly and avoid costly replacement, a composite repair was chosen, 12" HydraWrap fabric with the standard epoxy.

HydraWrap was applied in a weld repair fashion. A layer is applied, completely encircling the pipe. Then the next wrap layer was offset 2" from the previous wrap. Each layer was applied the same way until all 12 feet were wrapped. The result was 5 layers of fabric over the repair area. Applying these 5 layers only took 2 days.

HydraWrap repaired the thru-wall leak and will provide a barrier against corrosion. This repair was completed at a fraction of the time and cost associated with replacement.
