Market
Water & Utilities

Challenge

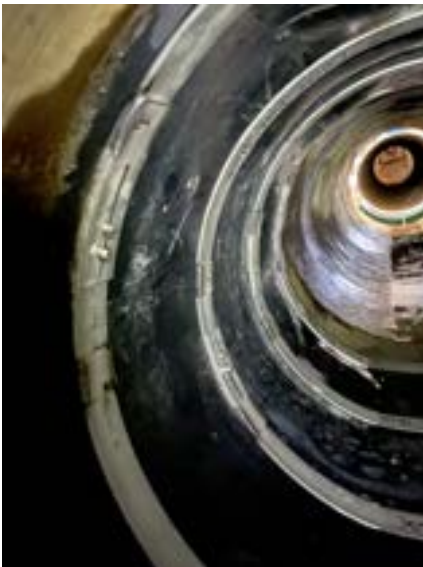
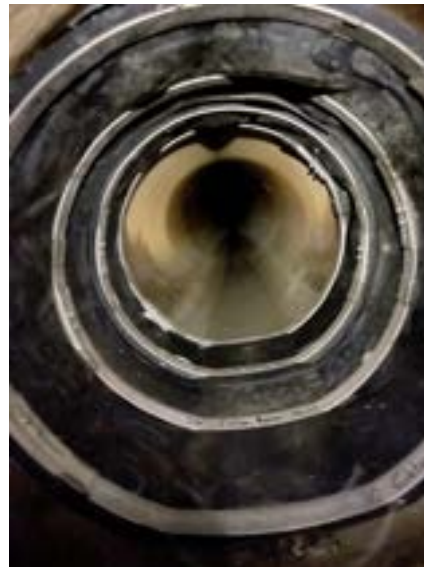
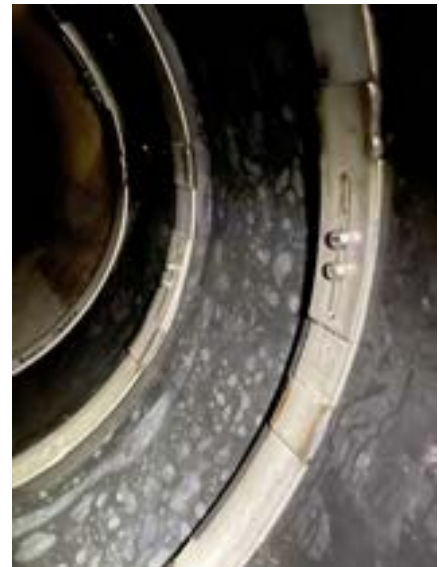
A four-inch crack had formed in a reinforced concrete pipe (RCP) near a joint where this pipe connected to a steel pipe. As a result, there was an active leak in this 30" pipe that raised concerns of the crack growing, contaminating the potable water, and creating voids around the pipe leading to eventual total system failure.

The chosen solution was to isolate the crack by sealing it with three interlocked Standard-Wide HydraTite Internal Pipe Joint Seals.

Before the installation, the facility lowered the reservoir and shut off all valves to the affected pipe to ensure the field crew's safety. In only seven hours the three seals were installed over the RCP's crack.

The HydraTite's flexibility of application allowed for this unique, long-term repair and the seal proved to be an economical and time-efficient repair that will protect the pipe for years to come.
