INTERNAL PIPE

# HydraTite®

JOINT SEAL

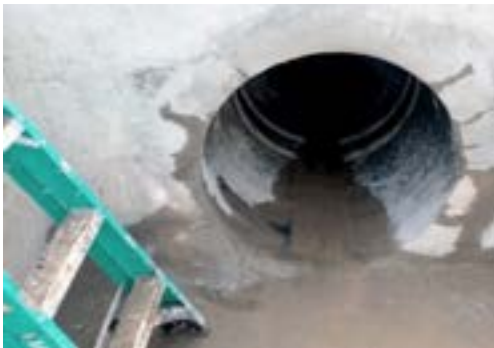
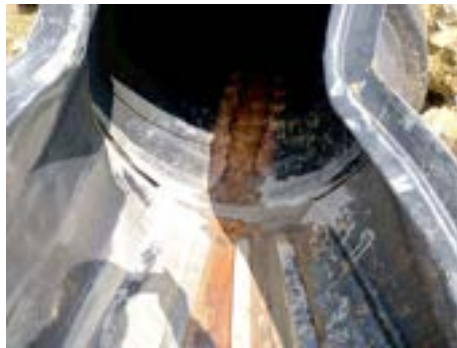
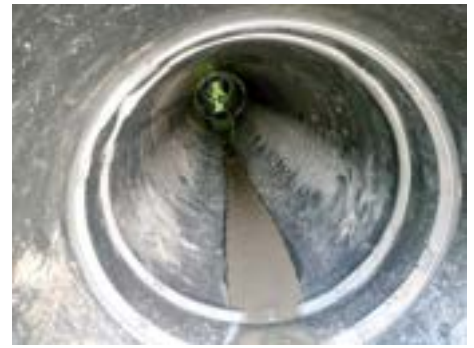
The joints of a 36 inch corrugated polyethylene outfall pipe had become separated due to increasing soil and live loads. Eliminating the infiltration without disrupting the traffic flow raised concerns. The preferred method of repair was to eliminate the infiltration without interrupting traffic flow.

Standard wide HydraTite Internal Pipe Joint Seals were used at the disconnecting joints to prevent infiltration.

11 HydraTite seals were used to repair the joints that had shifted apart. The headwall was fixed with Hydraulic cement. All repairs were completed in 2 days.
