INTERNAL PIPE

# HydraTite®

JOINT SEAL

*Power Plant*

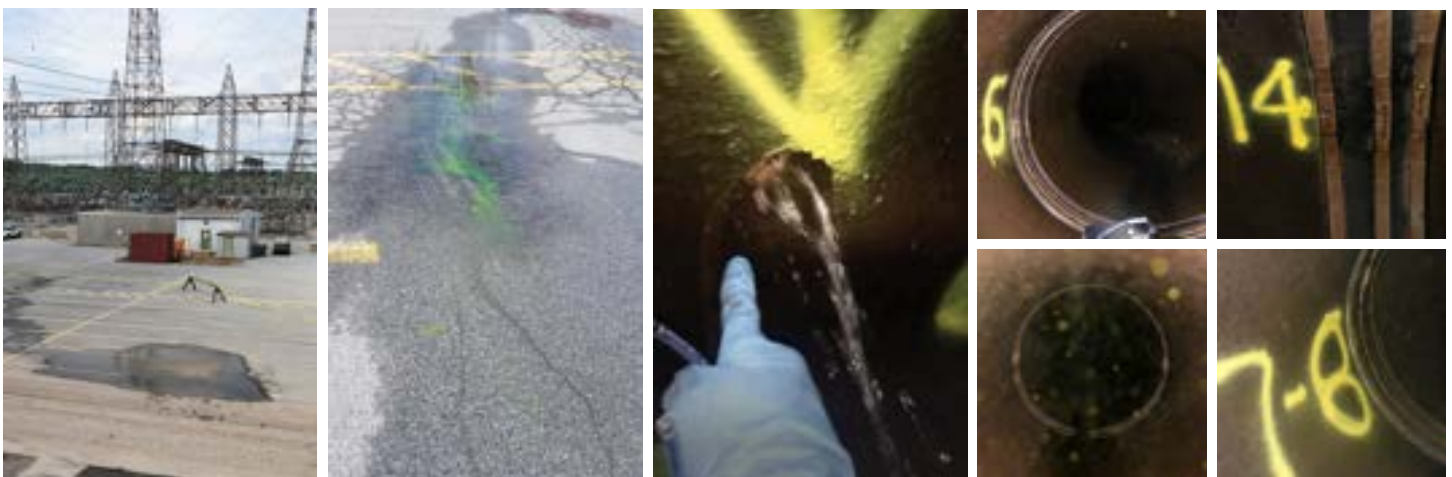
HydraTech was given 48 hours to find and stop the leaks. The system was shut down, the pipe was dewatered and a safety brief was performed with the Station and HydraTech before entering the pipe. HydraTech cleared a permit confined space and two technicians entered the pipe to identify the location of the leak. Several pipe joints were found with some deterioration, but one was clearly the actively leaking. Three HydraTite seals were installed at three different locations. The concrete to steel transition joint, the active leak between joints, and another leaking concrete joint. The HydraTite seals were installed in 10 hours.

## Solution
