# INTERNAL PIPE HydraTite® JOINT SEAL

A leak was identified in a 30" pump suction line at a coal power plant in Ohio. A repair method was needed to prevent digging up the building.

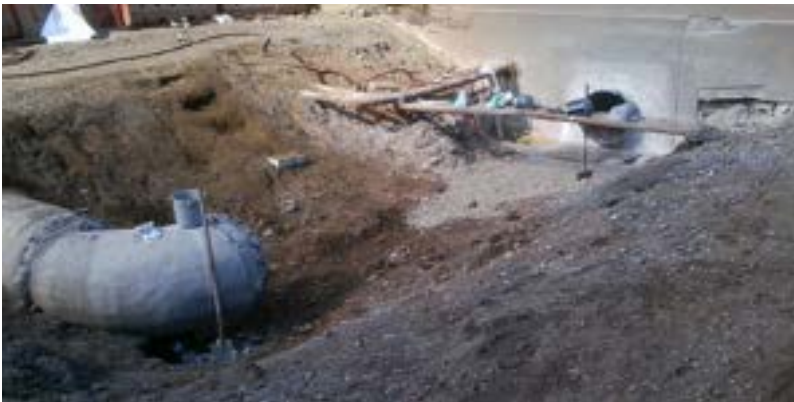
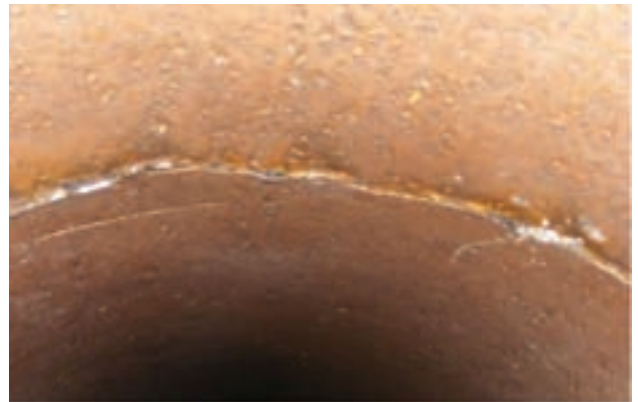
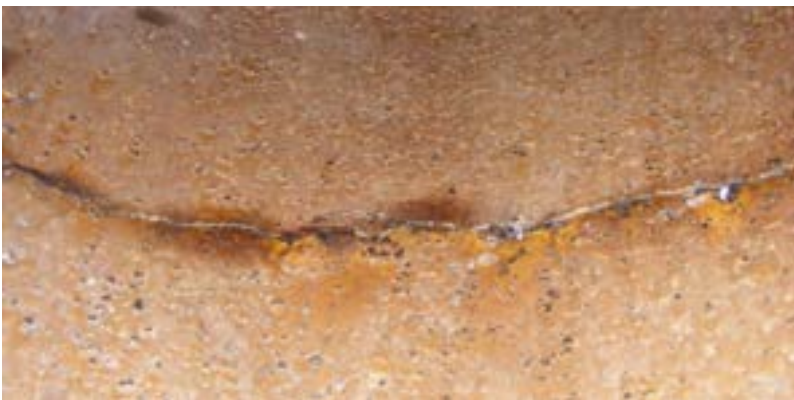
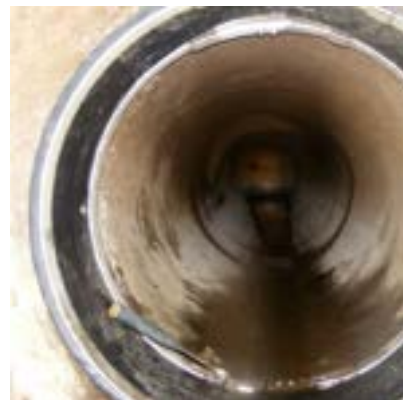
## Phase 1

A circumferential crack had formed 16" upstream from the transition joint where the steel connected with the concrete pipe. An extra-wide seal was installed over the leak in only 2 hours.
