# HydraTite®

JOINT SEAL

*Power*

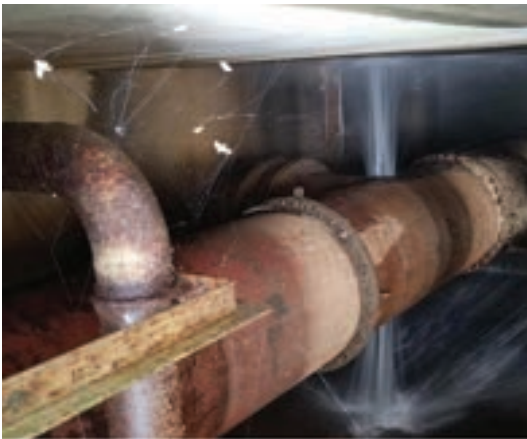
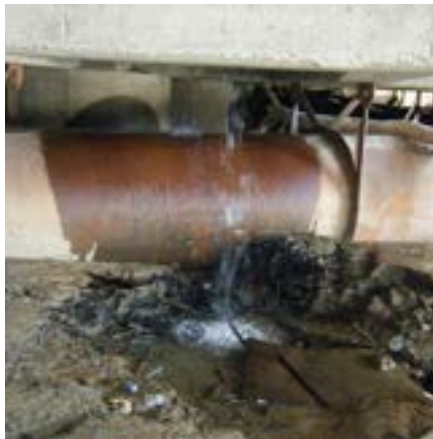
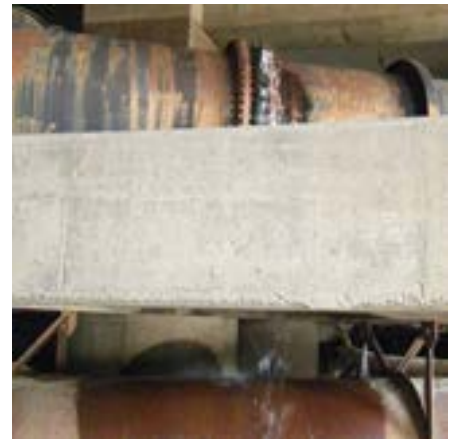
External crack to a 78-in circulating water pump expansion joint caused extensive leakage and forced the power station to shut down.

The solution utilized the HydraTite® seal consisting of three two-piece 304 stainless steel bands, a double wide EPDM seal, and a 16 gauge stainless steel backing plate to provide an internal slip joint repair.

Once the HydraTite® internal seal was installed, the leak was isolated and the circulation system was operational. This saved the power company extended downtime.
