INTERNAL PIPE

# HydraTite®

JOINT SEAL

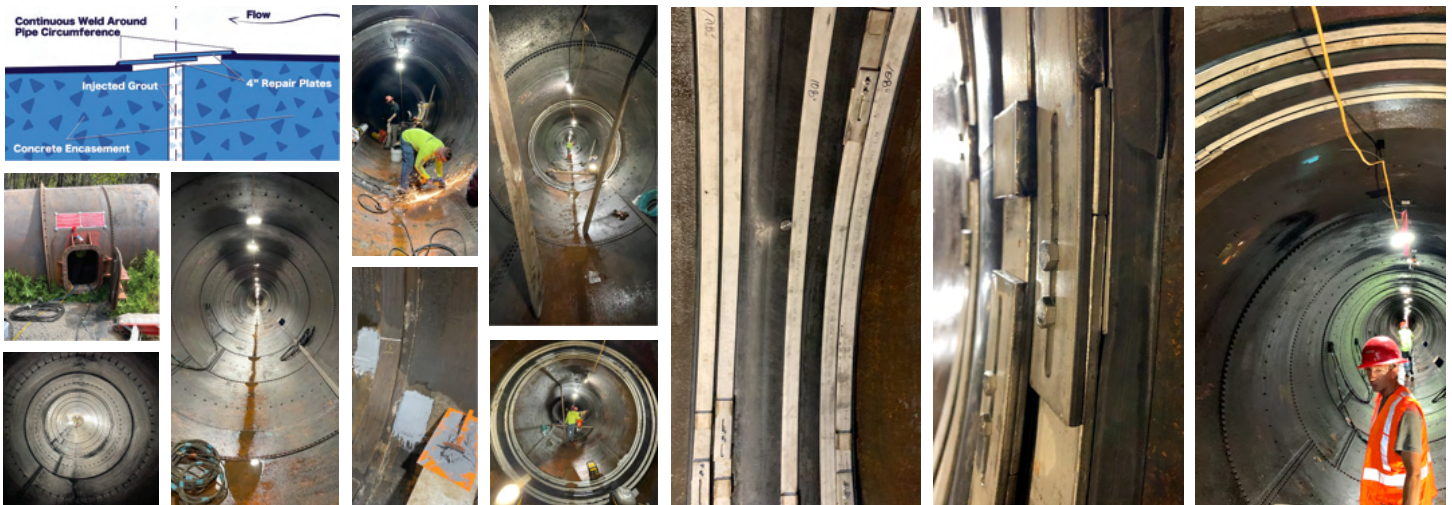
A 9' diameter steel penstock had become separated at a riveted connection and shifting had created 1.25" of offset. The pipe was encased in concrete and within an embankment, which would complicate replacement. The repair would have to withstand a high velocity of water, approximately 9-10.5 ft per second as the pipe was part of a flowline from a hydroelectric dam.

The chosen solution was multifaceted. Grout, repair plates, epoxy, and a double-wide HydraTite Seal with 5 retaining bands would be implemented together to ensure that this repair would be permanent.

This project consisted of several steps, of which several were completed prior to HydraTech's involvement. First, the grout was injected into the joint between the encasement and penstock. Next, two overlapping repair plates were welded over the joint. Then epoxy was applied to transition the 0.75" drop off created by the plates. Then HydraTech helped instruct and install the HydraTite seal over the plates with five retaining bands holding the rubber in place. Finally, the seal was air tested and was proven to be airtight. The HydraTite installation and air test were completed in one day.
