INTERNAL PIPE

# HydraTite®

JOINT SEAL

*Stormwater*

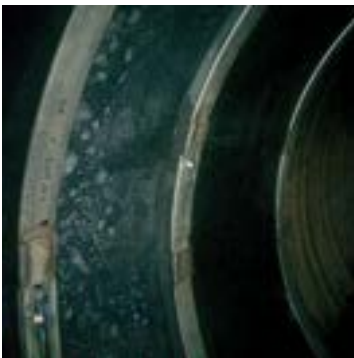
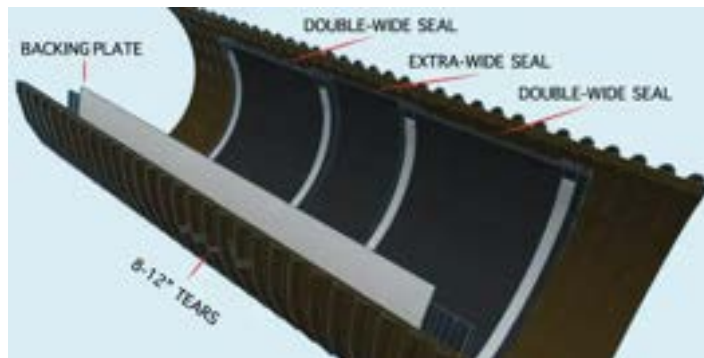
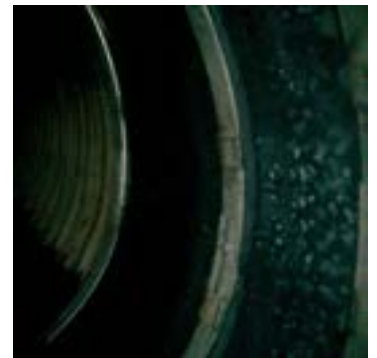
During a visual inspection of 48" HDPE pipes in Massachusetts, multiple tears were discovered near the discharge to the catch basins. The tears were between eight to twelve inches in width. Excavation would be difficult due to the affected pipes being 25 feet below grade.

Soil had fallen into the pipes and had to be removed before installation to ensure a proper seal. Then a backing plate was positioned over the first repair location. Two double-wide seals and one extra-wide seal were then installed in an interlocking fashion so that the outer ribs reached beyond the backing plate and pressed into the interior surface of the pipe. This process was repeated in the other two repair areas. Three sleeves, nine seals, were installed in two days.

HydraTite was installed quickly, providing a permanent repair that eliminated infiltration of groundwater and preserved the soil bedding around the pipes. The integrity of the pipes was restored without compromising the hydraulic capacity of the storm drain system.
