# HYDRAWRAP

STRUCTURAL COMPOSITE REPAIR SYSTEM

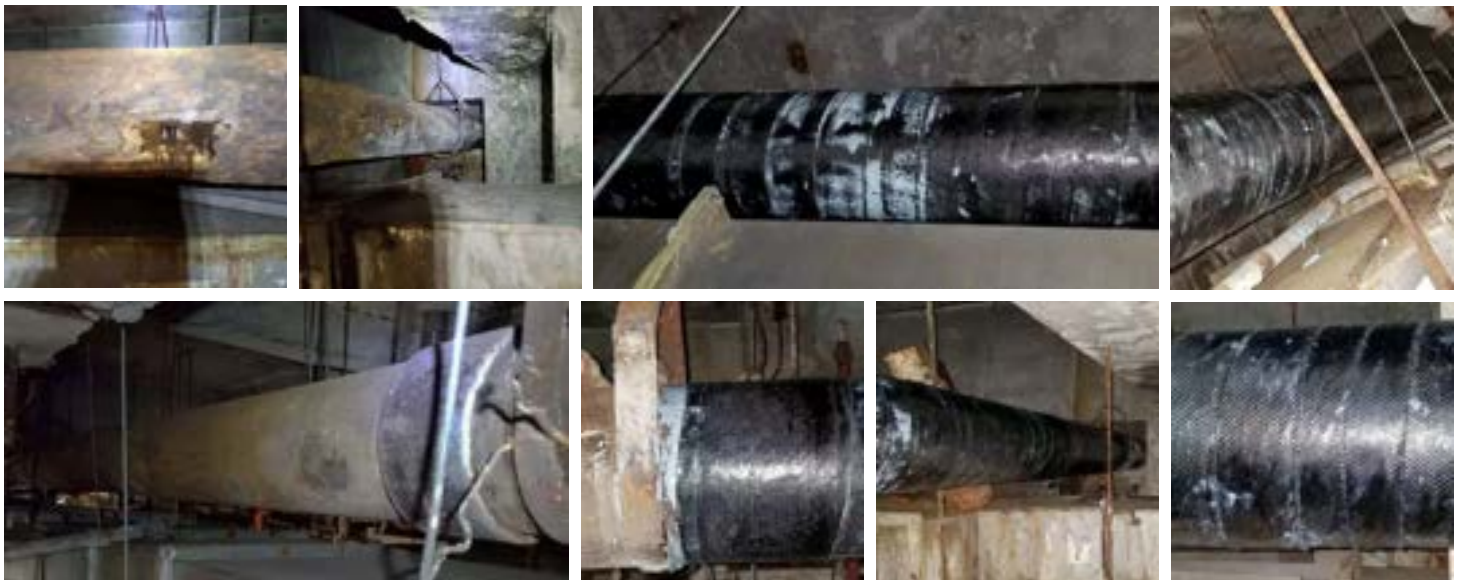
A gas main that ran through a hotel basement suffered from severe external corrosion, threatening the integrity of the pipe. The 8" pipe required an external repair to ensure that it continued to successfully supply the hotel.

Surface preparation was completed with nonsparking tools to remove irregularities, creating the desired surface profile for FRP installation. Primer epoxy was then applied to the prepared surface. The carbon fiber was then saturated with wet-out and applied to the primed surface. Then two layers of fabric were applied in a spiral that ran 18°. After the epoxy cured, a protective top coat of paint was added. The installation was completed in 2 days.

HydraWrap reinforced the pipe while providing a layer of corrosion protection for this gas main at a fraction of the cost and time associated with replacement.
