## Market

*Commercial / Stormwater*

## Challenge

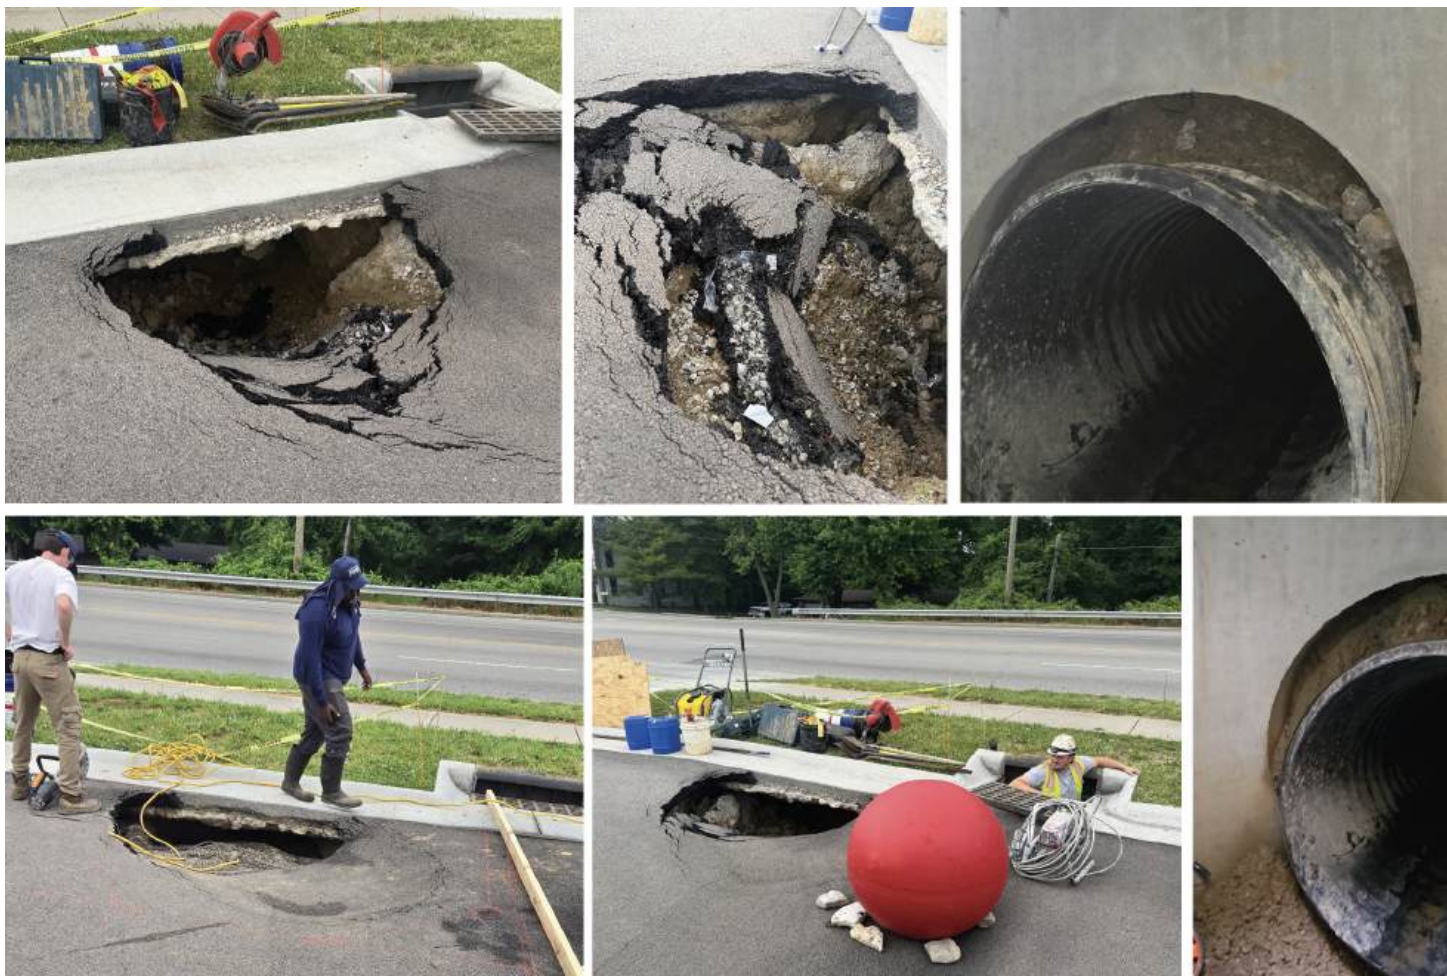
A commercial car wash discovered a developing sinkhole after pavement above a stormwater system began to settle and partially collapse. Investigation revealed that an aging stormwater pipe had gradually become deformed, preventing it from properly connecting where it entered the manhole junction box. The resulting gap allowed groundwater to infiltrate and surrounding soils to migrate into the manhole, creating an underground void that eventually caused the surface pavement to fail.

Rather than simply filling the sinkhole, the Field Services team developed a repair plan that addressed the underlying cause of the failure. The project began by verifying the exact infiltration pathway before repairing the defective pipe-to-manhole connection using polyurethane chemical grout injection. Once the leaking penetration was stabilized, the underground void and surface pavement could be reconstructed with confidence that future soil migration had been eliminated.

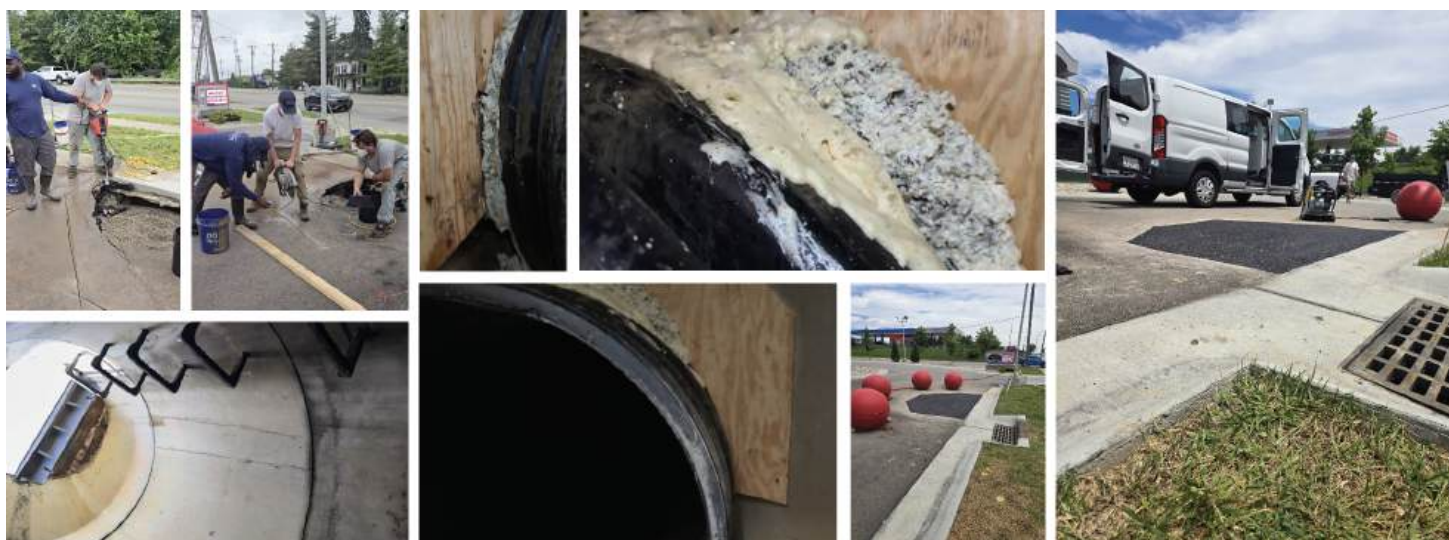
The repair successfully restored this defective connection that had been responsible for washing soil into the stormwater structure and creating the underground void. With the pipe penetration rehabilitated and the pavement fully restored, the sinkhole was eliminated, and the parking area was safely returned to service.

Inside the manhole, deteriorated material surrounding the pipe penetration was removed, and filler was placed in the void between the wall of the manhole junction box and the end of the pipe. Then a wooden form was constructed around the connection point. Polyurethane chemical grout was then injected behind the form, creating a barrier against debris falling into the manhole junction box. Following completion of the internal repair, approximately twenty 50-pound bags of asphalt were placed, compacted, and finished to restore the parking lot to its original grade.
