# HYDRAWRAP

STRUCTURAL COMPOSITE REPAIR SYSTEM

## Challenge

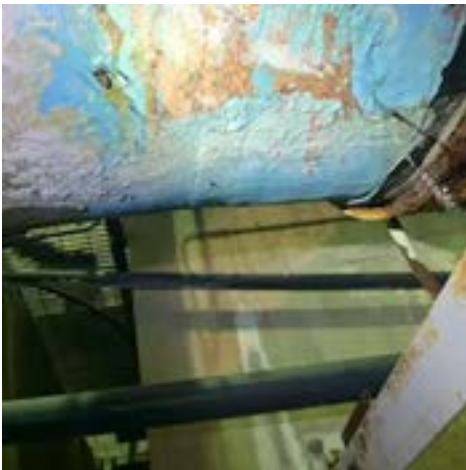
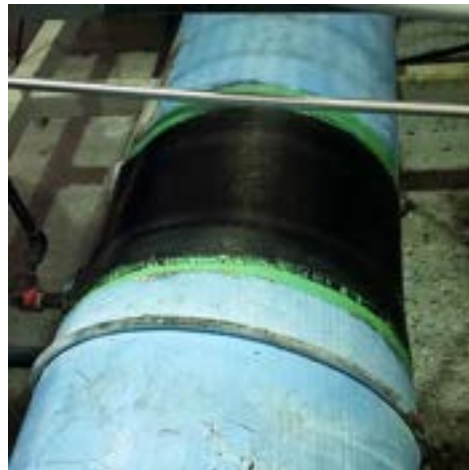
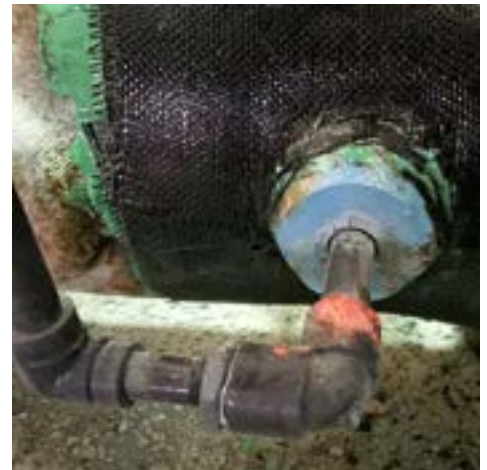
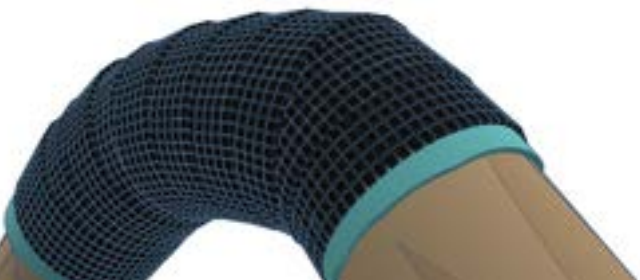
A municipal pump station discovered a cluster of pinholes in an 18" FRP pipe. A repair was needed that could be applied quickly and withstand the corrosive properties of the pipe's contents.

The pipe was briefly shut down to stop the active leak. First, the repair area's surface was cleaned. For pipes with smooth surfaces, such as FRP pipes like this, PVC, and HDPE, extra attention is needed to create a textured surface. To extend the service life of this repair, the surface of the pipe was abraded to promote good bond strength. This newly created mechanical profile extended 3" beyond the compromised portion of the pipe. Once the pipe's surface was clean, dry, textured, and even, the primer epoxy was applied. Next, the carbon fiber fabric was saturated with wet-out epoxy. Finally, two layers of fabric were wrapped around the repair area. The entire process was completed in a single day, limiting the necessary downtime.
