# INTERNAL PIPE HydraTite® JOINT SEAL

*Stormwater*

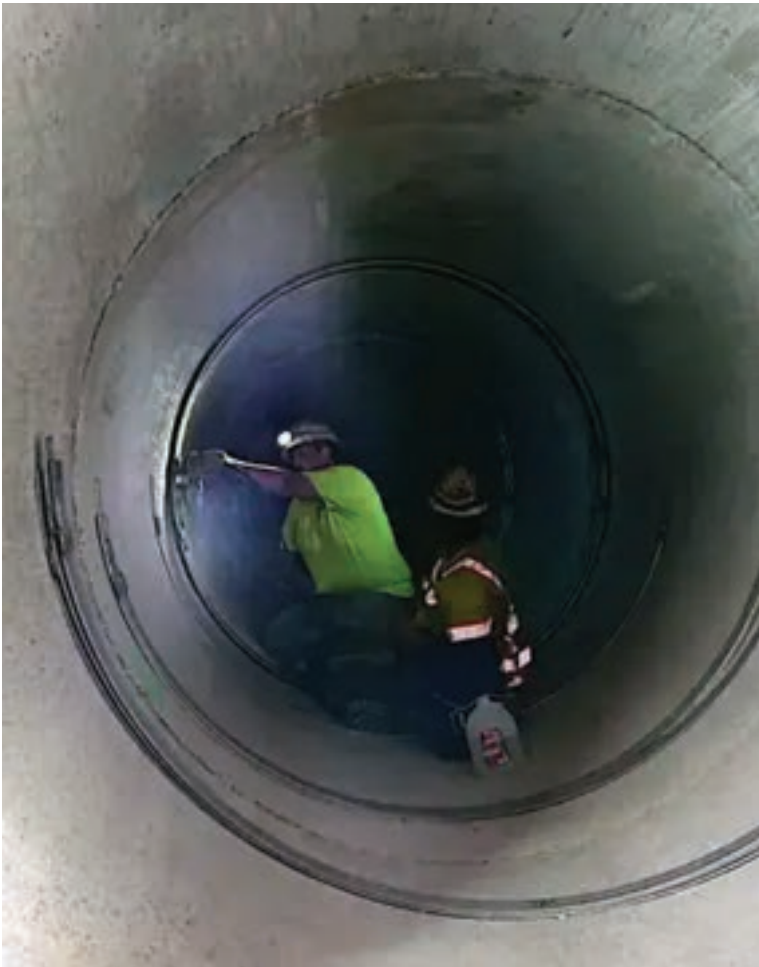
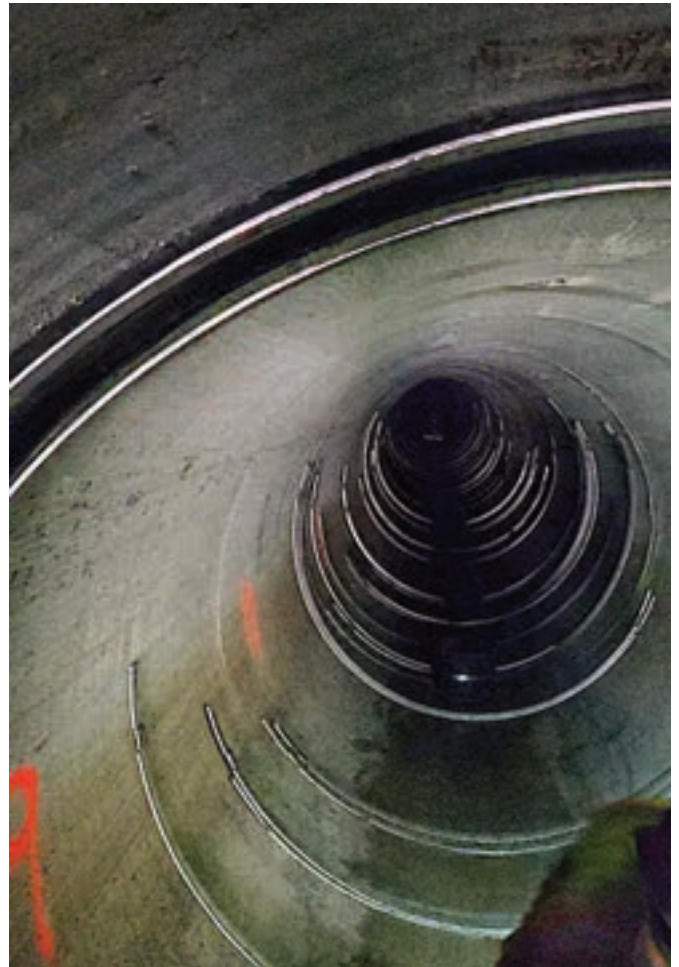
A 72" storm drain in Texas had recently been installed but failed a pressure test. Replacing pipe that had just been installed was not an option and grouting the joints would not be a long-term solution. A permanent repair option was needed that could withstand the anticipated high head pressure once the pipes were put in service. A trenchless repair was required to ensure that the road above would not be disturbed.

Since this pipeline was recently installed, the interior surface of the pipe was in good condition and free of debris. There was minor joint separation, but none separated more than an inch. The rubber seals were placed at each of the joints so that the ribs made contact with the interior surface of the pipe on either side of the joint. Then two retaining bands were installed atop the rubber, putting pressure on the ribs. The third band was loosely constructed and positioned between the initial two bands. After that, the seals were each air tested. Finally, the third band was expanded and locked in place. Our crew of 3 installed 61 seals in 9 work days.

Standard-wide HydraTite Internal Pipe Joint Seals with three of the two-piece retaining bands was the chosen solution for this system. The additional retaining band was selected to address the expected high head pressure.

Every joint in this storm drain was fortified against leaks in only 9 days. This trenchless installation did not disrupt the traveling public and will provide decades more protection compared to grout.
