HydraTite® Internal Joint Seal

The challenge was to eliminate infiltration at pipe joints in an ash pond outfall pipe.

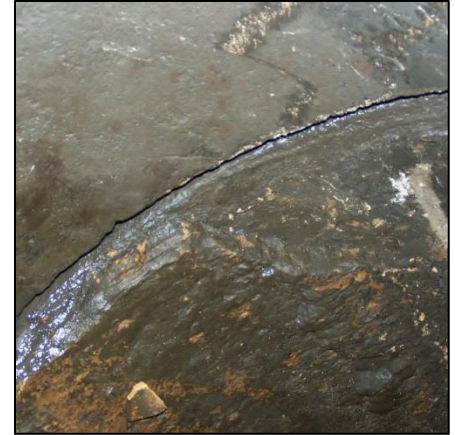
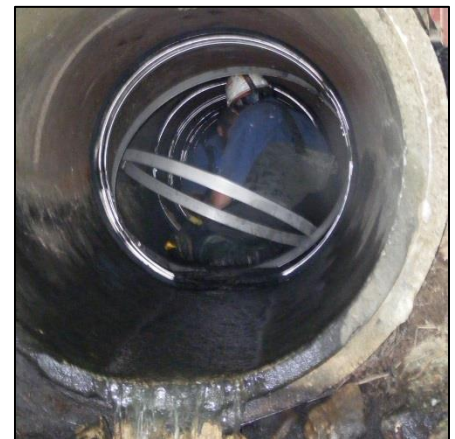
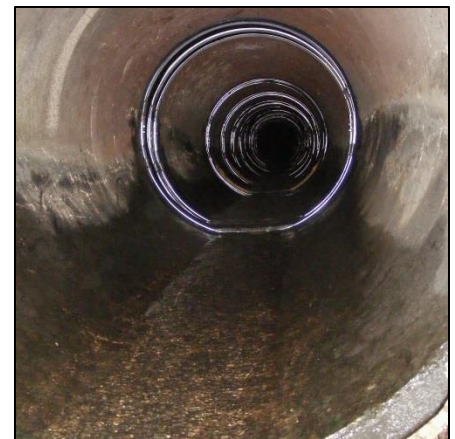
During a routine inspection, company staff identified several sinkholes following the path of the ash pond outfall pipe. Inspection of the reinforced concrete pipe revealed the pipe joints had deteriorated, and the sinkholes were caused by infiltration. The station made the decision to use the HydraTite internal joints seals that are designed for the rehabilitation and restoration of declining pipe joints. Due to the short window for installation, the HydraTite seals were used to eliminate infiltration. Mindful of the environmental issues associated with the ash pond, HydraTech closely monitored and controlled the ash pond level during the installation of the HydraTite seals, minimizing flow.

The limited shutdown time of the outfall pipe made the HydraTite internal pipe seal the ideal solution since no excavation was required. The HydraTite installation was completed in one day, and eliminated further infiltration and prevented ground shifting and sinkholes.
