## HydraTite® Internal Joint Seal

The challenge was to eliminate pipe joint leaks in a 120-in recirculating cooling line in a fossil fuel power generation station.

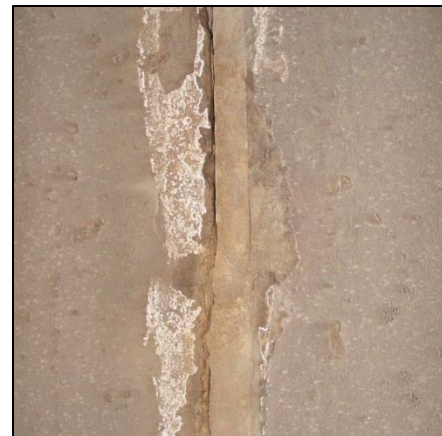
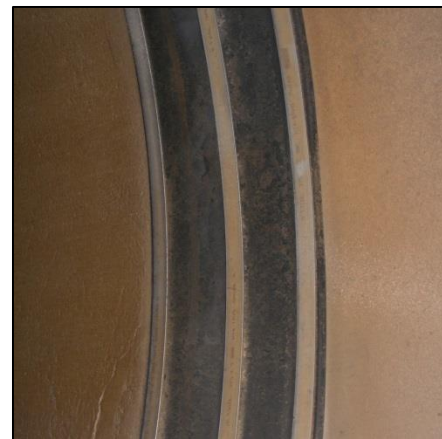
The joints showed deterioration and exposed steel cylinder, as well as broken and missing mortar. There was visual indication of leaking from the exterior during inspection.

The solution utilized double wide and extra wide HydraTite internal joint seals with 316L stainless steel retaining bands to eliminate further leakage.

Prior to installing the seals, cementitious filler was used in areas of large joint separation and where missing and spalling concrete was evident. Existing man-ways and access points were utilized to transport seal components and manpower.

All leakage was eliminated. The seals were installed in one day to prevent extended loss downtime.
