## HydraTite® Internal Joint Seal

A water treatment plant in western Ohio was confronted with repairing leaks of costly treated water from an underground transfer chamber without draining the system.

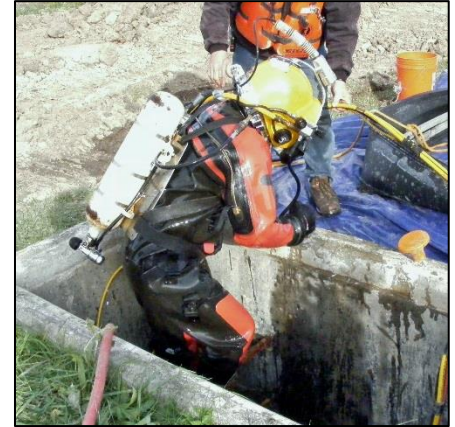
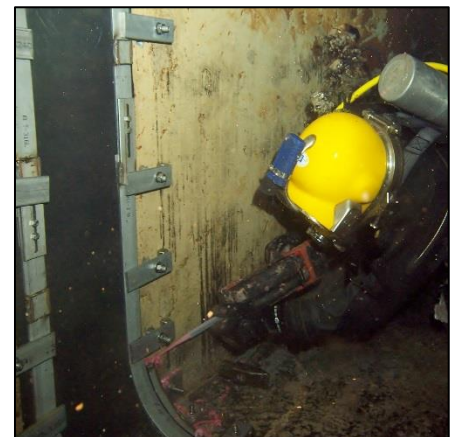
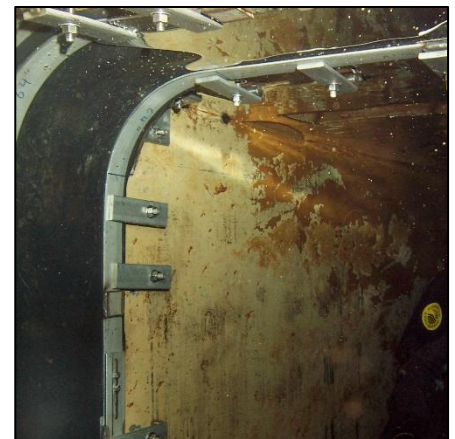
During an inspection performed by divers, a total of five (5) construction joints in various reinforced concrete transfer chambers were identified as the sources of the leaks. The corners of the square cross section chambers required prefabricated stainless steel forms to produce the required radius. The straight sections of the HydraTite seal are equipped with anchor clips.

Divers, after training on the installation of the HydraTite seal, prepared deteriorated surface areas on either side of the joints and installed the HydraTite seals with the furnished stainless steel forms and anchor clips.
