## HydraTite® Internal Joint Seal Saves Bison on Ranch!

**McCall River Ranch of Idaho**

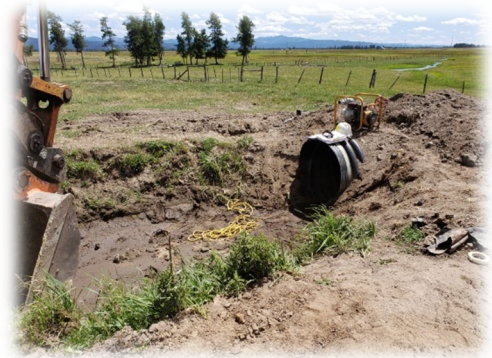
HydraTech's factory technicians installed the HydraTite seals in a matter of a few days. The 45 Degree bend within the pipe made the access of repair locations difficult for the HydraTech installers, yet their specialization in confined space allowed them to complete the job successfully. Custom band size and multi-piece configurations were engineered and manufactured for this project in order for seal installation to be completed beyond and around the 45-degree bend.

The proposed solution involved sealing leaking pipe joints of the ADS irrigation pipe. HydraTech suggested sealing of pipe joints with the HydraTite Internal Joint Seal. The HydraTite is a cost effective and fast solution to repairing leaking joints and points of underground pipe.
