Market

Culvert rehabilitation

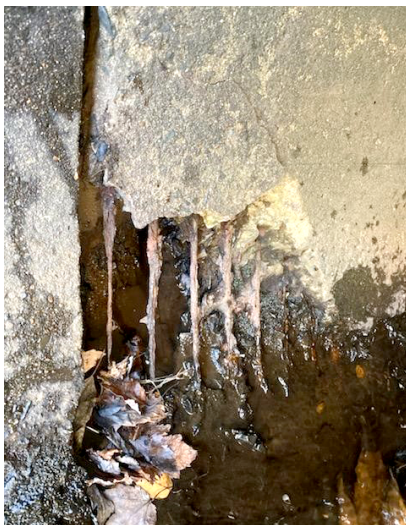
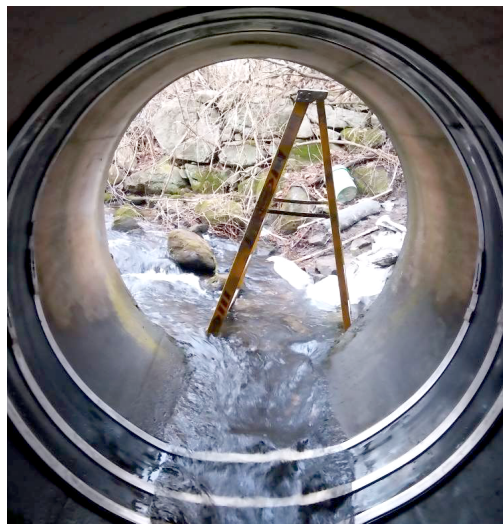
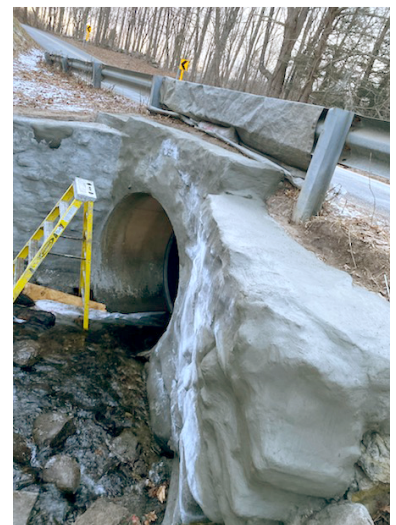
A culvert in Watertown, CT had a significant water flow and erosion problem which led to culvert joint separation, invert deterioration, erosion issues, and headwall damage. The erosion had undermined the outlet which resulted in a disruption in water flow. With the age of the culvert, the inlet headwall was made with stacked stone. Over time these stone headwalls can settle and become weak and start to lose structure. This culvert was located under a roadway which also has challenges with traffic control. The separating joints caused concerns with the above roadway being damaged by infiltration.

Hydratech implemented an engineered solution to address all of these issues. HydraTite Seals were installed over the culvert joints for a permanent solution to the separated joints that were leaking and eroding the ground below the roadway. 5 tons of riprap (large diameter stone) was placed over the existing outlet void to prevent further deterioration and erosion by restoring natural water flow. The stone headwall was encased in two layers of concrete to prevent further structural damage and environmental erosion.

The job consisted of the installation of 9 HydraTite Seals that were 72" in diameter, placement of 5 tons of riprap, concrete patching inside the pipe, the concrete casing of inlet stone headwall.
