Market:
Waste Water Treatment

Challenge:
The existing pipe that carried the wastewater through the treatment process had developed leaks at the pipe joints. The leaking pipe caused infiltration under the facility that was threatening its structural integrity as well as air quality. The pipes were also filled with debris and sediment that needed to be cleaned out.

Engineered Solution:
The HydraTite seal was specified to stop infiltration, preventing further structural damage to the pipe and above facility.

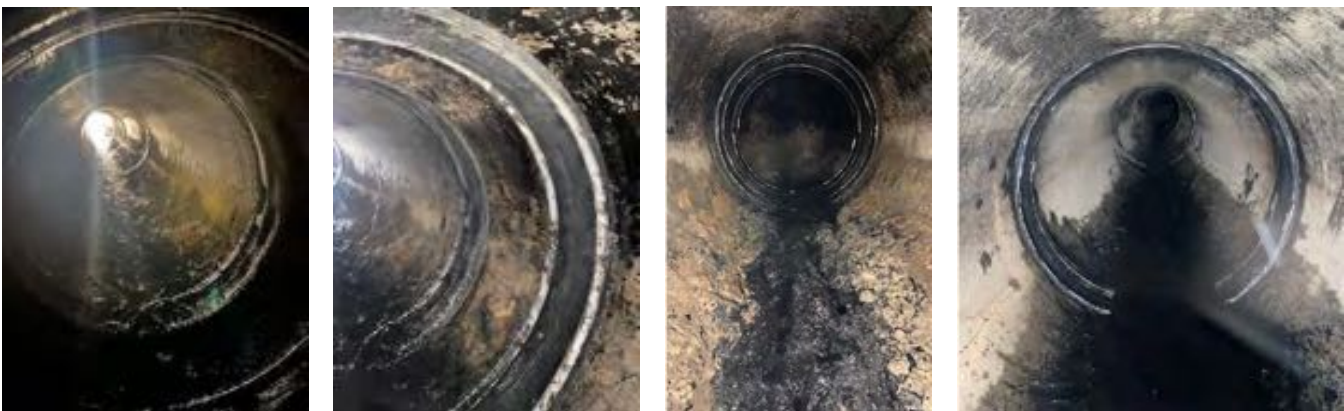
Scope:
The pipe rehabilitation required confined space entry. Technicians had to tie off in case of emergency pipe escape. Fresh air had to be pumped into the pipe to ensure the atmosphere was safe. The air needed to be monitored in several locations for the entirety of the installation. Sections of the pipe had different diameters, 8 seals with a diameter of 42" had to be installed in one section and 6 seals with a diameter of 64" had to be installed in another section. The debris and sediment had to be hand shoveled so the joints were clear and the seals could be watertight.

Solution:
Using the HydraTite Internal Pipe Joint Seal, the existing clarifier pipe was sealed so that the entire system was watertight. The above facility was protected from infiltration and possible structure damage. This point repair method proved to be more cost-effective than lining or replacing the pipe. The treatment facility was able to stay on schedule as the repair was completed in less than a week.
