# HydraTite

JOINT SEAL

Drinking-Water

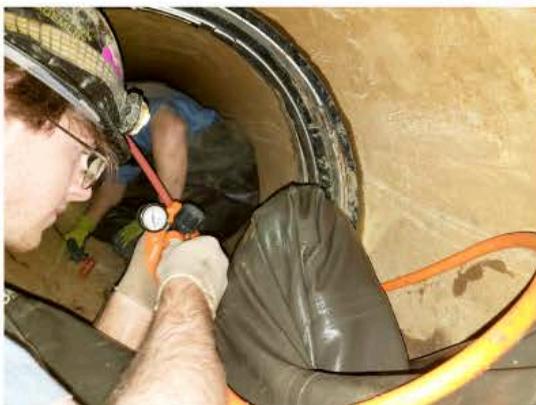
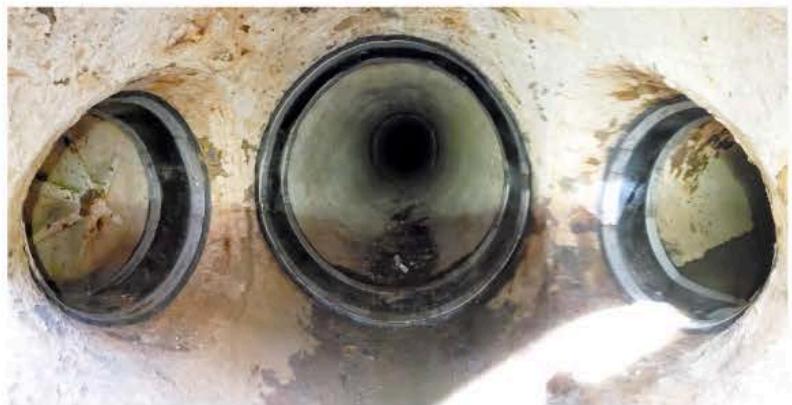
The mechanical Internal Joint Seal HydraTite was selected for the many needs of the water main. Seals of different diameters and differing thicknesses were employed for this project. Backing plates were used with the seals to cover the abandoned connecting 12" pipe and service taps.

The pipe had a low section that required dewatering. 1152 seals were installed throughout the entire water main. These were used to seal joints, unused service taps and abandoned connecting pipes. Several seals were installed with backing plates.

The HydraTite seals eliminated infiltration at all joints. The HydraTite Solution enabled a trenchless repair at a fraction of the cost of alternatives. None of the above trees or facilities were affected by the water main rehabilitation The HydraTite seal proved to be an economical in situ repair solution making the operation of the penstock pipe more cost-effective.
