Market:
DOT

Concrete columns and the crash walls of a bridge had begun to spall, exposing the reinforcing bars, and beginning to raise the concern of the structure's integrity.

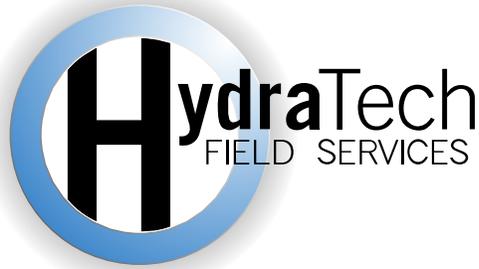
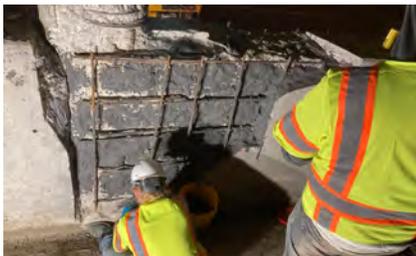
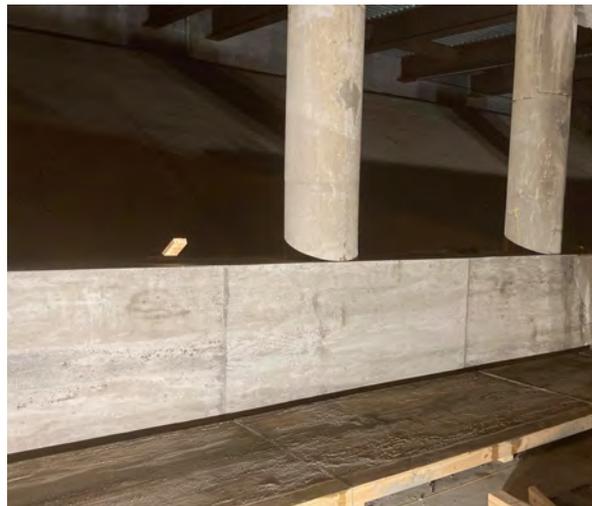
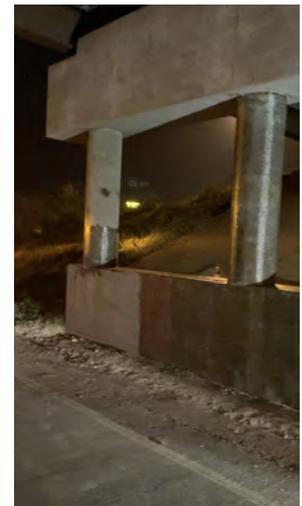
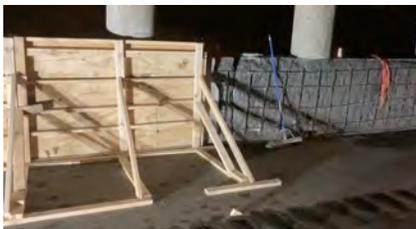
Damaged sections were marked and jackhammers were used to remove the spalling sections. Sections of the crash wall had deteriorated sufficiently to expose the reinforcing bar. Tie wire was used to restore the rebar back into place. The surface was then media-blasted to remove any remaining loose debris. The concrete form was put up and the new concrete was applied. Once the concrete was set, grinders were used to rough up the surface to ensure the carbon fiber wrap would adhere correctly. Next, the carbon fiber wrap was applied. Finally, the fiber wrap was given a topcoat. The total repair resulted in reinforcing five crash walls and 30 columns.

The project plan involved removing loose and spalled concrete sections of both the column and crash wall and replacing the deteriorated areas with new concrete. In addition to the concrete repairs, the columns were wrapped with a carbon fiber composite to provide concrete confinement. This additional step provided a cost-effective and long-term repair, adding extra strength and protection.

Replacing deteriorated concrete and installing carbon fiber wrap confinement provides a time-efficient economical solution compared to replacement while extending the service life of the bridge.
