HydraTech

PROJECT EXAMPLES BY MARKET

Project Examples Highlighting

HydraTite®

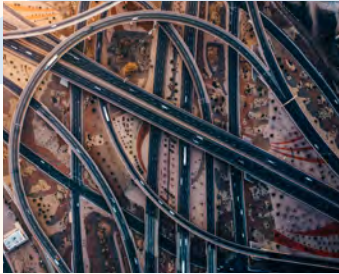
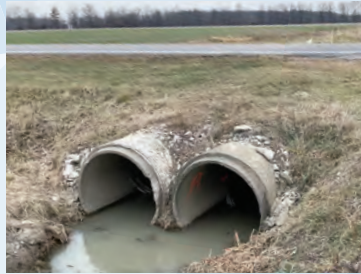
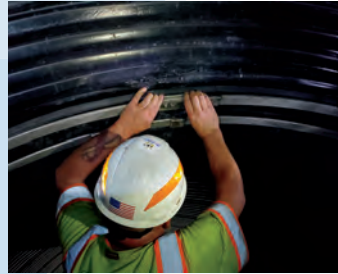
Transportation & DOT

HydraTite® protects culverts, tunnels, and similar drainage structures.

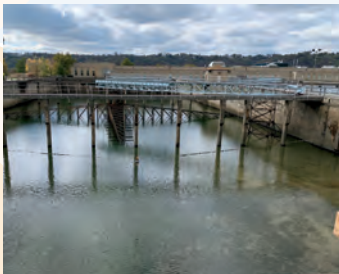
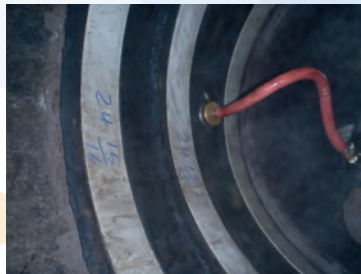
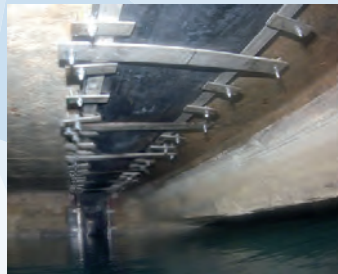
Water & Utilities

HydraTite® is NSF/ANSI 61 approved for potable water 18"-288" diameter pipe. Recognized by AWWA M28, AWWA C621-18, and forthcoming M81.

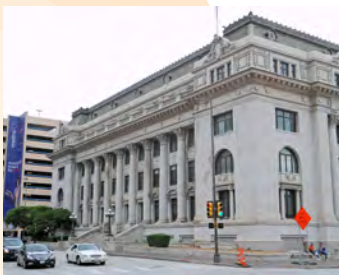
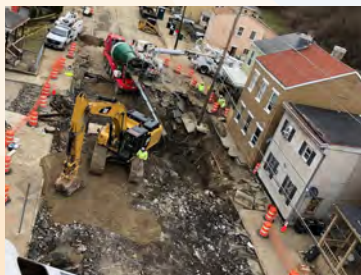
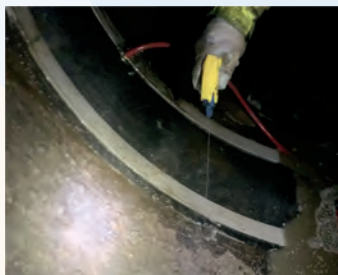
Municipal

HydraTite® is utilized in water and wastewater piping. Approved and specified by various municipalities.

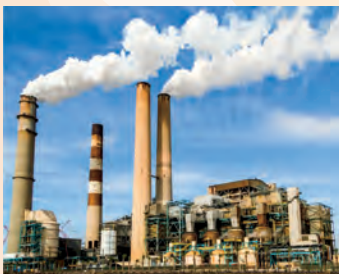
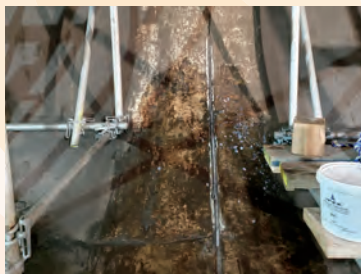
Power & Utilities

HydraTite® is utilized in cooling water piping and tunnels in power plants.

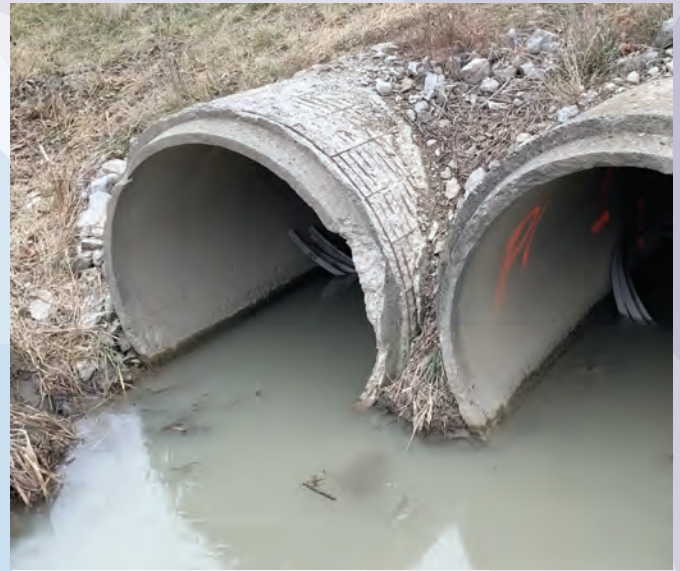
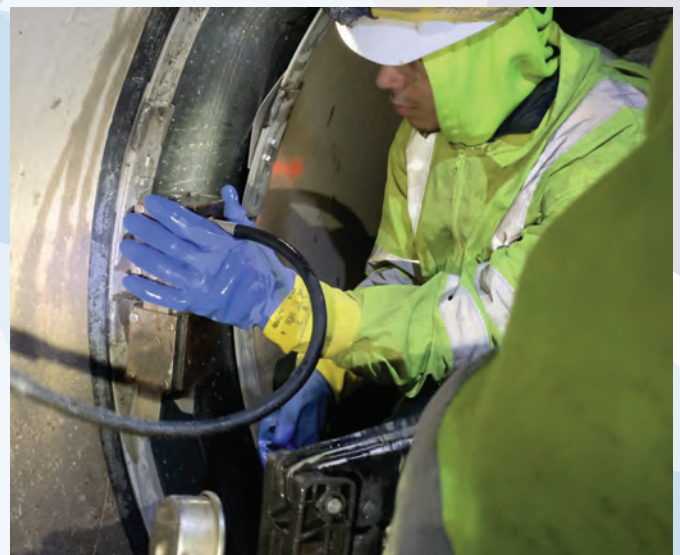
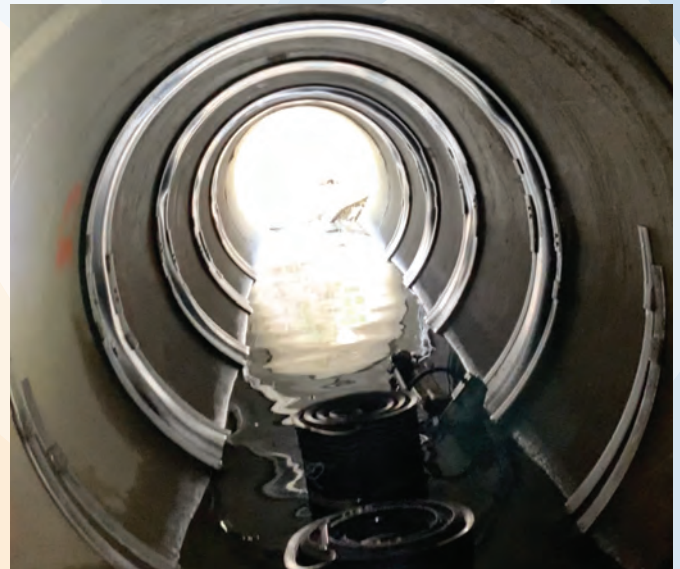
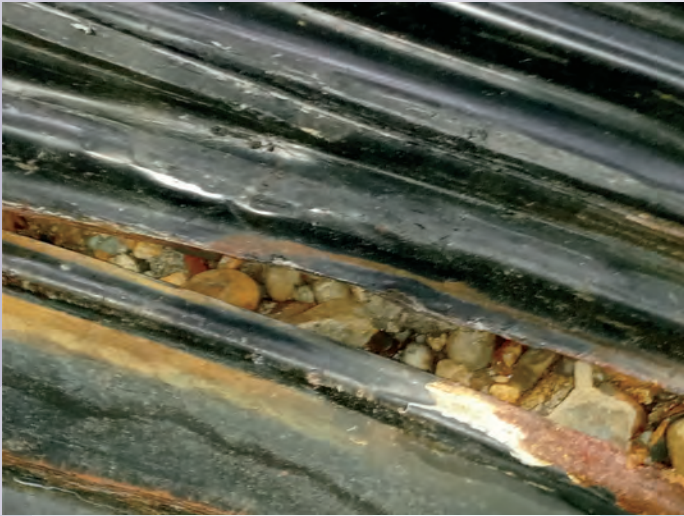
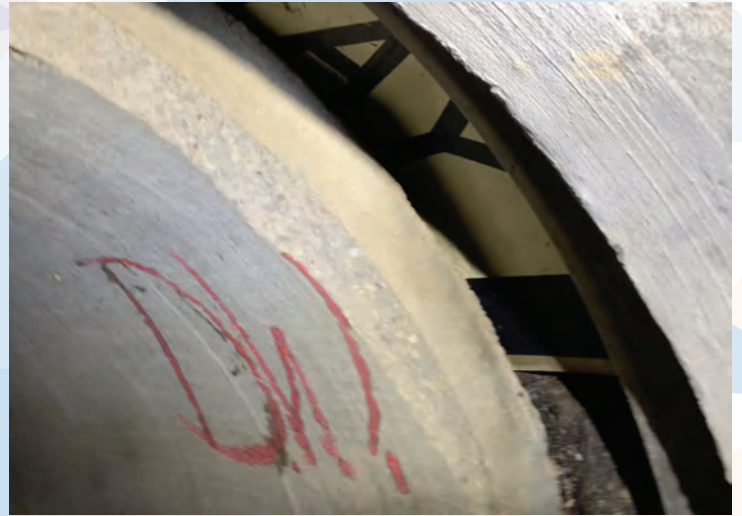
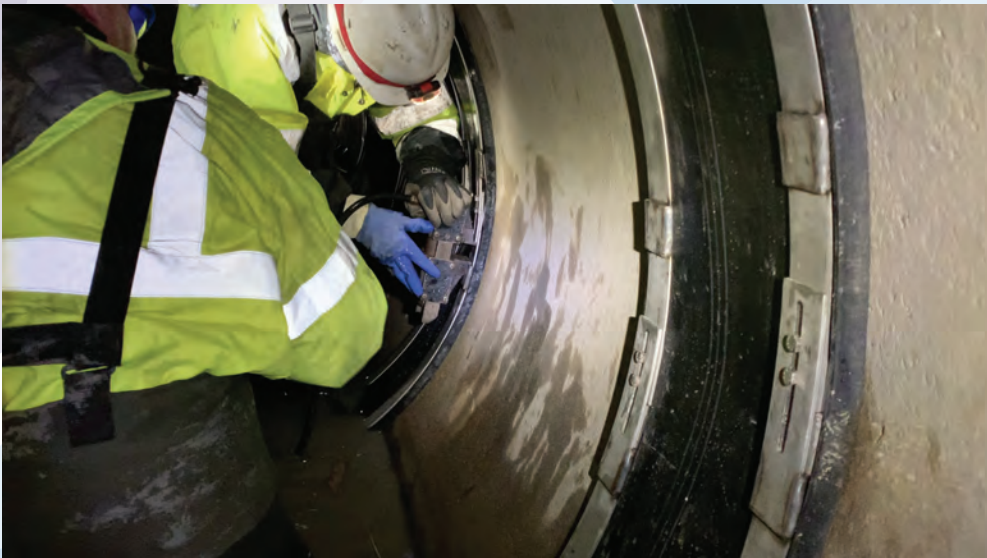
31 Seals In Two Days

Rocks and soil had become exposed at the culvert's separating joints and the quickly falling temperature pressed the project's time frame. The project needed to be completed as soon as possible. Previous repair methods that utilized sealant and grout were now failing. Infiltration, erosion, and eventual sinkholes were a concern as they could stop the above traffic.

31 HydraTite® seals of various widths ranging from 11" to 21", all 54" in diameter, were installed. Stainless steel backing plates were installed beneath the EPDM seal where the joint's separation was more severe.

The project was scheduled to take 3 days but was completed in only 2 days. HydraTech had to grind and clean the concrete surface of the culvert to ensure the 31 seals were installed properly, many with backing plates. The entire project was completed despite the low temperatures and standing water.

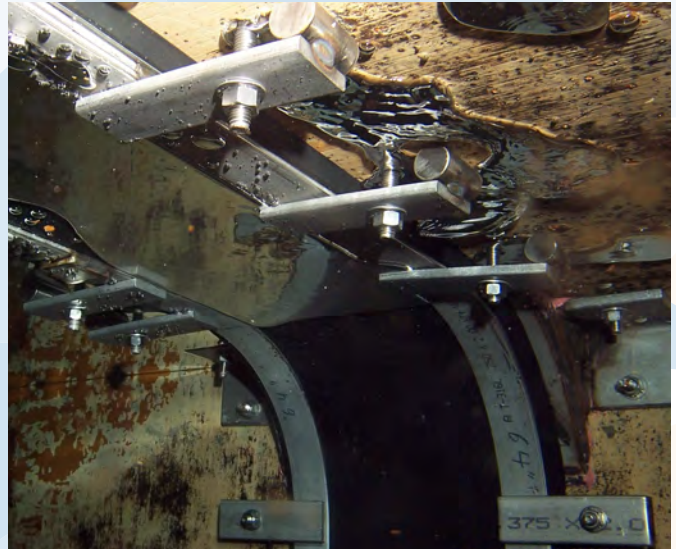
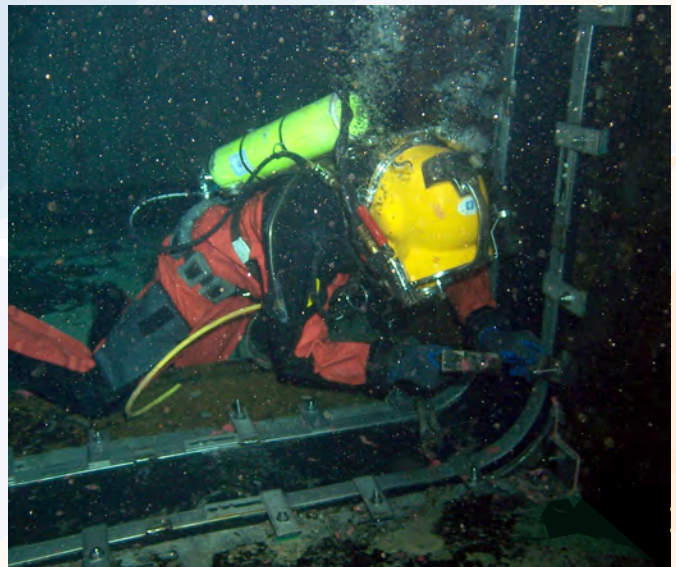
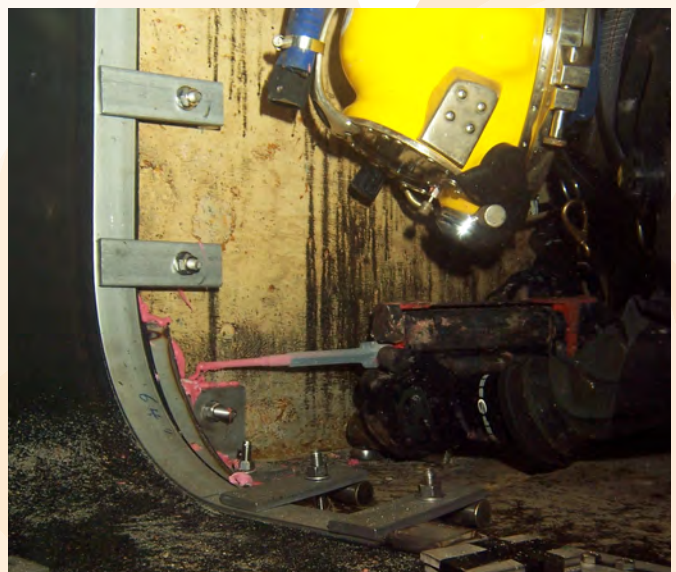
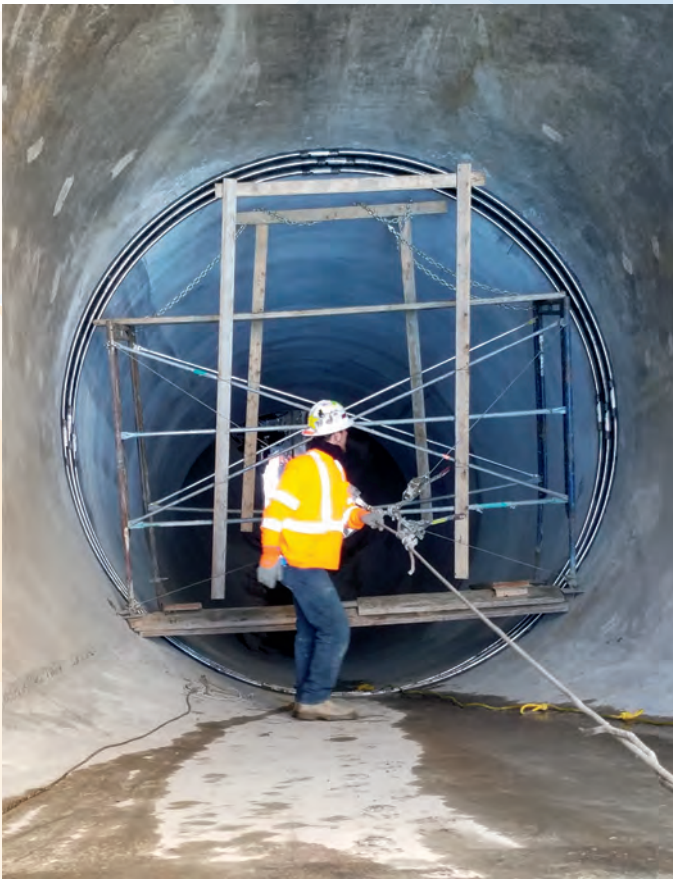
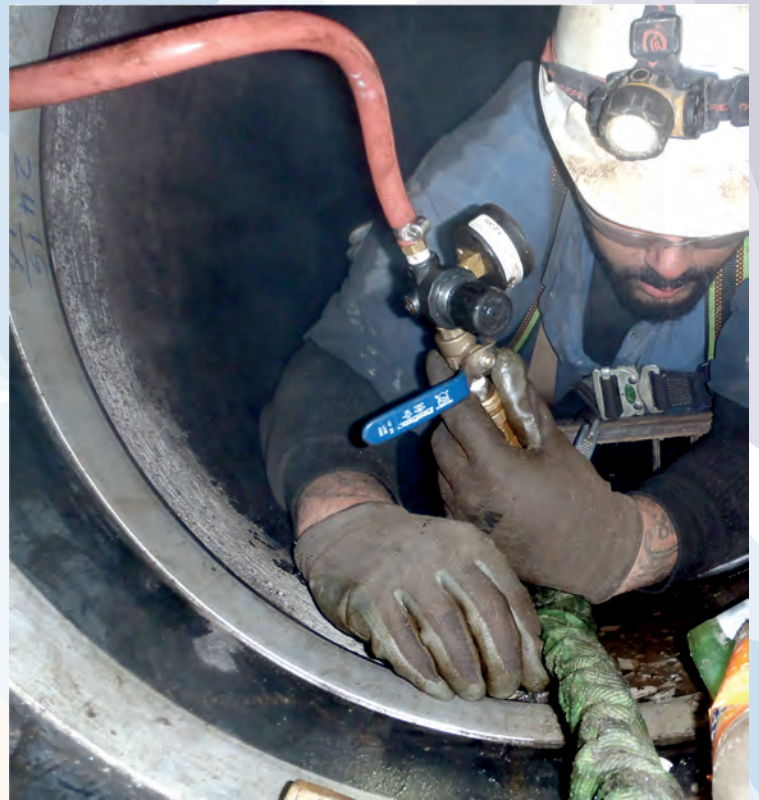
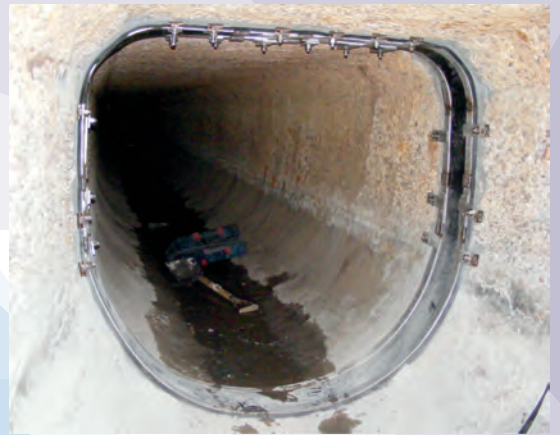
Submerged Square Conduit

A water treatment plant in western Ohio was confronted with repairing leaks of costly treated water from an underground transfer chamber, without draining the system.

During an inspection performed by divers, a total of five (5) construction joints in various reinforced concrete transfer chambers were identified as the sources of the leaks. The corners of the square cross section chambers required prefabricated stainless steel forms to produce the required radius. The straight sections of the HydraTite® seal are equipped with anchor clips.

Custom manufactured NSF61 HydraTite® Extra Wide Seals were selected as a solution. The HydraTite® seal, which is typically used to repair joints in pipe and elliptical conduits, was custom designed to accommodate the inside corners and straight surfaces of the rectangular transfer chambers.

Divers, after training on the installation of the HydraTite® seal, prepared the deteriorated surface areas on either side of the joints and installed the HydraTite® seals with the furnished stainless steel forms and anchor clips.

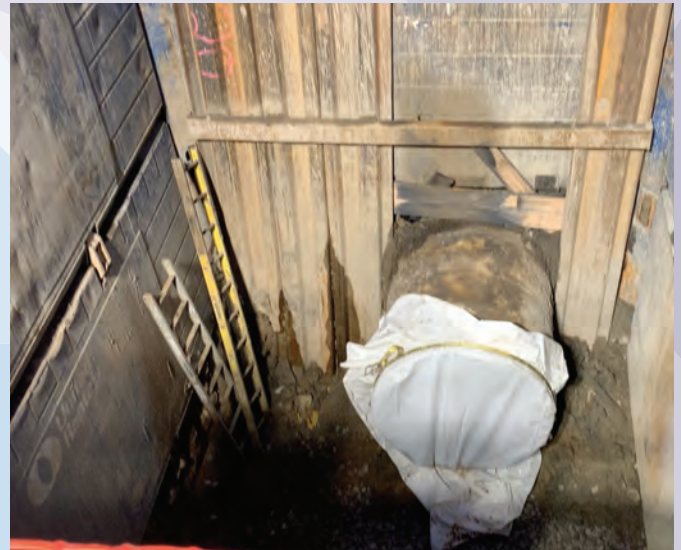
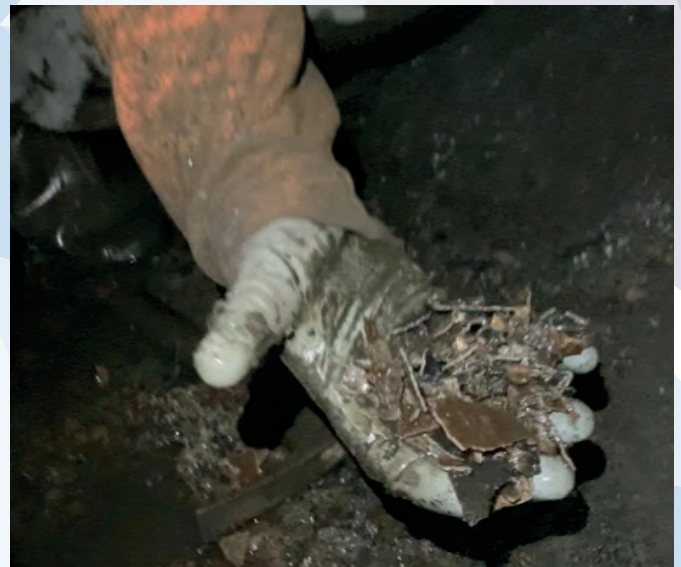
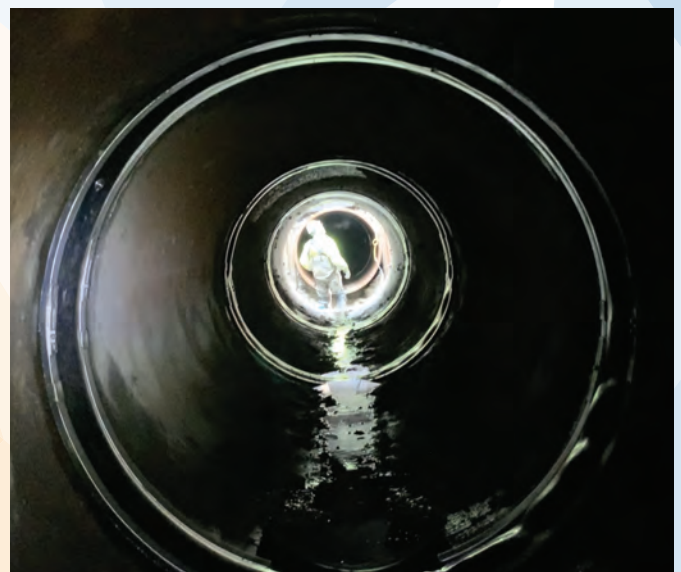
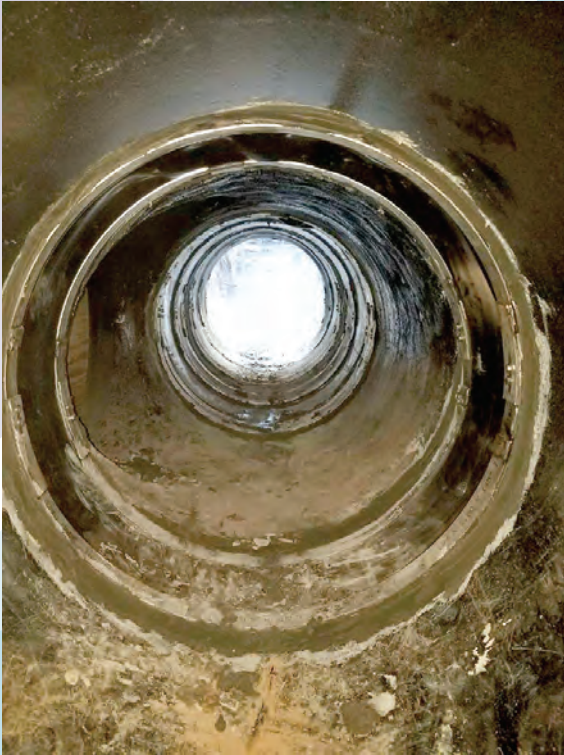
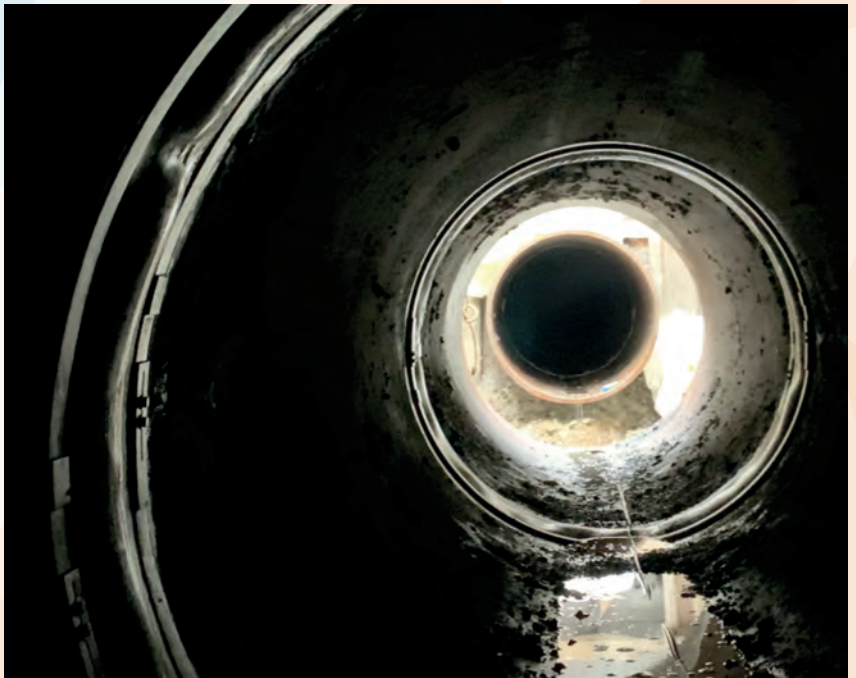
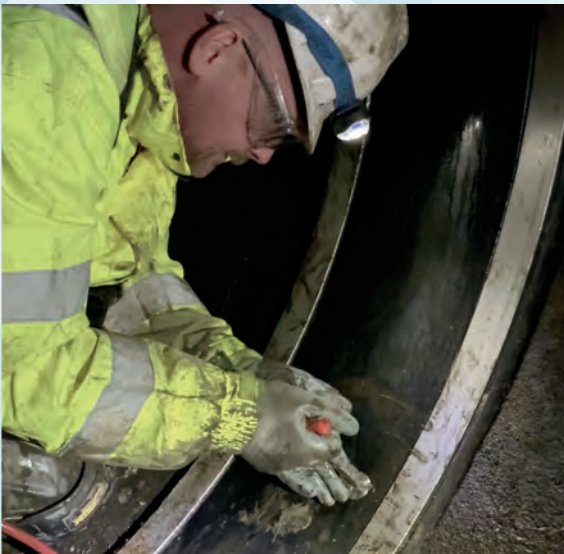
Six Joints In A 60" Water Main

A water main break flooded the streets at River's Edge in Cincinnati, Ohio. A new section of pipe was ordered in to replace the failed section of pipe, but there were concerns that the neighboring joints in the pipe would fail if preventative action was not taken immediately.

The water main leak caused extensive erosion of the soil compaction around the pipe and surrounding areas. Any shifting of the pipe joints could cause leaking. The engineer specified HydraTite® to eliminate joint leaking near the pipe break and guarantee a watertight fix.

Six HydraTite® seals were ordered for installation. These 60" seals were to be installed on the three closest pipe joints on either side of the new section of pipe. HydraTech prepared the pipe joints by clearing away the calcium build-up on the interior pipe surface. Next, the six seals were installed and air tested to ensure that they would guarantee no leaks. The project was expected to take several days, however, HydraTech completed ahead of schedule, in only two days.

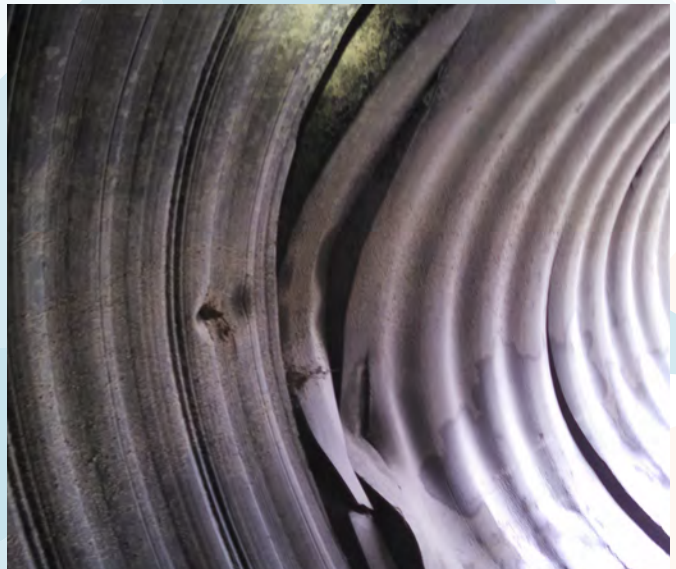
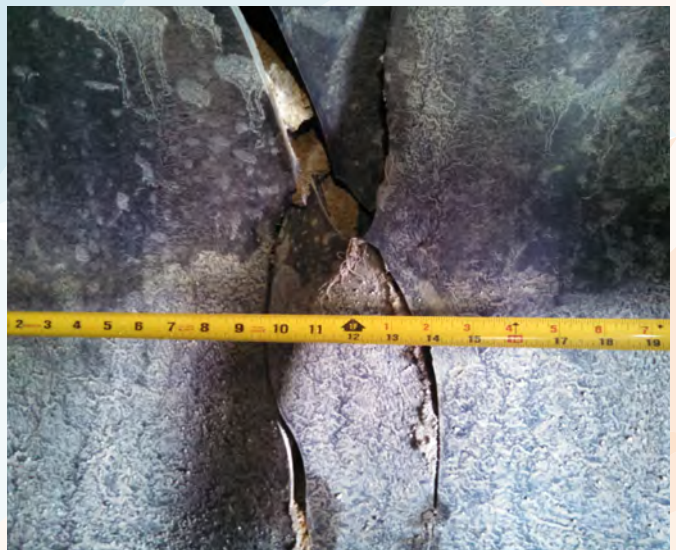
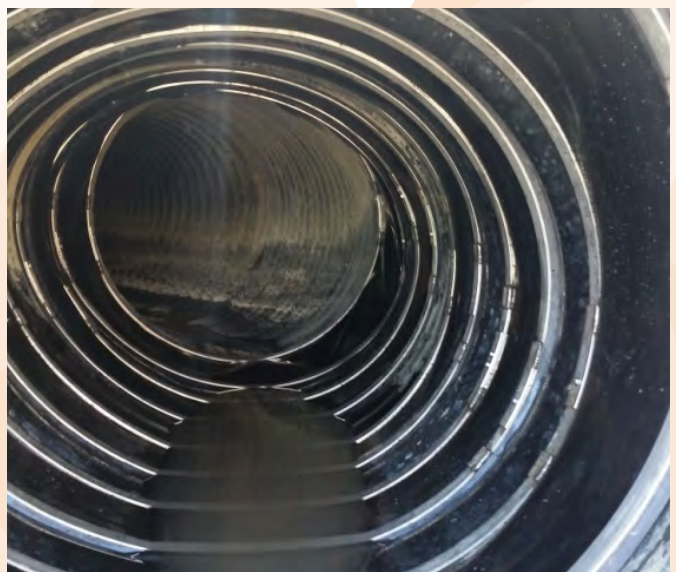
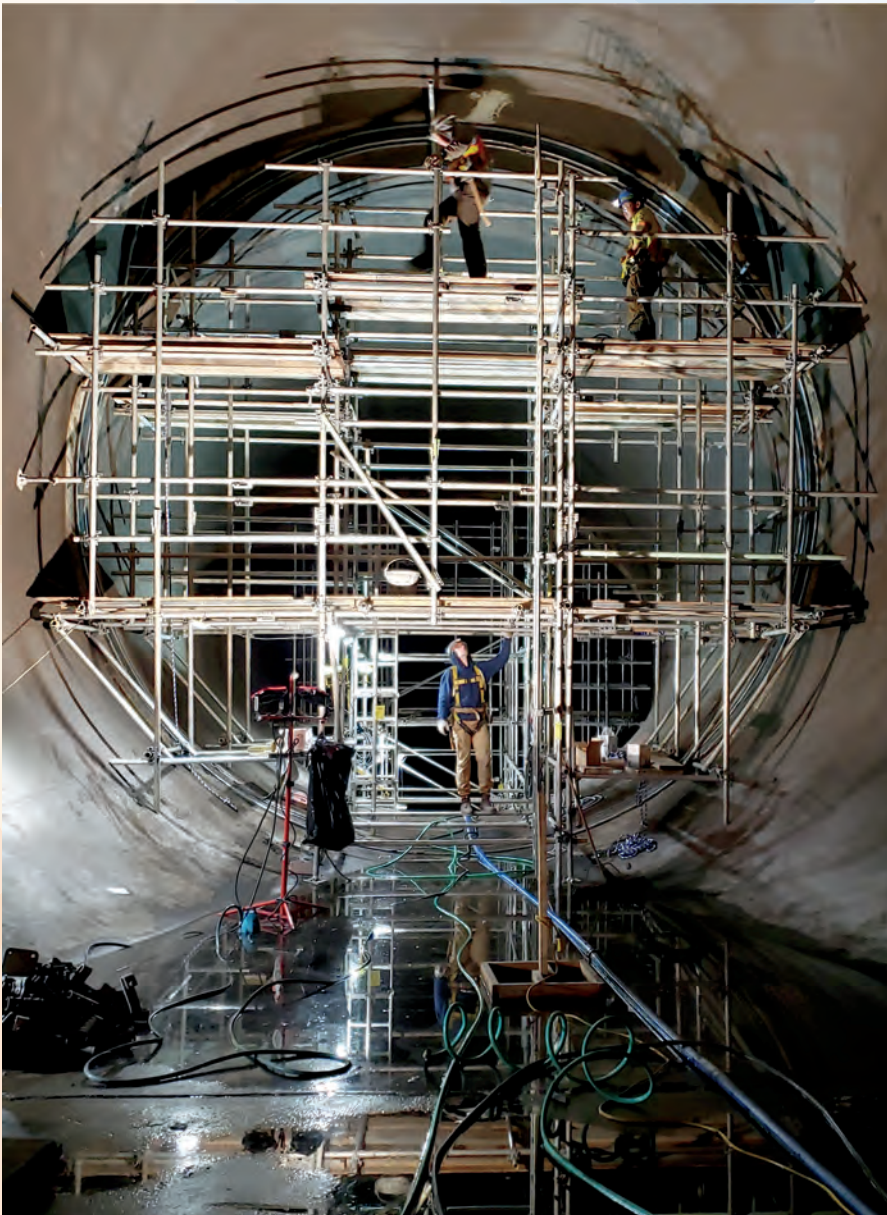
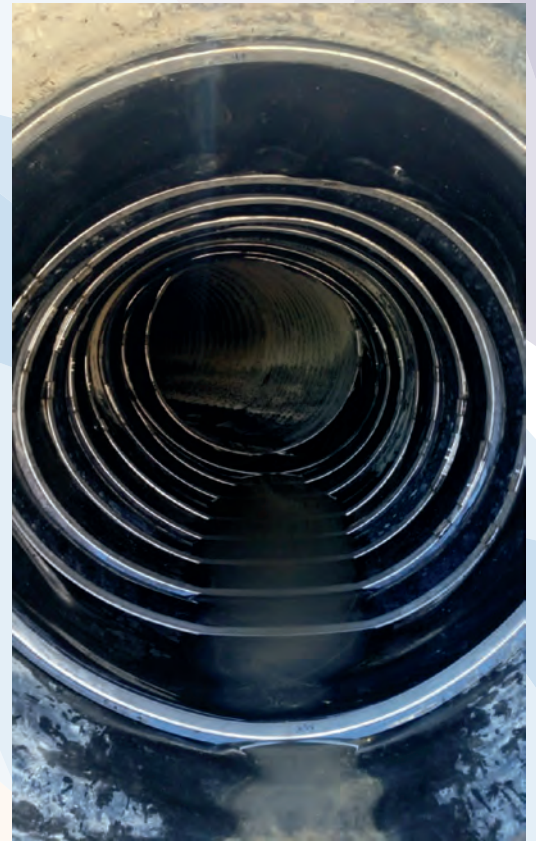
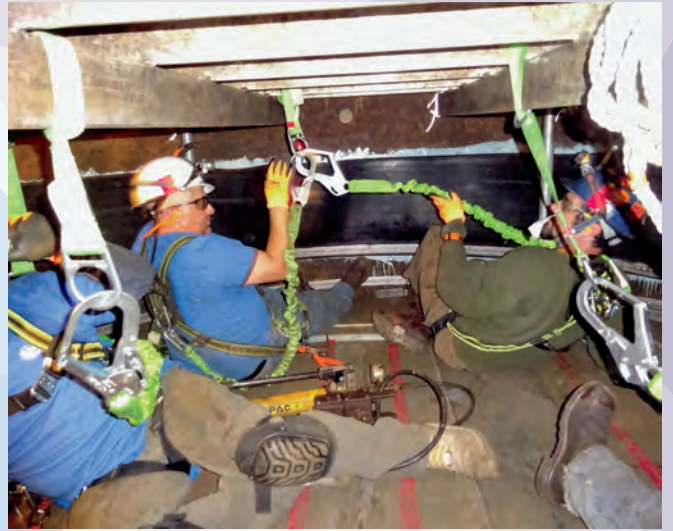
Sediment Pond Sinkhole

During a monthly landfill inspection of a sediment pond, a sinkhole was noted behind the headwalls of two ADS 48-inch pipes. It was identified that each pipe had cracking at the interface between the concrete headwall and the pipe, which allowed groundwater and sediment to enter the pipe, causing the sinkhole.

The HydraTite® seal was selected to cover the cracks within the pipes, as a proven method to eliminate infiltration and provide movement of pipe as settling occurs.

The HydraTite® seals, manufactured at HydraTech's Cincinnati facility and installed inside the outlet pipes, were sleeved together to provide additional length over the defective areas and eliminate further infiltration. Sleeving is a process in which HydraTite® seals are interlocked to provide a continuous length along the defective area of piping. The entire project took two days to install and will provide a long-term repair.
