#### Market Storm Sewer

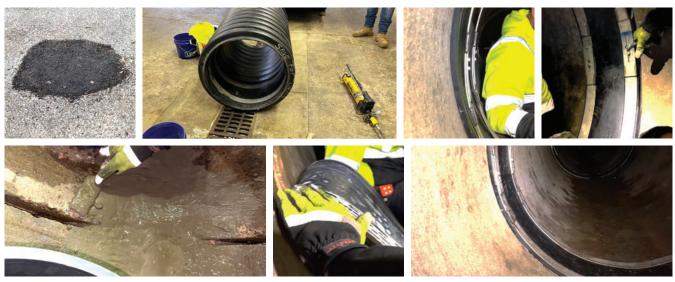
The gold installation package was selected by the township. With this option, the client is provided with the materials and oversight from a HydraTech Field technician. HydraTech gave a demonstration on a portion of pipe in a department building and then followed the township personnel out to the jobsite to oversee the installation of two seals. Water was pumped to make installation easier and a patch of concrete was added at the invert of both joints, creating a uniform surface for proper installation. Then the EPDM seal was lightly lubricated and placed over the joint. The retaining bands were then expanded and locked into place. The installation only took two hours.
