# HydraTech

PROJECT EXAMPLES BY MARKET

# Project Examples Highlighting

# HydraTite®

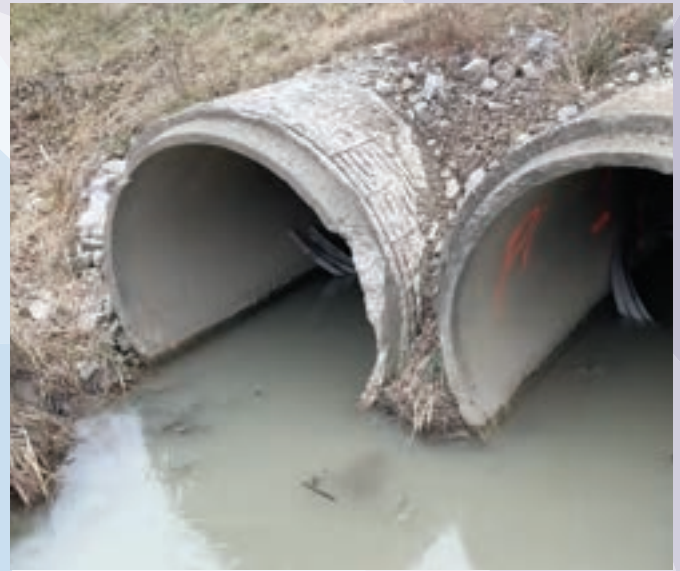
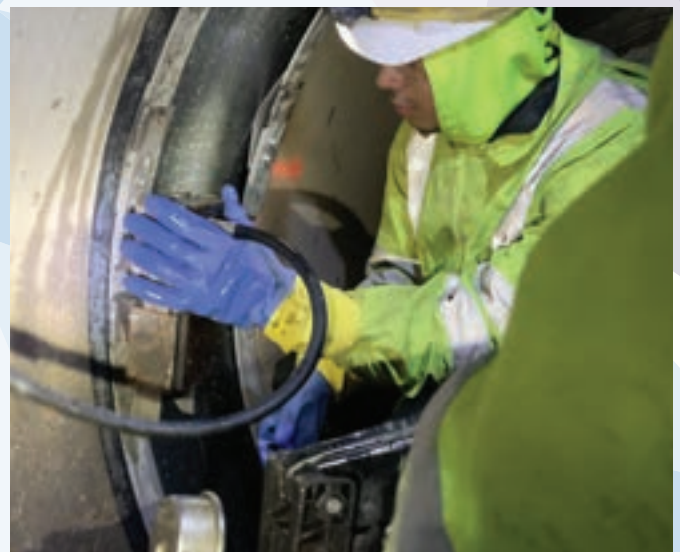
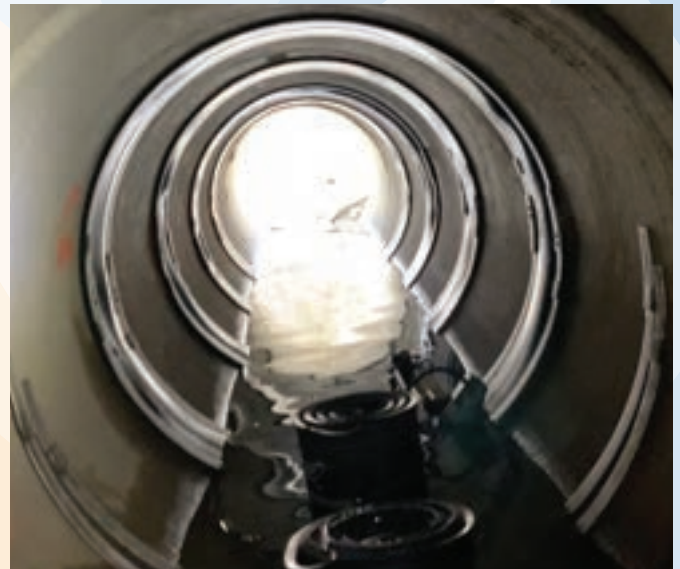
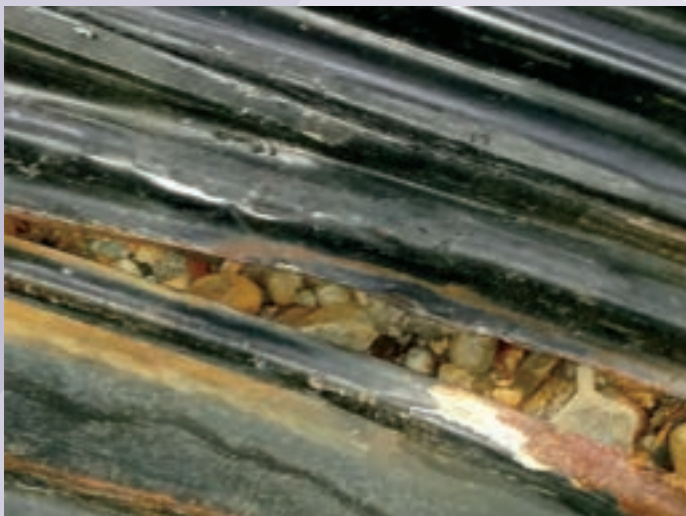
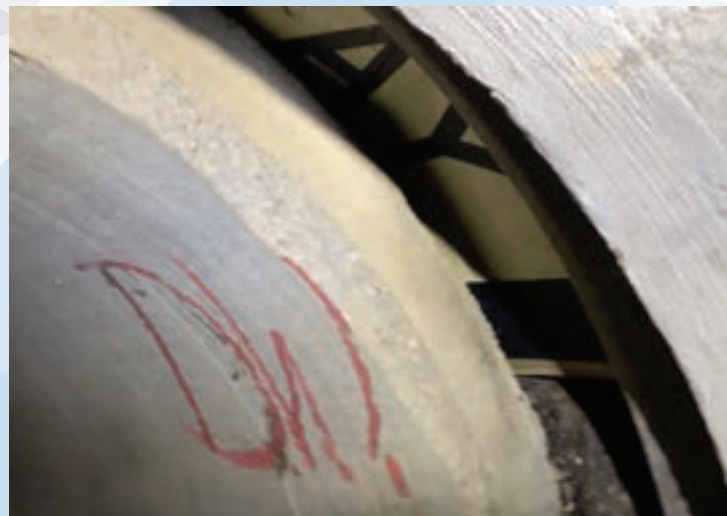
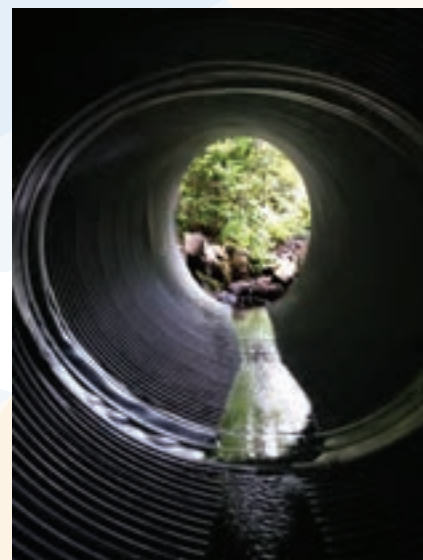
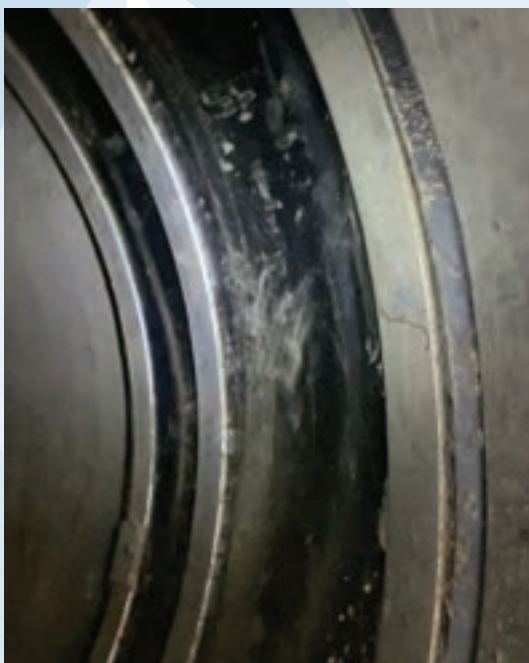
# 31 Seals In Two Days

Rocks and soil had become exposed at the culvert's separating joints and the quickly falling temperature pressed the project's time frame. The project needed to be completed as soon as possible. Previous repair methods that utilized sealant and grout were now failing. Infiltration, erosion, and eventual sinkholes were a concern as they could stop the above traffic.

The project was scheduled to take 3 days but was completed in only 2 days. HydraTech had to grind and clean the concrete surface of the culvert to ensure the 31 seals were installed properly, many with backing plates. The entire project was completed despite the low temperatures and standing water.

31 HydraTite® seals of various widths ranging from 11" to 21", all 54" in diameter, were installed. Stainless steel backing plates were installed beneath the EPDM seal where the joint's separation was more severe.

The HydraTite® seal provides an economical repair to prevent infiltration and erosion without the need for dewatering or digging. The project did not affect the above traffic and ensured that the traveling public would be safe from future sinkholes. The quick turnkey solution was implemented before the freeze and thaw of the coming months, which could further separate the pipe joint. The HydraTite® seal does not rely on adhesive or sealant and is not adversely affected by temperatures.

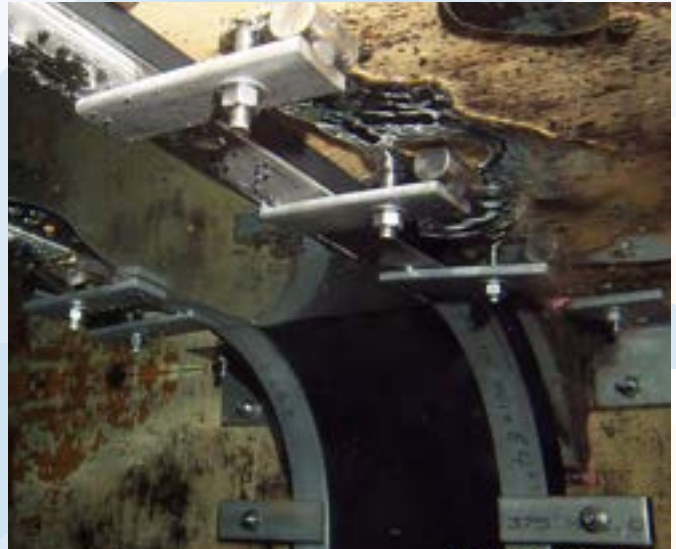
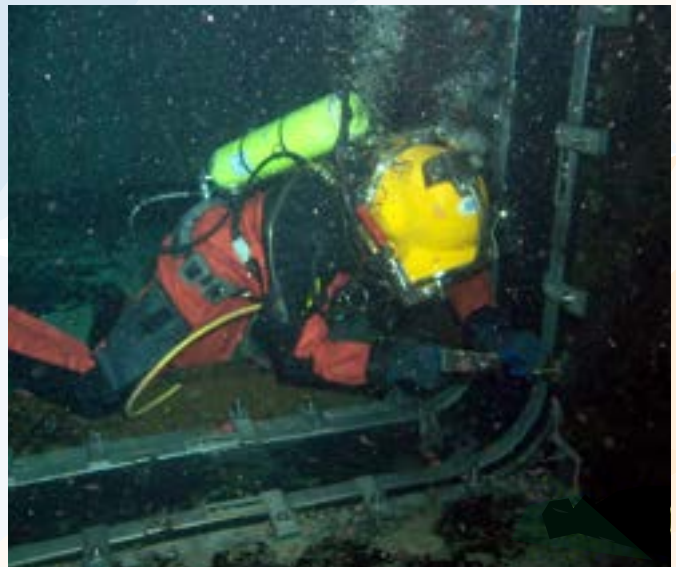
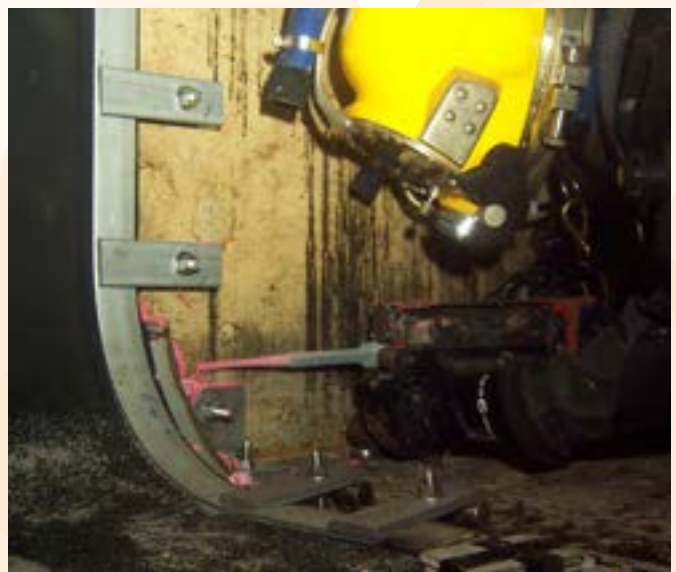
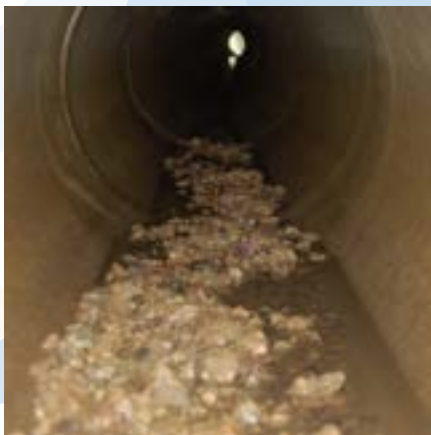
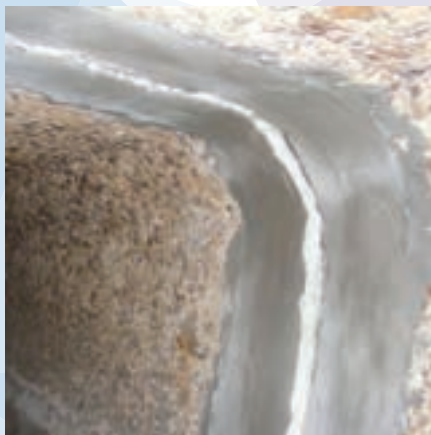
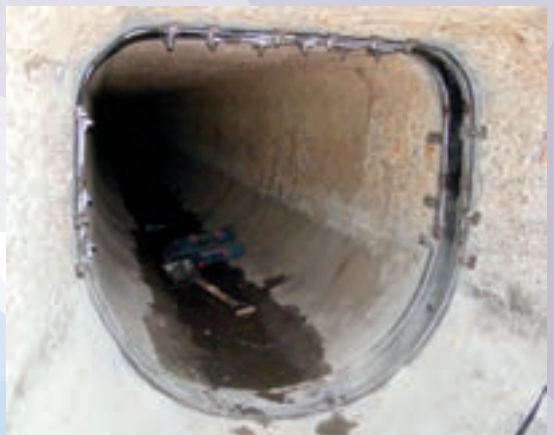
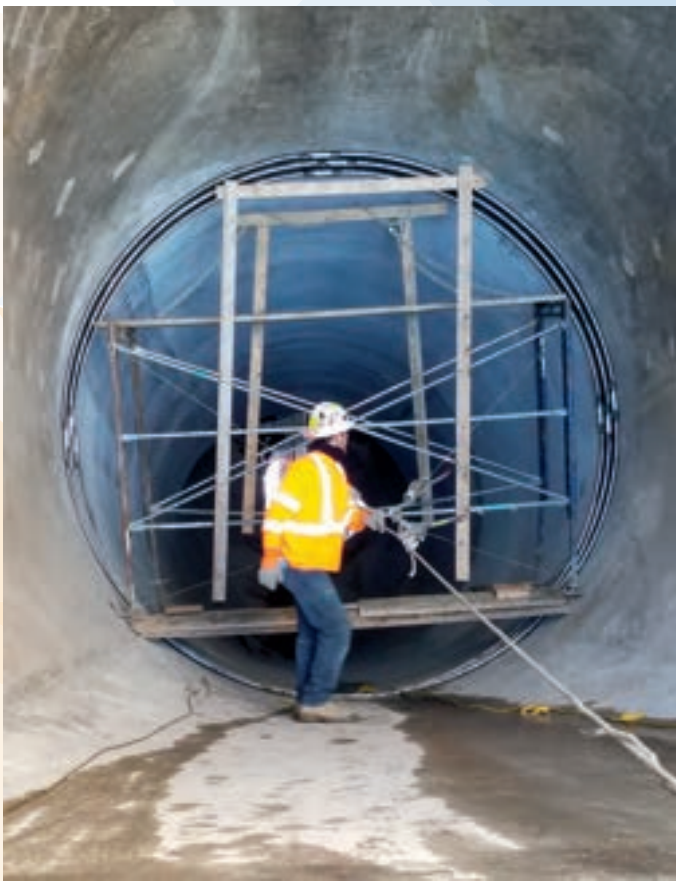
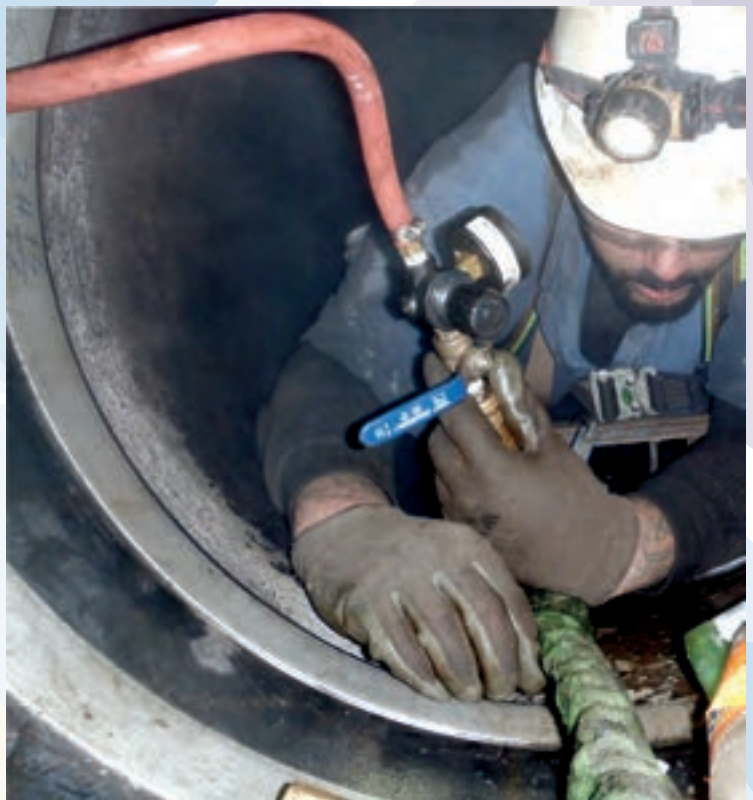
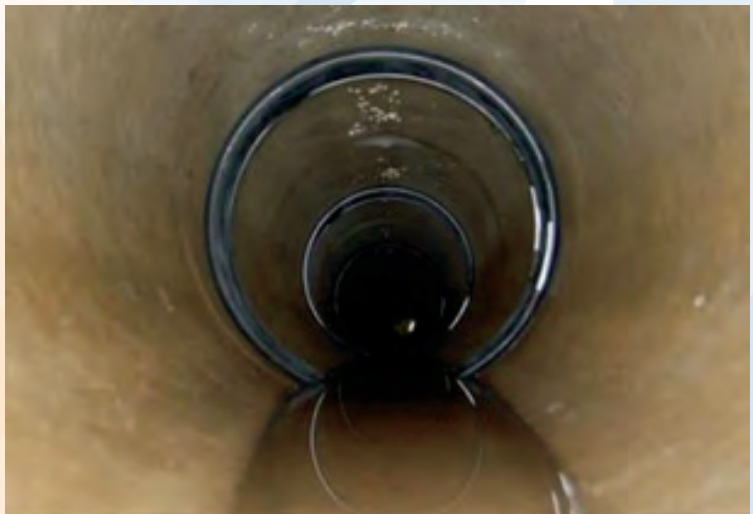
# Submerged Square Conduit

A water treatment plant in western Ohio was confronted with repairing leaks of costly treated water from an underground transfer chamber, without draining the system.

During an inspection performed by divers, a total of five (5) construction joints in various reinforced concrete transfer chambers were identified as the sources of the leaks. The corners of the square cross section chambers required prefabricated stainless steel forms to produce the required radius. The straight sections of the HydraTite® seal are equipped with anchor clips.

Custom manufactured NSF61 HydraTite® Extra Wide Seals were selected as a solution. The HydraTite® seal, which is typically used to repair joints in pipe and elliptical conduits, was custom designed to accommodate the inside corners and straight surfaces of the rectangular transfer chambers.

Divers, after training on the installation of the HydraTite® seal, prepared the deteriorated surface areas on either side of the joints and installed the HydraTite® seals with the furnished stainless steel forms and anchor clips.

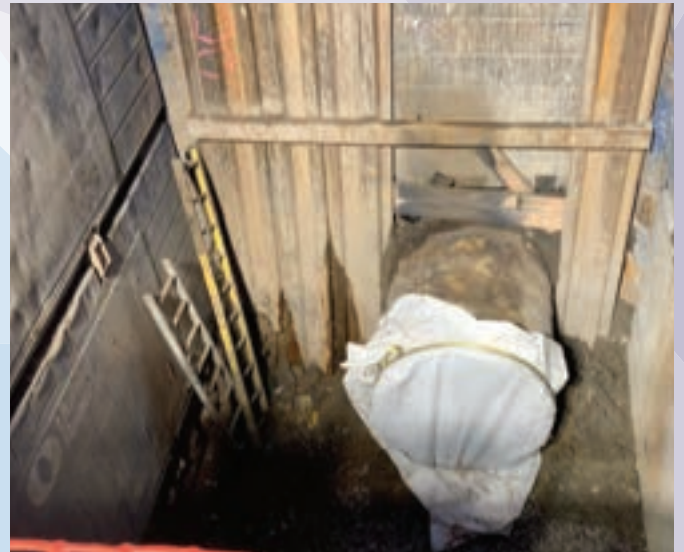
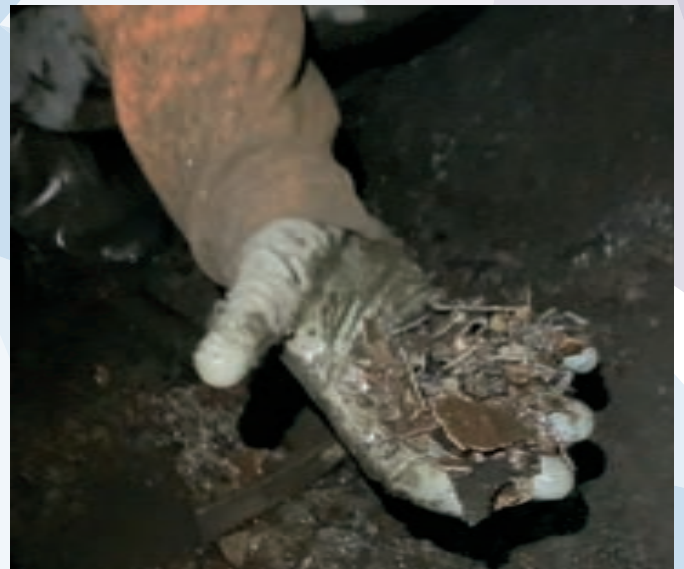
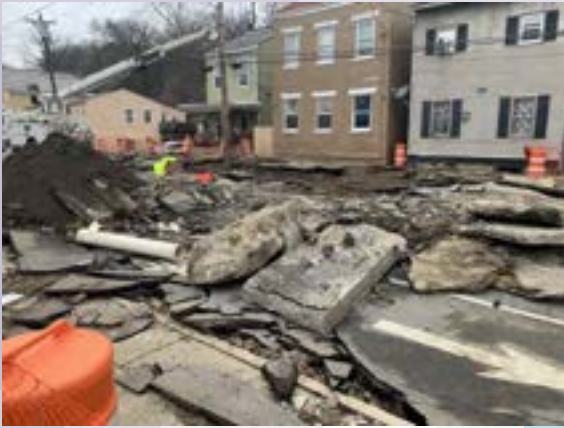
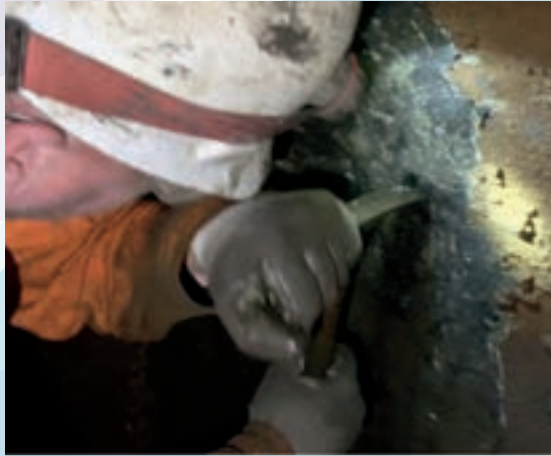
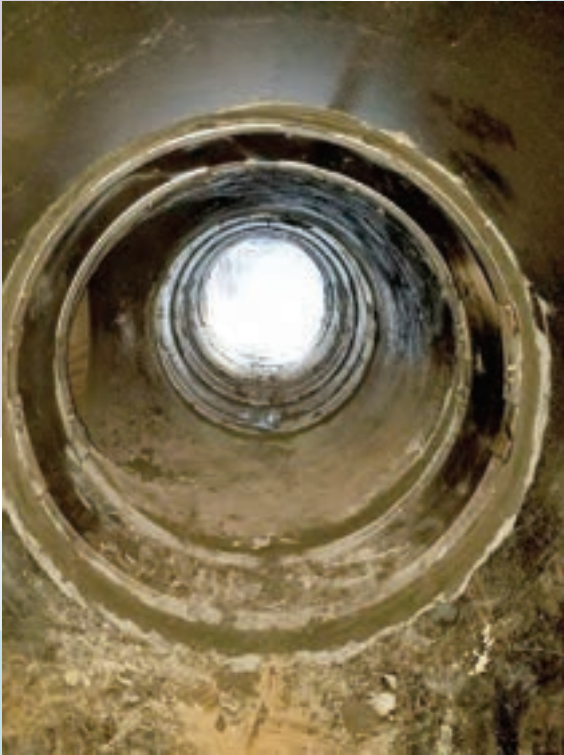
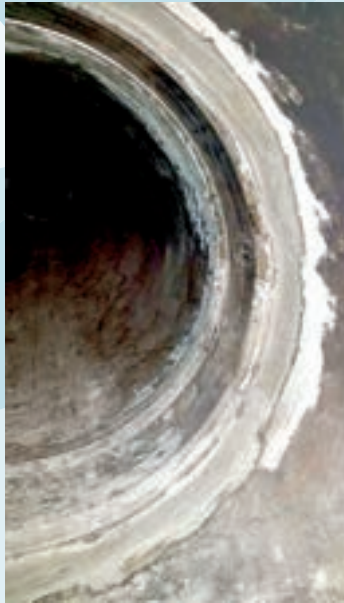
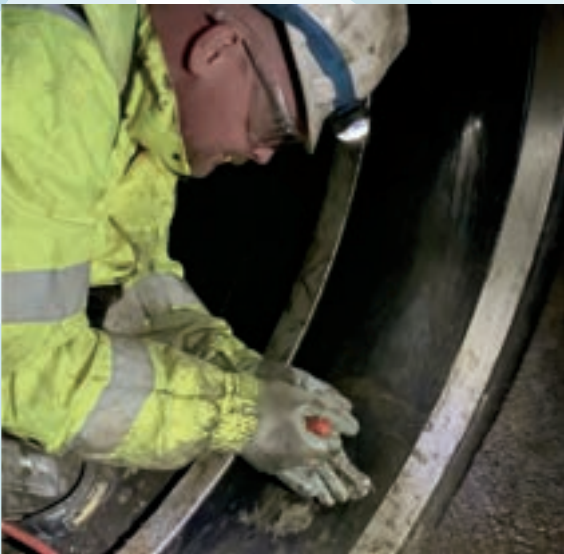
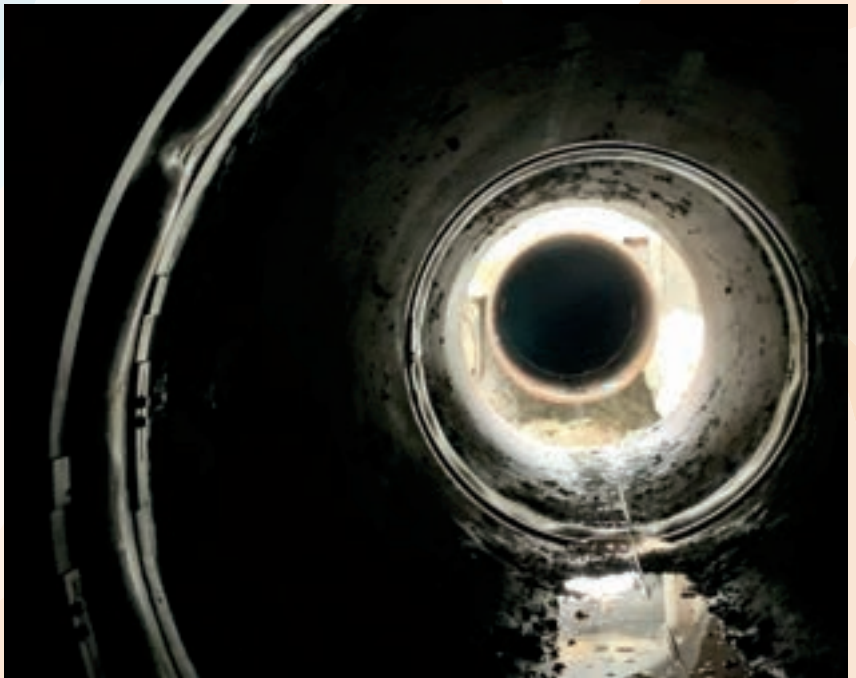
# Six Joints In A 60" Water Main

A water main break flooded the streets at River's Edge in Cincinnati, Ohio. A new section of pipe was ordered in to replace the failed section of pipe, but there were concerns that the neighboring joints in the pipe would fail if preventative action was not taken immediately.

The water main leak caused extensive erosion of the soil compaction around the pipe and surrounding areas. Any shifting of the pipe joints could cause leaking. The engineer specified HydraTite® to eliminate joint leaking near the pipe break and guarantee a watertight fix.

Six HydraTite® seals were ordered for installation. These 60" seals were to be installed on the three closest pipe joints on either side of the new section of pipe. HydraTech prepared the pipe joints by clearing away the calcium build-up on the interior pipe surface. Next, the six seals were installed and air tested to ensure that they would guarantee no leaks. The project was expected to take several days, however, HydraTech completed ahead of schedule, in only two days.

HydraTite® provided an economical repair to prevent joint leakage and erosion without the need for additional excavation. HydraTite® will protect the people living above this section of the pipe against future sinkholes.

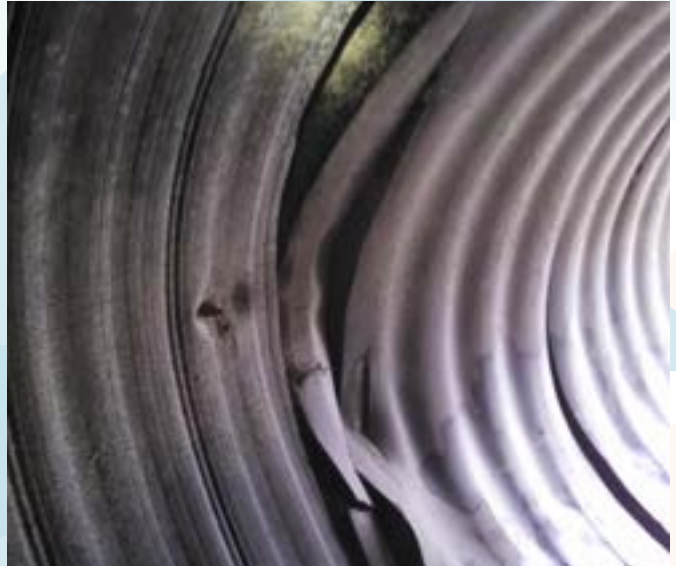
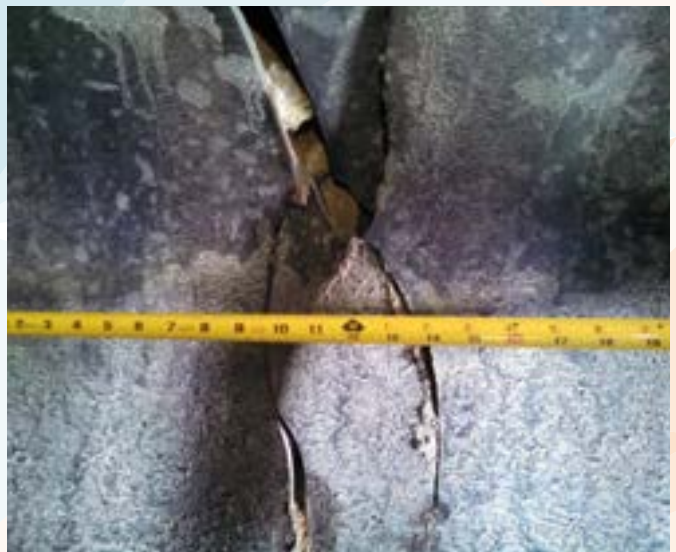
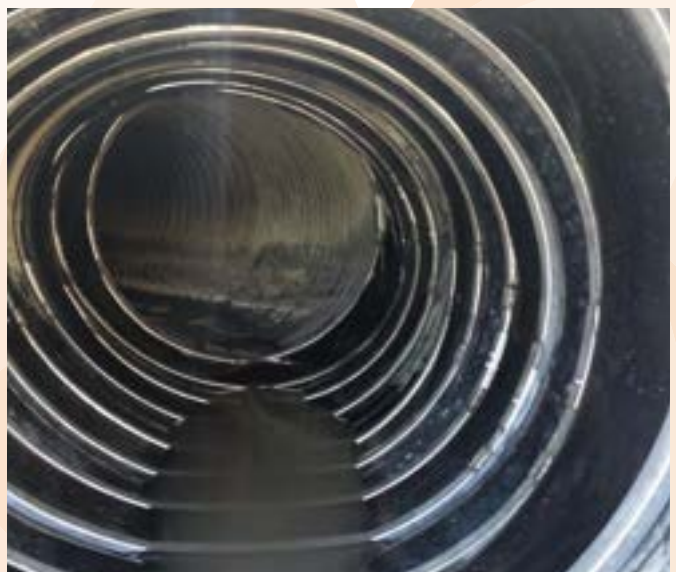
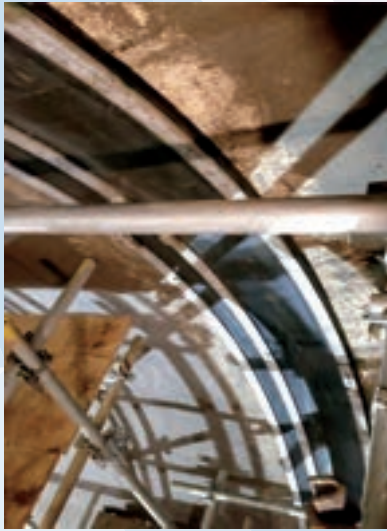
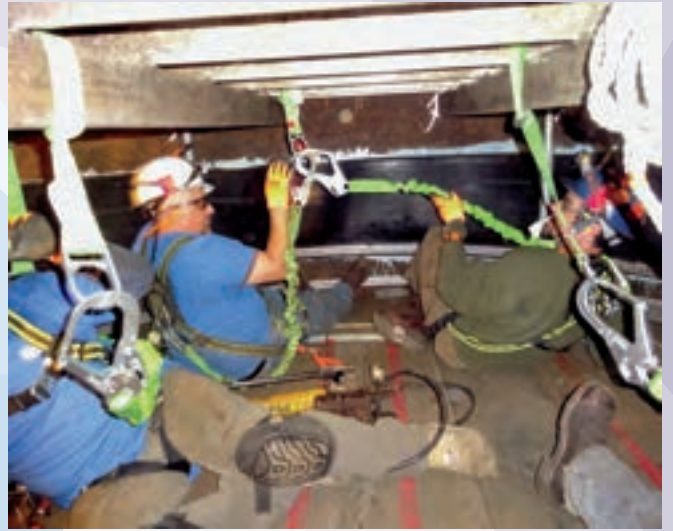
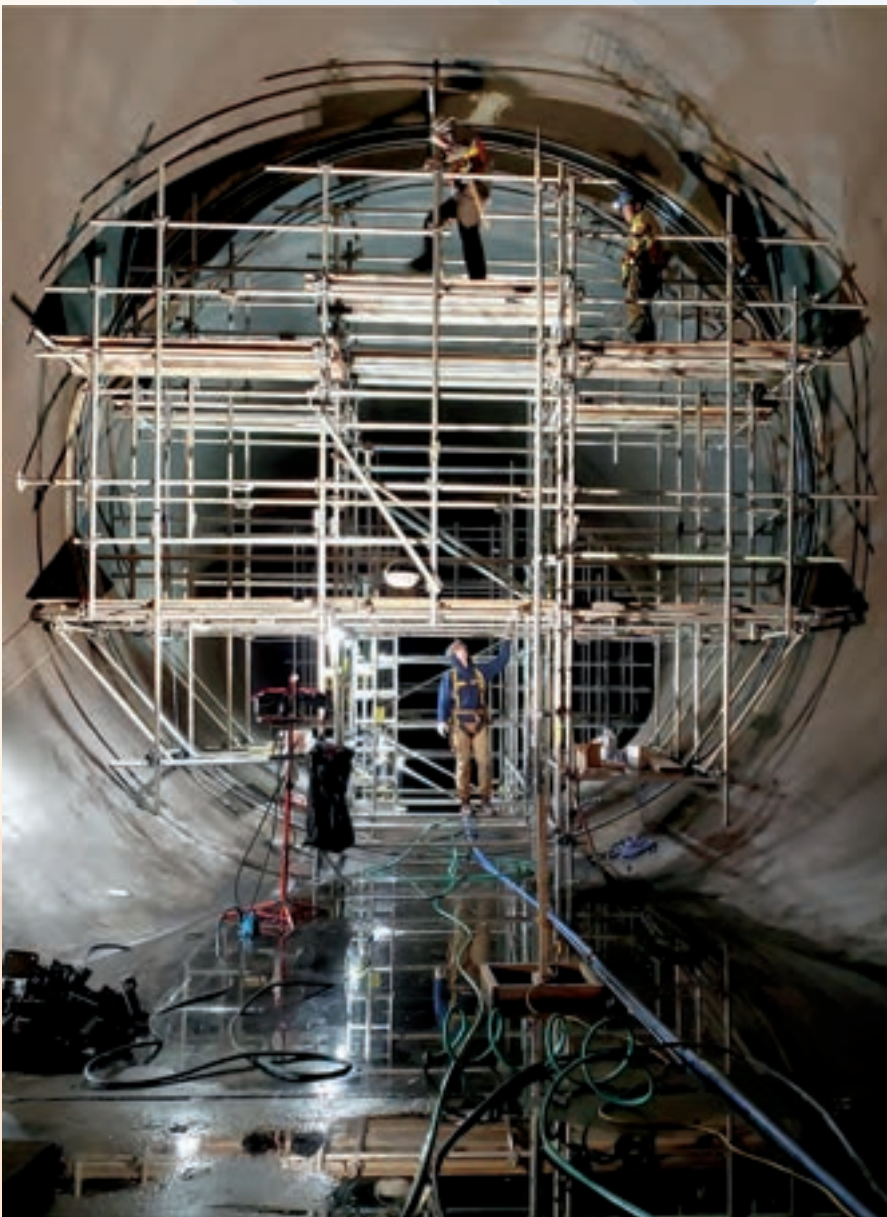
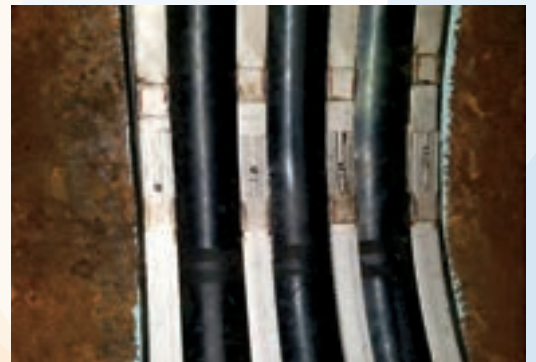
# Sediment Pond Sinkhole

During a monthly landfill inspection of a sediment pond, a sinkhole was noted behind the headwalls of two ADS 48-inch pipes. It was identified that each pipe had cracking at the interface between the concrete headwall and the pipe, which allowed groundwater and sediment to enter the pipe, causing the sinkhole.

The HydraTite® seal was selected to cover the cracks within the pipes, as a proven method to eliminate infiltration and provide movement of pipe as settling occurs.

The HydraTite® seals, manufactured at HydraTech's Cincinnati facility and installed inside the outlet pipes, were sleeved together to provide additional length over the defective areas and eliminate further infiltration. Sleeving is a process in which HydraTite® seals are interlocked to provide a continuous length along the defective area of piping. The entire project took two days to install and will provide a long-term repair.
