Private, Livestock – Bison Ranch

To repair this ADS irrigation pipe, HydraTech provided HydraTite, a solution that can be installed quickly and is cost-effective.

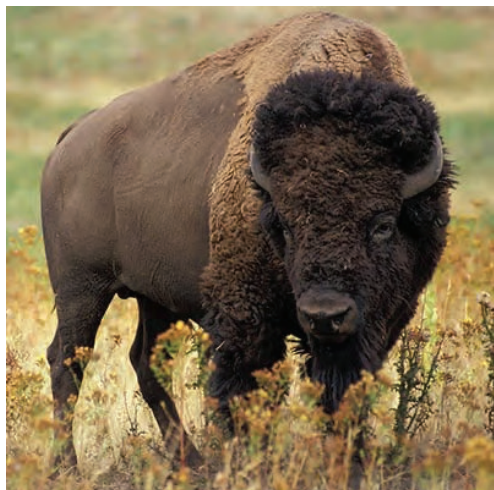
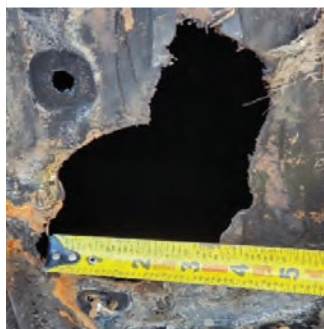
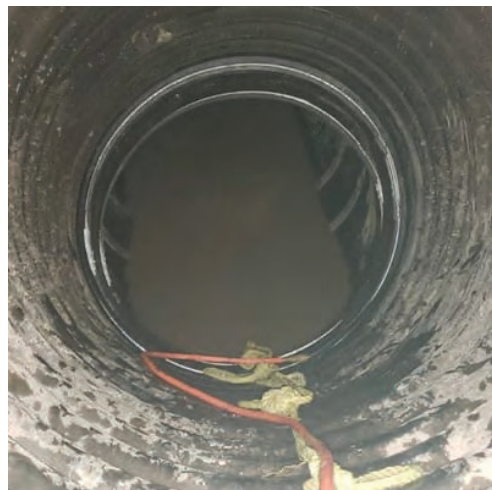
Access to the repair location was limited by a 45-degree bend within the pipe. HydraTech manufactured a custom band size with a multi-piece configuration to accommodate the 45-degree bend. HydraTech's technicians successfully installed the seal despite access being restricted as they specialize in confined space installations. In only a few days the pipe was operational again.

Our speedy installation impressed the ranch and they saved money by choosing HydraTite. The seal will ensure that this pipe continues to operate and bring the bison their much-needed water.
