# HydraTite®

JOINT SEAL

Following a major earthquake in Chile in 2010, a drinking water and irrigation system experienced structural displacement within a pipe bridge system. The seismic event caused beam movement and separation at multiple bridge joints, creating visible gaps where the exterior of the bridge could be seen from inside the structure.

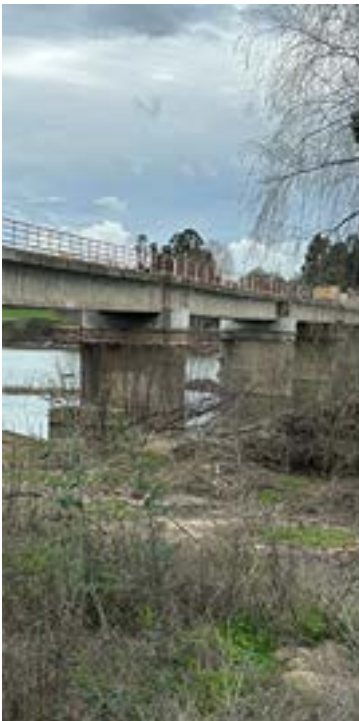
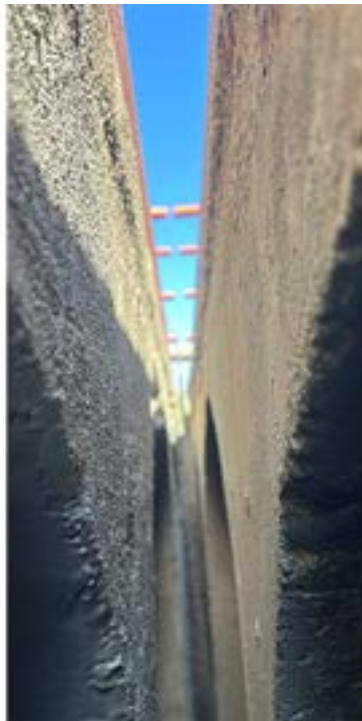
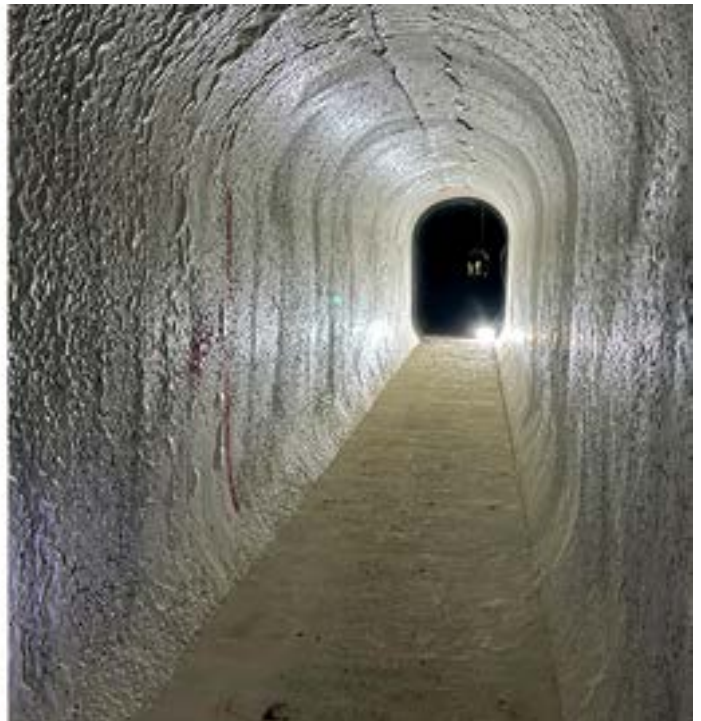
HydraTech engineered and manufactured custom HydraTite® Internal Pipe Joint Seals specifically adapted for the arched aqueduct geometry and flat invert, demonstrating the system's flexibility beyond standard round pipe applications. The seals were equipped with two 6-piece stainless steel retaining bands.

The initial repair plan utilized extra-wide (EW) rubber seals, mechanically locked into place using stainless steel retaining bands, anchors, and hold-downs to ensure stability under flow and pressure conditions. The seals were designed to conform to the non-cylindrical shape while maintaining full circumferential contact across the joints.

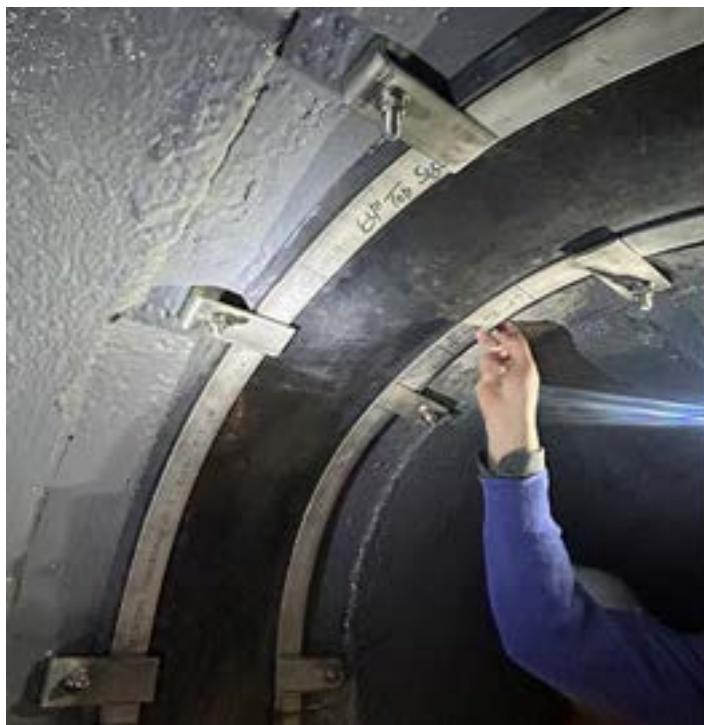
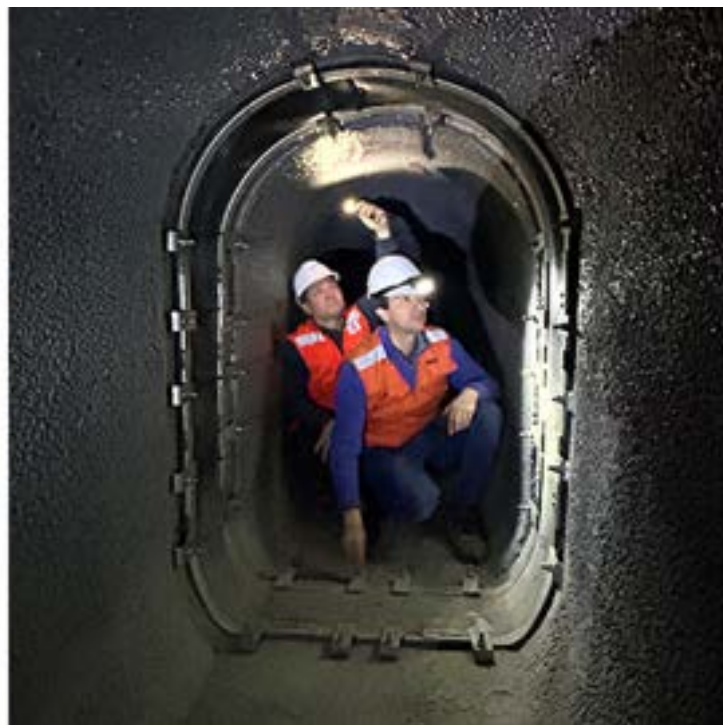
HydraTech manufactured and supplied the extra-wide HydraTite® seals. Constructora Rio Maule installed these seals across the 18 sections of the bridge. After installation, it became apparent that one joint exhibited significantly greater separation than anticipated, exceeding the effective coverage of the extra-wide seal.

To address this condition, HydraTech quickly manufactured a double-wide HydraTite® seal to span the increased joint gap. The replacement seal was installed and secured using the same mechanical retention system, restoring the severely displaced joint.

The customized HydraTite® sealing system successfully eliminated leakage at all repaired joints despite their non-standard geometry. By adapting seal design to an arched aqueduct with a flat invert and rapidly supplying a wider solution when conditions demanded it, HydraTech restored watertight integrity where external sealing methods had failed.
