INTERNAL PIPE

JOINT SEAL

Challenge

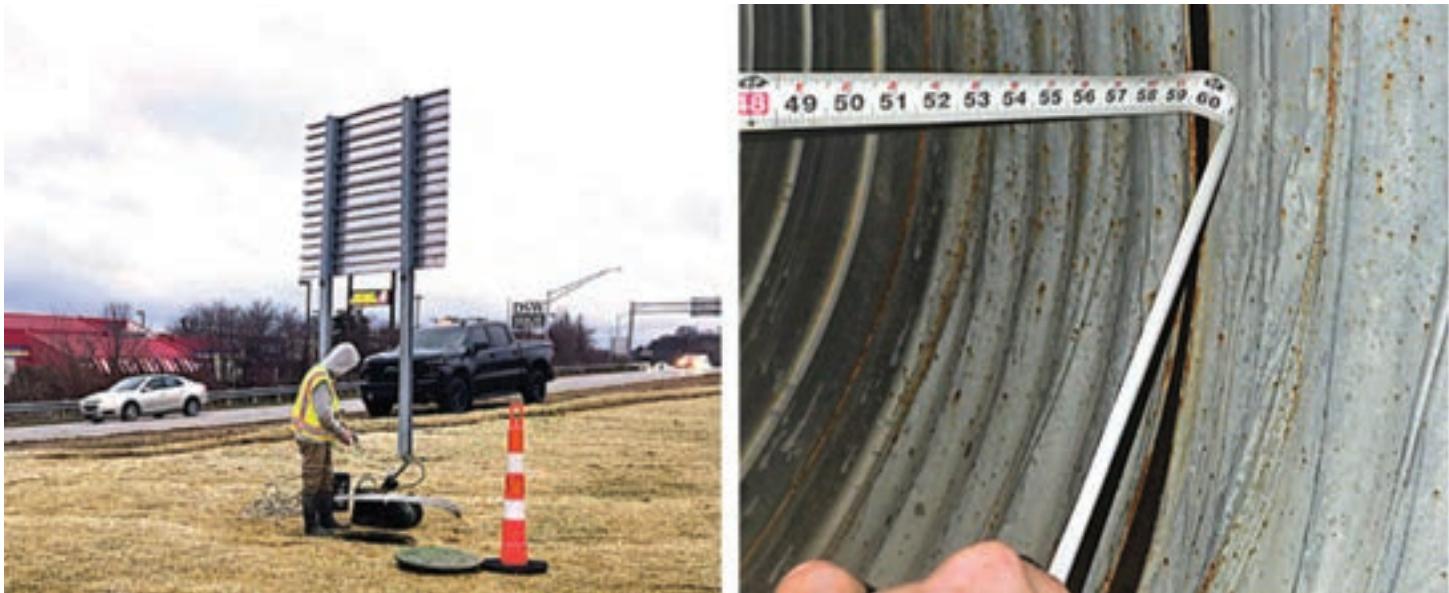
HydraTech engineered a custom HydraTite® Internal Pipe Joint Seal solution to accommodate the unique transition conditions. Each repair utilized interlocked seal sleeves, consisting of a double-wide (DW) inner rubber sleeve and a pair of extra-wide (EW) outer rubber sleeves.

The seals were equipped with five 4-piece stainless steel retaining bands, allowing greater adjustability and uniform compression across the transition. The outer EW rubber was manufactured $\frac{3}{4}$ inch smaller in diameter to nest securely atop the DW seal, while one set of retaining bands was fabricated 1 inch smaller in diameter to ensure proper clamping over both overlapping layers.

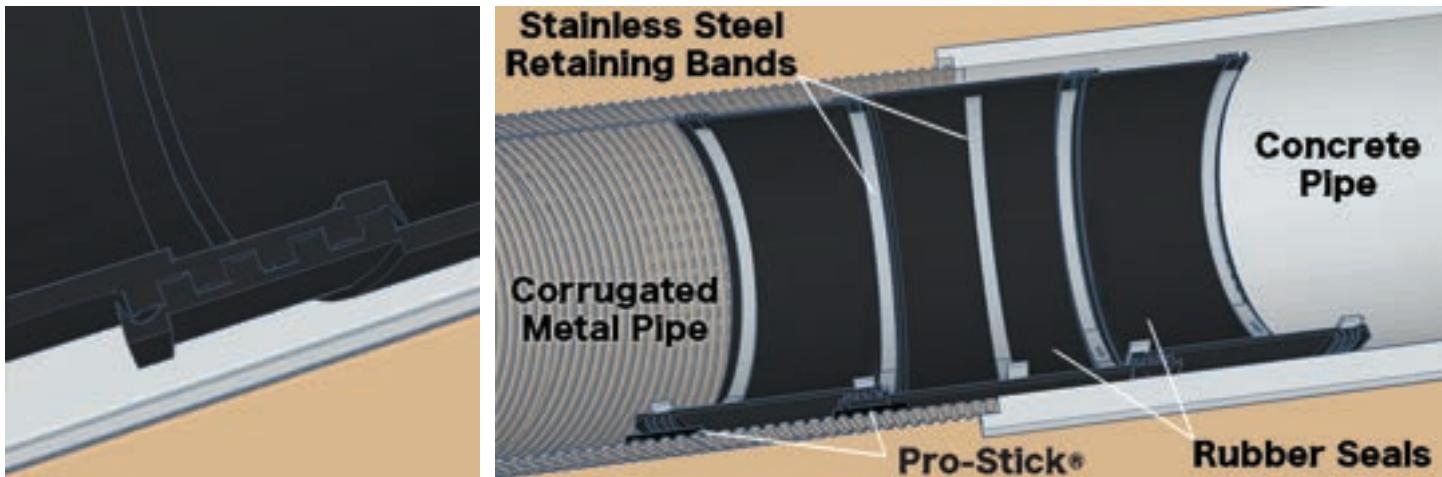
HydraTech's two-person field crew installed the custom-manufactured, interlocking HydraTite® seal sleeves. On the corrugated side of each transition, Pro-Stick® was applied to fill corrugation valleys and create a unified sealing surface prior to installation. The extra-wide outer seals were installed with the rubber ribs facing the pipe wall, while the double-wide inner seal was inverted so its ribs faced outward toward the pipe interior. The opposing ribs were pressed together.

Retaining bands were expanded within all designated channels of the extra-wide rubber sleeves, with the final retaining band installed over the center of the double-wide seal. A single intruding bolt at one joint was safely cut back to allow proper seal placement.

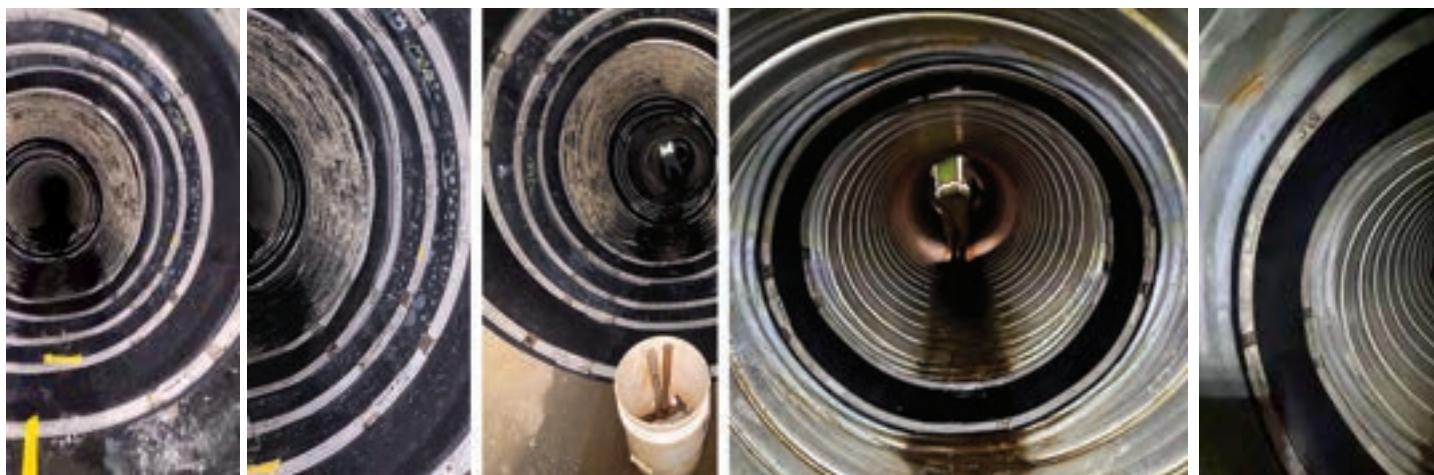
During installation, the crew identified an additional compromised joint on the corrugated side of one transition. The additional joint was repaired by first filling corrugation irregularities with Pro-Stick®, followed by installation of a custom 59.5-inch extra-wide HydraTite® seal secured with two 2-piece stainless steel retaining bands. All work was completed over two days, working onsite, with all joints successfully sealed.

All repaired joints were successfully sealed, eliminating infiltration. The HydraTite® system restored watertight integrity across both corrugated-to-concrete transitions and the additional compromised joint, without excavation or traffic disruption. This project demonstrated HydraTite®'s ability to adapt to complex transition geometries, manage dimensional variability, and deliver long-term performance using custom-engineered trenchless solutions.
