INTERNAL PIPE

**HydraTite**  
JOINT SEAL

The Ohio Department of Transportation (ODOT) identified infiltration issues at multiple joints within stormwater drainage pipes beneath a roadway in Cincinnati, Ohio, located near HydraTech's manufacturing facility and headquarters. Compromised joints in a 48-inch corrugated metal pipe (CMP) and a 23-inch concrete pipe were allowing soil and sediment to enter the system, contributing to buildup at a downstream pump station and resulting in minor roadway sag above.

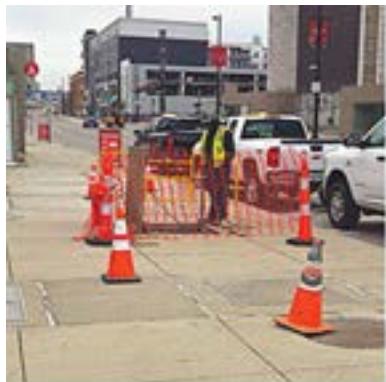
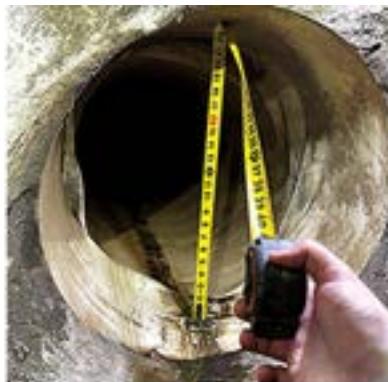
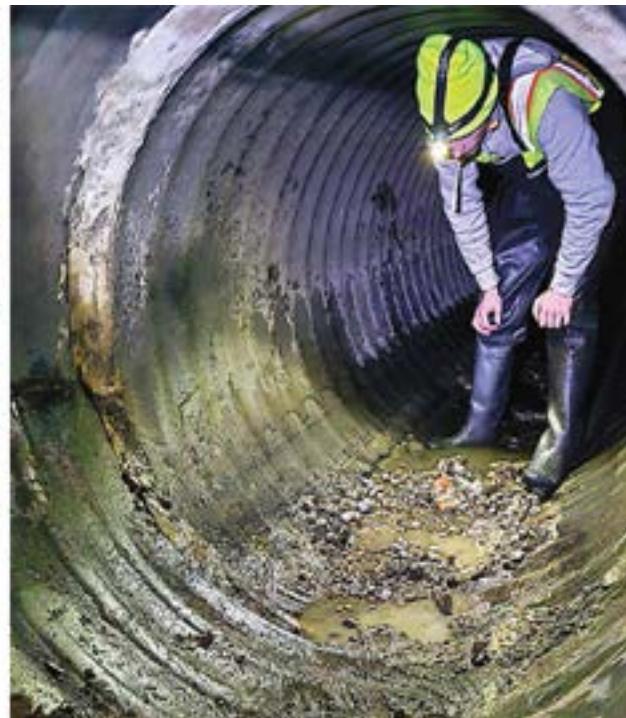
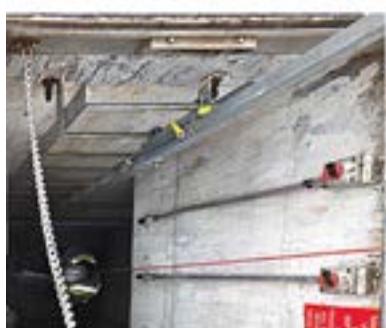
In the 48-inch corrugated metal pipe, one joint contained a concrete patch over the invert that required removal via jackhammer prior to installation. Due to the shallow corrugation depth, a limited amount of Pro-Stick® was applied to low points in the corrugation to unify the surface and ensure smooth, continuous sealing. Six joints were sealed in this pipe along an 80-foot span.

Two joints were sealed in the 23-inch concrete pipe, all within 10 feet of the access point. Installation required working on an incline, and any liner protrusions that could interfere with seal placement were removed. HydraTite® seals demonstrated their flexibility by conforming to offset and misaligned joints, maintaining full circumferential contact despite the challenging geometry of the pipe.

HydraTech recommended the HydraTite® Internal Pipe Joint Seal system, engineered to adapt to irregular pipe geometries and provide long-term infiltration control. Double-wide EPDM rubber seals, paired with three, two-piece stainless steel retaining bands, were selected to accommodate the varying pipe conditions.

All eight joints were successfully sealed, eliminating infiltration and preventing further sediment migration into the drainage system. The trenchless HydraTite® installation stabilized subsurface conditions, protected the roadway above, and restored reliable drainage performance, without excavation or extended disruption. This project was completed quickly and highlighted HydraTite®'s adaptability, even in tight access conditions and non-uniform pipe profiles.
