# INTERNAL PIPE HydraTite® JOINT SEAL

*Power / Industrial*

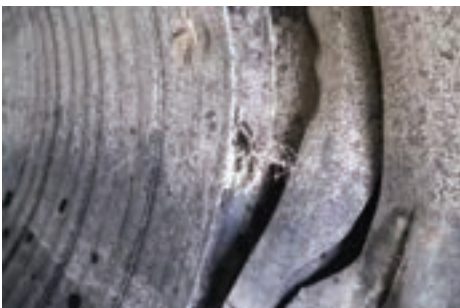
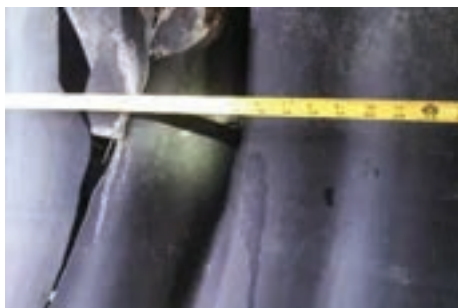
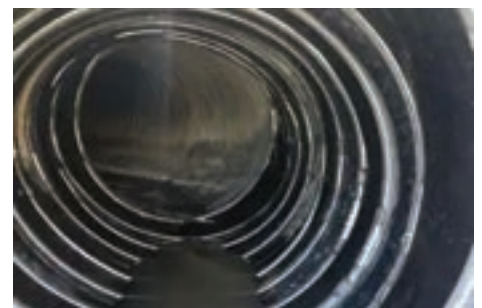
During a monthly landfill inspection of a sediment pond, a sinkhole was noted behind the headwalls of two ADS 48-inch pipes. It was identified that each pipe had cracking at the interface between the concrete headwall and the pipe, which allowed groundwater and sediment to enter the pipe, causing the sinkhole.

The HydraTite® seals, manufactured at HydraTech's Cincinnati facility and installed inside the outlet pipes, were sleeved together to provide additional length over the defective areas and eliminate further infiltration. Sleeving is a process in which HydraTite® seals are interlocked to provide a continuous length along the defective area of piping. The entire project took two days to install and will provide a long-term repair.
