# HydraTite®

JOINT SEAL

The challenge was to eliminate air leaks from the through wall.

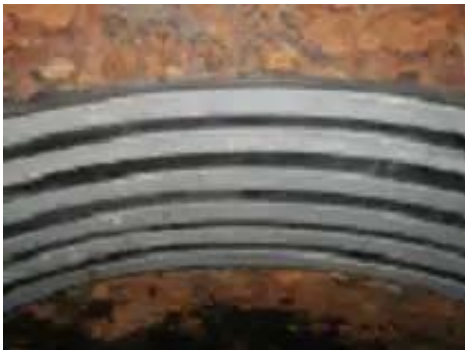
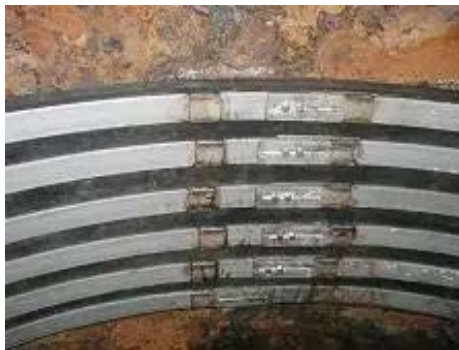
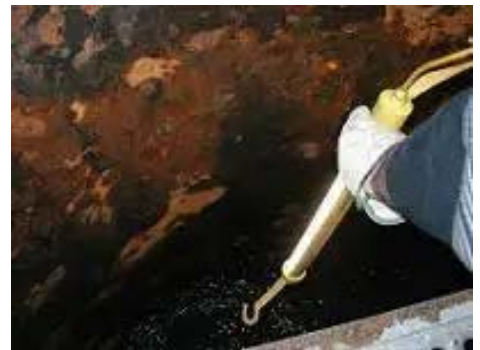
The solution proposed utilized the HydraTite® seal with six three-piece stainless steel 316 steel bands, a double wide HydraTite® seal, and a 16 gauge stainless steel backing plate.

The crew and all materials entered through an existing manhole and were able to complete the system installation within the work window provided by the station.

At the completion of the project, the system performance was brought back to as built specifications with the nuclear plant operating at better efficiency and thus increasing electrical generation output.
