# INTERNAL PIPE HydraTite® JOINT SEAL

*Drinking Water*

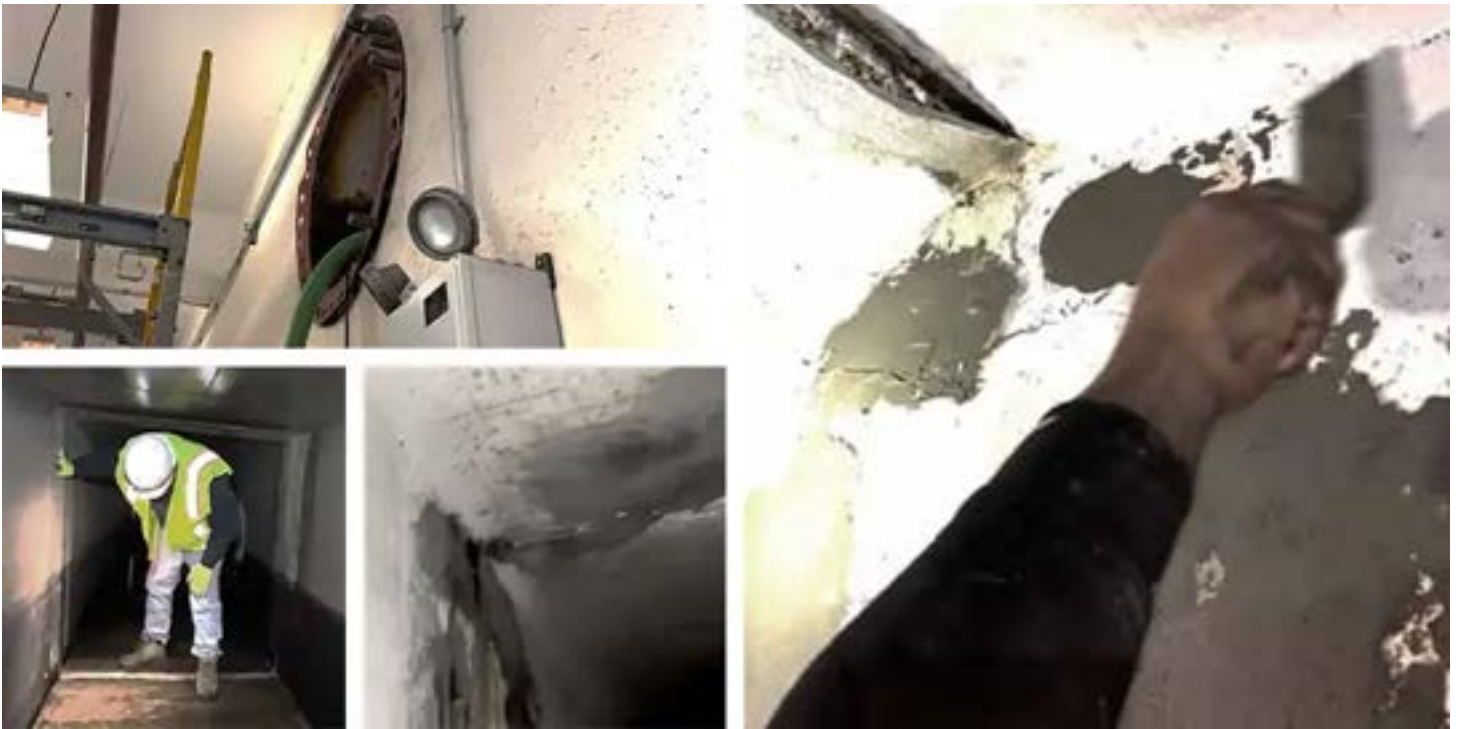
Previous repairs were failing and an active leak threatened the integrity of a water facility in Kentucky. The affected joint ran through two box-shaped flumes that were stacked vertically. One was 48" by 54.5" and the other was 48" by 97".

HydraTech provided custom-made HydraTite seals with anchors and corner forms for both joints.

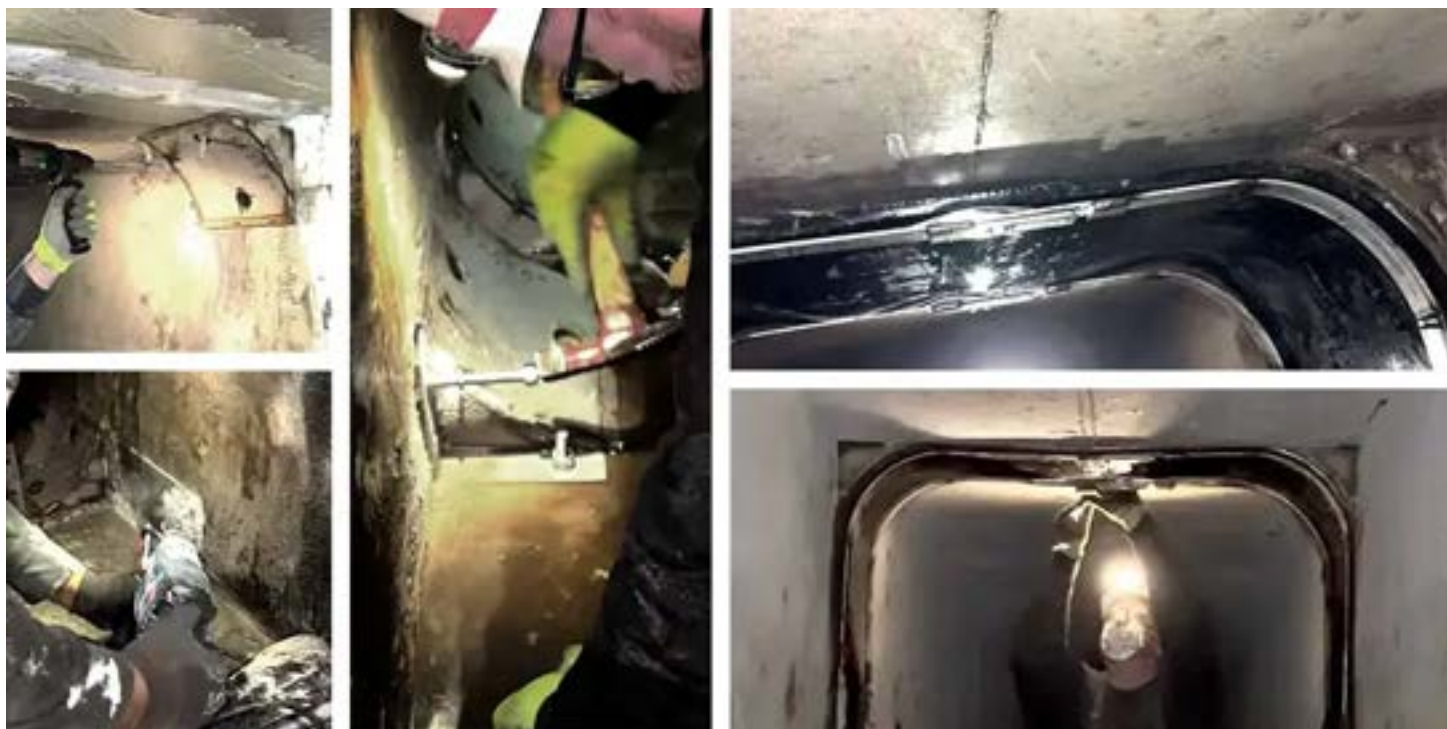
Upon arrival, HydraTech technicians discovered that the corners of the flume were not perfectly sharp 90-degree angles. The result was that the corner forms would not sit flush with the walls. HydraTech chipped out the corners and applied concrete as needed to allow the corner forms to sit properly against the walls. All other abnormal indents and raised portions were smoothed out with chipping and concrete as well. Next, the corner forms were installed, the rubber and steel were positioned over the joint, and the anchors were installed. The retaining bands were expanded and the anchor plates were tightened onto the bands. Finally, a sealant was applied to the edge of the corner forms.

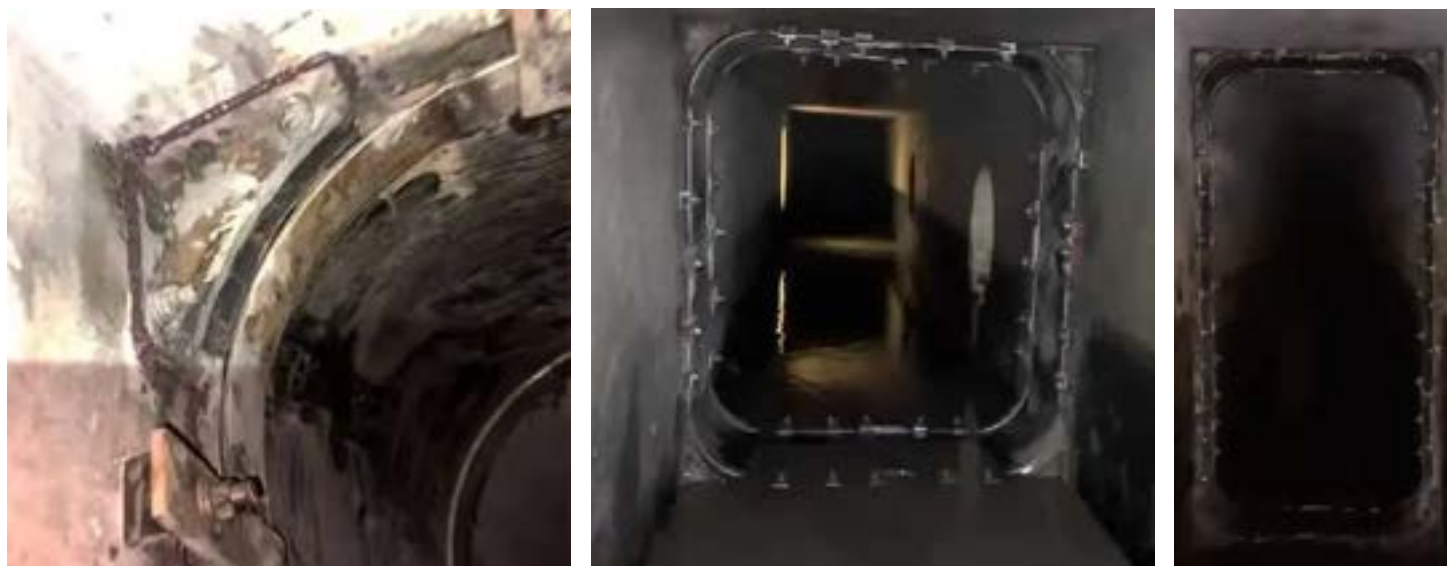
HydraTech provided customized seals to eliminate leaks in failing joints and the field crew adapted the installation plan to accommodate the irregular corners. These two joints will be fortified against leaks for much longer than the previous repair.
