INTERNAL PIPE

# HydraTite®

JOINT SEAL

## Challenge

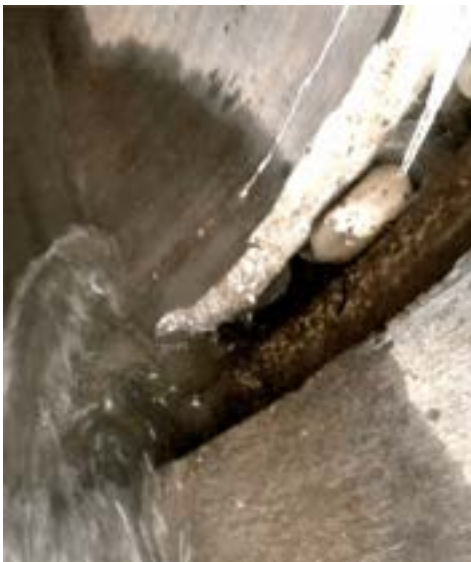
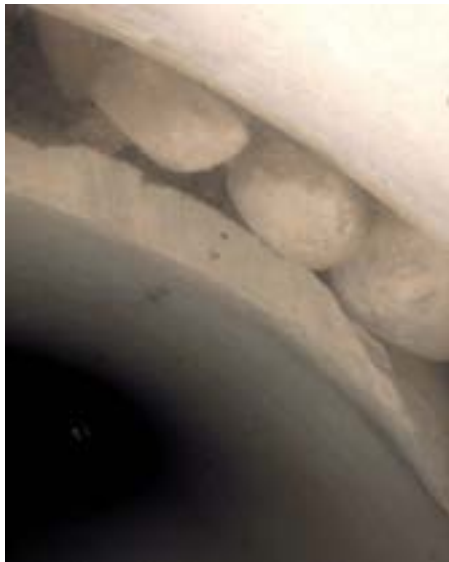
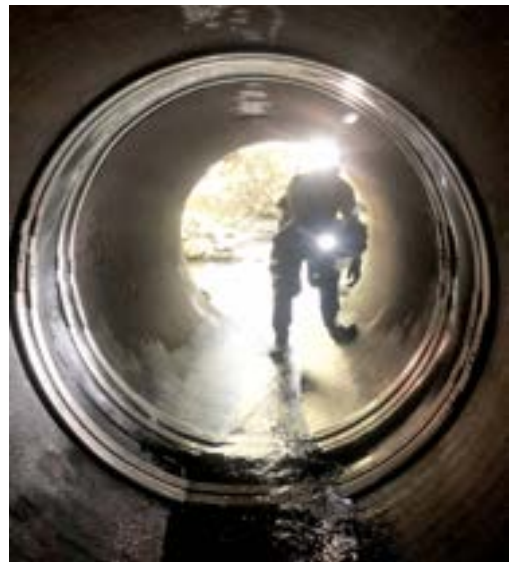
A 60-inch concrete pipe's joints were spreading far apart to the point where large rock and backfill are falling through the pipe joints and creating sinkholes at grade. Each of the joints gets worse as you approach both the upstream and downstream end. Continued rainfall and high groundwater contribute to continued washout of the pipe backfill which allows the pipe to continue moving. The joint had both a vertical and horizontal offset.

The Maine DOT opted for the HydraTite Double Wide seal with 4 stainless steel bands. A stainless-steel backer plate was also utilized behind the rubber seal to help prevent backfill loss.

The HydraTite seal provided a watertight seal that stopped the washout that allowed the pipe to continue moving. The HydraTite seal proved to be an economical in situ repair solution.
