# HydraTite®

JOINT SEAL

The challenge was to eliminate pipe joint leaks in a 120-in recirculating cooling line located in a fossil fuel power generation station.

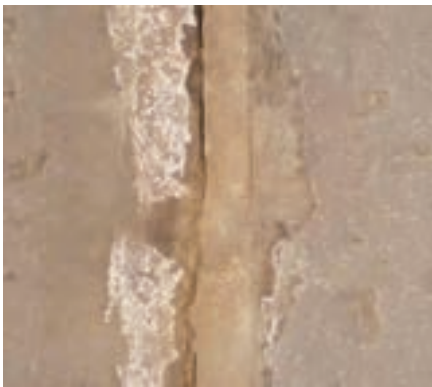
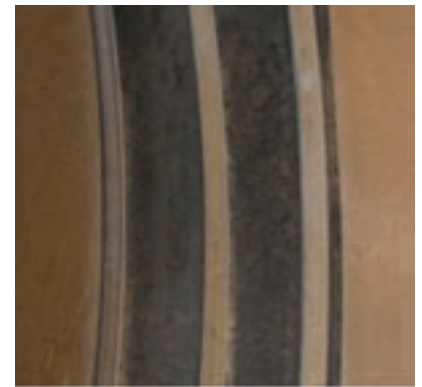
The joints showed deterioration and exposed steel cylinder, as well as broken and missing mortar. There was visual indication of leaking from the exterior during inspection.

The solution utilized double wide and extra wide HydraTite® internal joint seals with 316L stainless steel retaining bands to eliminate further leakage.

Prior to installing the seals, cementitious filler was used in areas of large joint separation and where missing and spalling concrete was evident. Existing man-ways and access points were utilized to transport seal components and manpower.

All leakage was eliminated. The seals were installed in one day to prevent extended loss during downtime.
