# INTERNAL PIPE HydraTite® JOINT SEAL

*Stormwater*

A newly installed storm drain sump that ran along the side of a levee failed its pressure test. Infiltration at the joints threatened the integrity of this box-shaped concrete pipe. A targeted repair was needed, rather than replace the newly installed system.

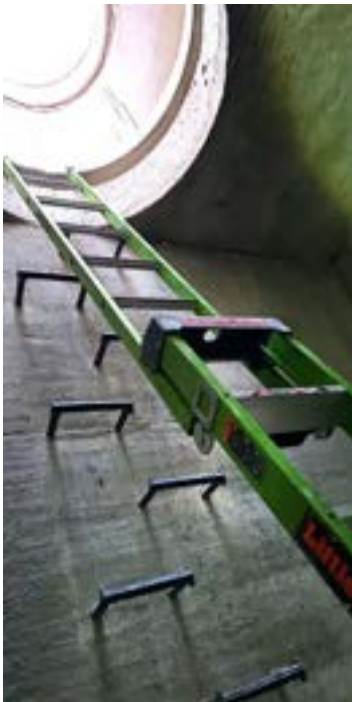
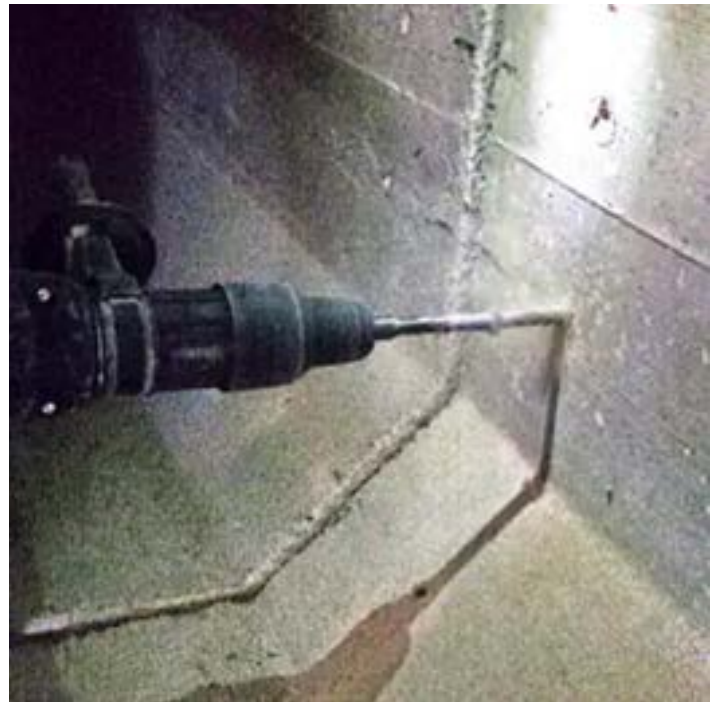
One crew member positioned the materials near the joints and loosely constructed the retaining bands. The two other crew members installed the seals. First, the holes for the anchors were drilled on either side of the joints. Next, the debris from the drilling was brushed away and the anchors were driven into each hole. Then the rubber was positioned over the joint and the retaining bands worked inside the rubber's designated channels. Butyl rubber was applied to the corners to aid the seal's rubber in the transition over the corner. After that, the anchor plates were loosely installed so they lay atop the retaining bands. The retaining bands were then brought to pressure and the hold-downs were tightened against the bands. Each seal was air tested and if the anchors protruded beyond the hold-downs, they were trimmed back. The crew of 3 installed 17 seals in 8 onsite days.

Standard-wide HydraTite Internal Pipe Joint Seals with anchors and hold-downs were the selected method to rehabilitate these joints without excavation.
