# INTERNAL PIPE HydraTite® JOINT SEAL

*Industrial*

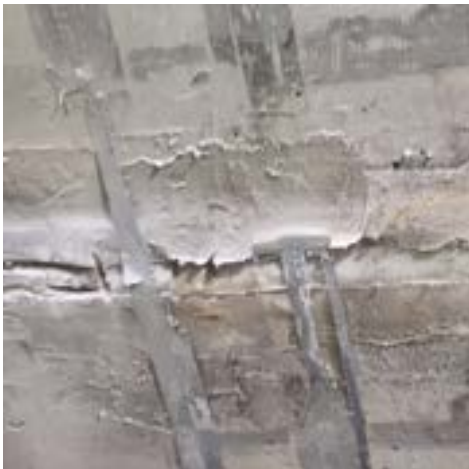
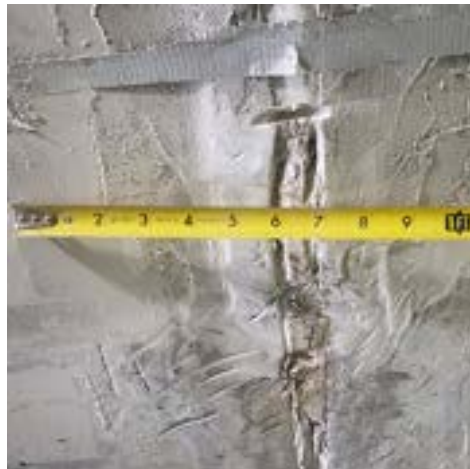
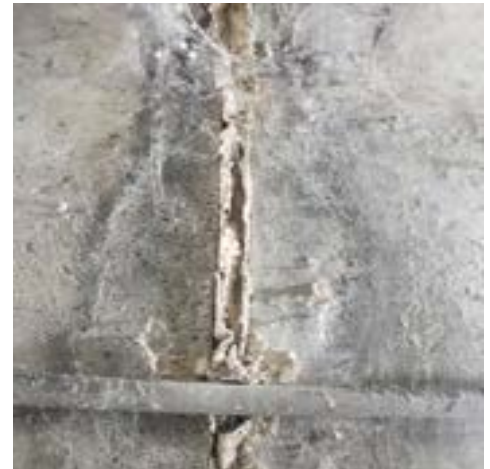
The conveyor was locked out and supports for the piping and conduit were removed to provide clearance from the wall. Prior to HydraTech's involvement, repair attempts had been made, leaving the surface uneven and so it needed to be ground down in preparation for the HydraTite Seal installation. The extra-wide EPDM rubber seal then was placed around the conveyor and cold bonded on-site. The shape of the tunnel allowed for installation without corner forms which are frequently required for these types of installations. Despite the challenge of bonding the seal in the field, the entire job was completed, prep to finish, in 60 hours (2 days).

HydraTite proved to be the flexible solution that was customizable enough for installation around an immovable conveyor. The project was completed quickly and economically, protecting the conveyor for years to come.
