# INTERNAL PIPE HydraTite® JOINT SEAL

*Water & Utilities*

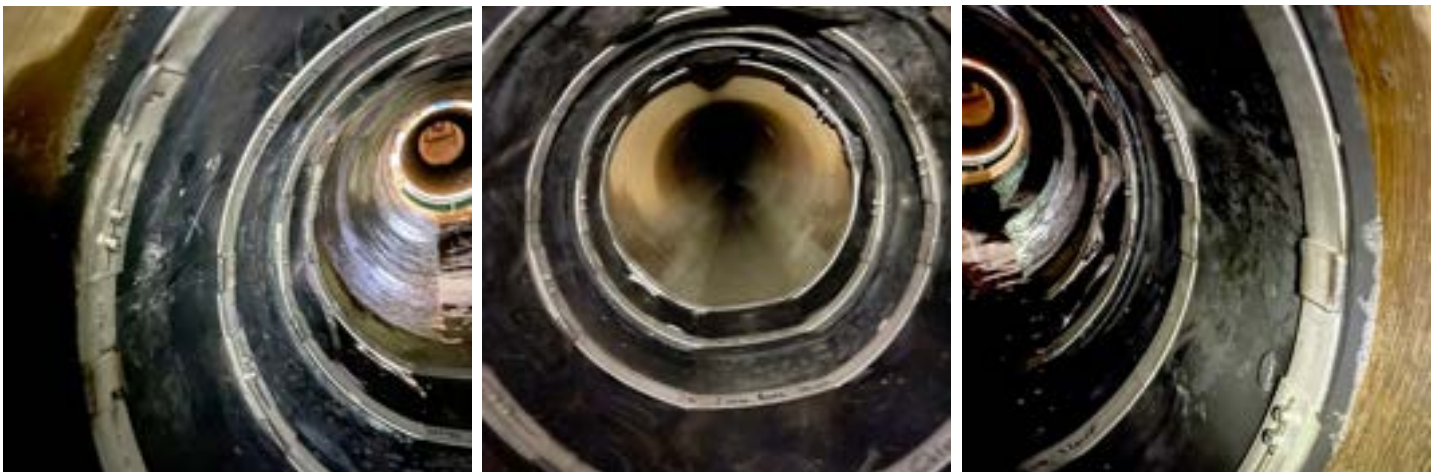
A four-inch crack had formed in a reinforced concrete pipe (RCP) near a joint where this pipe connected to a steel pipe. As a result, there was an active leak in this 30" pipe that raised concerns of the crack growing, contaminating the potable water, and creating voids around the pipe leading to eventual total system failure.

The chosen solution was to isolate the crack by sealing it with three interlocked Standard-Wide HydraTite Internal Pipe Joint Seals.

Before the installation, the facility lowered the reservoir and shut off all valves to the affected pipe to ensure the field crew's safety. In only seven hours the three seals were installed over the RCP's crack.
