# HydraTite®

JOINT SEAL

## Challenge

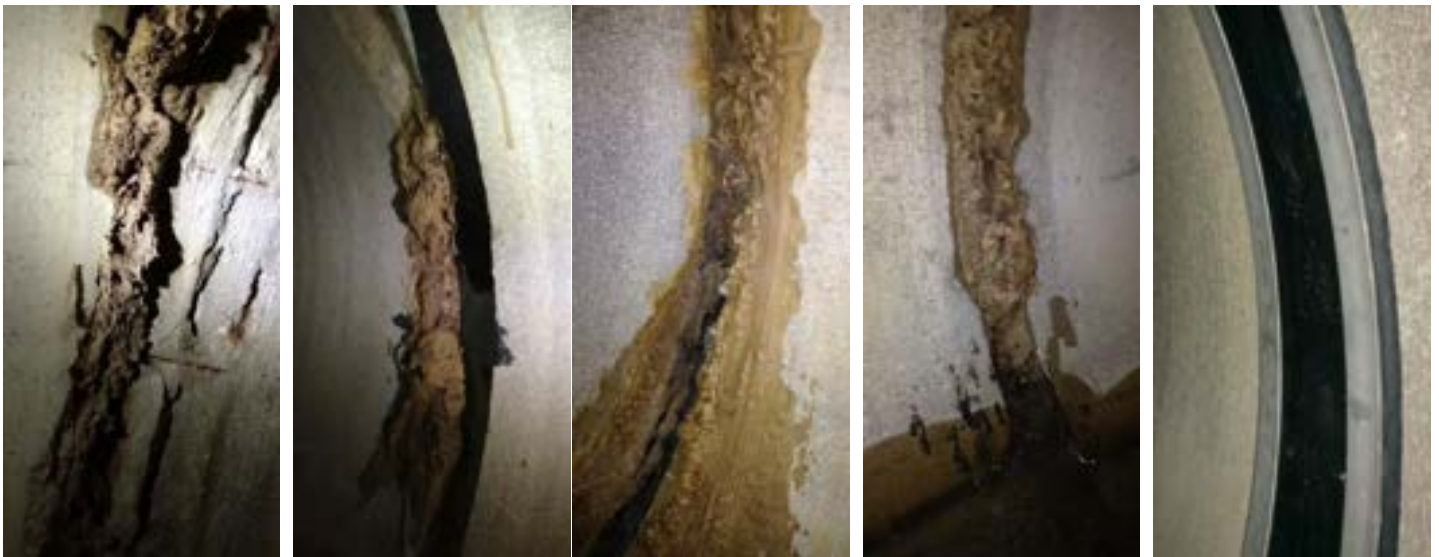
The HydraTite® seals successfully eliminated infiltration, preventing further washouts and sinkholes. City officials and residents were pleased with the results, and the client now plans to specify HydraTite® seals for future RCP repairs instead of grout.

The project was completed by HydraTech technicians without any excavation or surface disruption. Over the course of the work, all the joints were cleaned, prepped, and sealed internally, ensuring long-term protection. The four joints that were more severely deteriorated were sealed with extra-wide HydraTite seals with three of the one-piece retaining bands. The other three joints that were less degraded were sealed with three standard-wide HydraTite seals with two of the one-piece retaining bands.
