INTERNAL PIPE

# HydraTite®

JOINT SEAL

A power plant in Texas discovered a leak in their recirculating pump line. They were looking for an internal repair for this 108" prestressed concrete cylinder pipe (PCCP). The repair would have to withstand head pressure when the system was shut down for maintenance in the future. Access to the pipe was through an approximate 24" entry point.

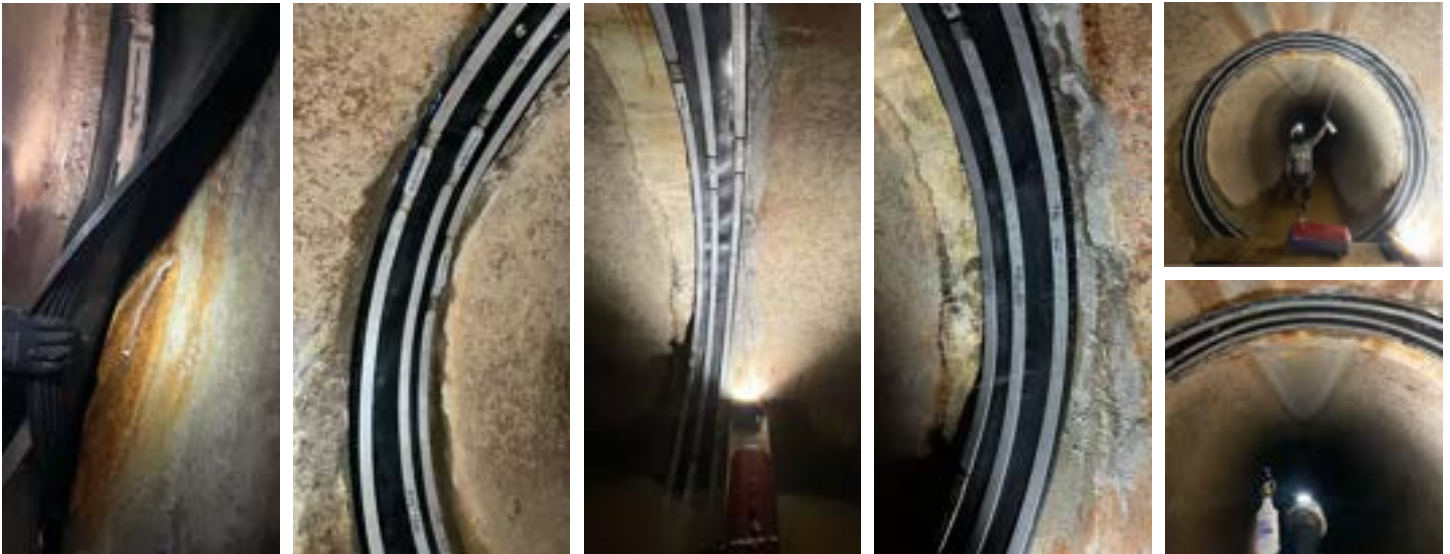
The system was shut down and sump pumps kept water low. HydraTech Field Services positioned the rubber over the leak and locked it in place with the retaining bands. Then air was pumped behind the rubber and a soapy water solution was sprayed around the outer edge of the rubber. It was inspected for bubbles that would indicate escaping air. Everything from installation to passing the air test was done in only about two hours.

The HydraTite® internal seal was installed, the leak was eliminated, and this quick installation saved the power company extended downtime.
