# INTERNAL PIPE HydraTite® JOINT SEAL

*Drinking & Irrigation*

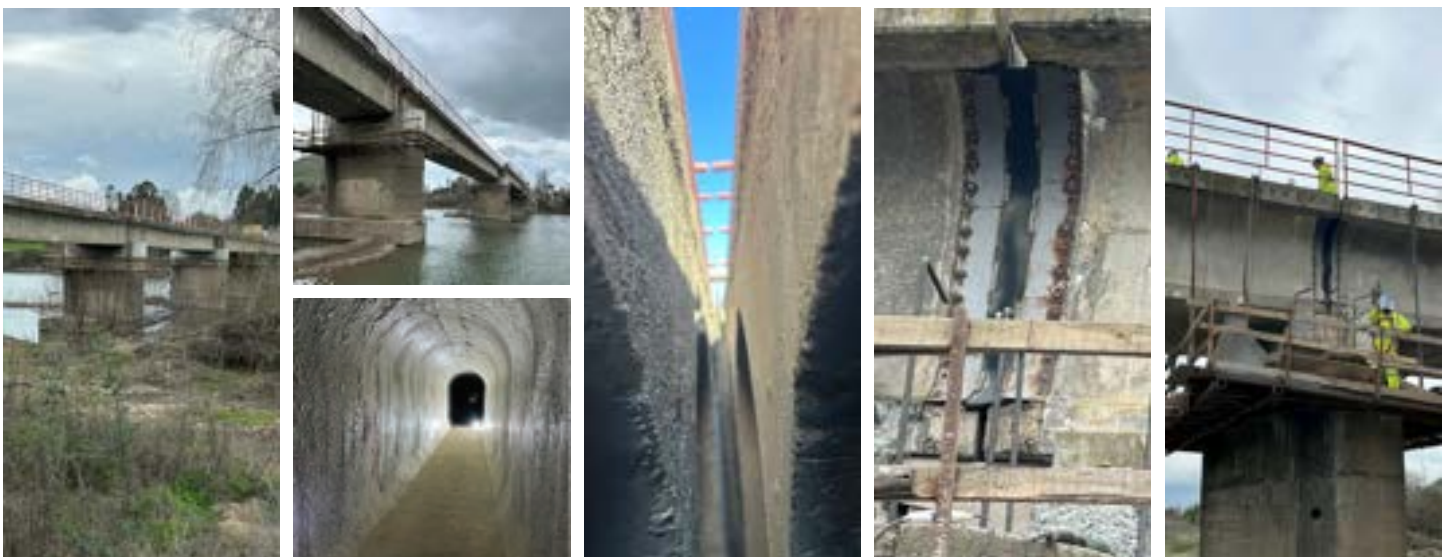
HydraTech engineered and manufactured custom HydraTite® Internal Pipe Joint Seals specifically adapted for the arched aqueduct geometry and flat invert, demonstrating the system's flexibility beyond standard round pipe applications. The seals were equipped with two 6-piece stainless steel retaining bands.

The initial repair plan utilized extra-wide (EW) rubber seals, mechanically locked into place using stainless steel retaining bands, anchors, and hold-downs to ensure stability under flow and pressure conditions. The seals were designed to conform to the non-cylindrical shape while maintaining full circumferential contact across the joints.

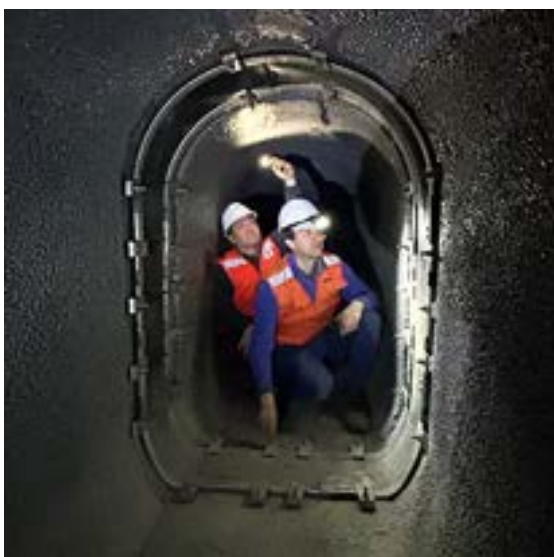
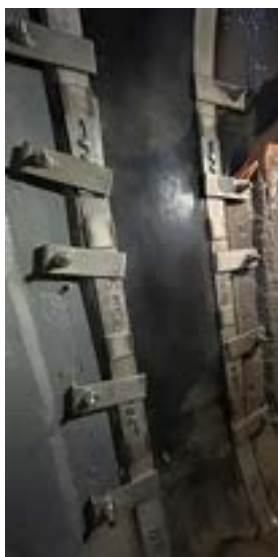
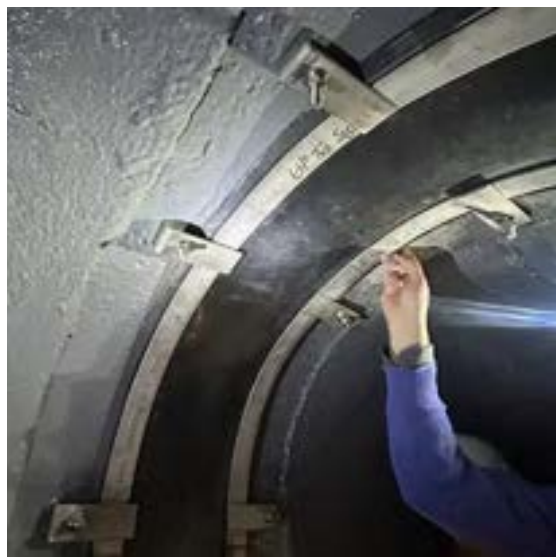
All repaired joints were successfully sealed, eliminating infiltration. The HydraTite® system restored watertight integrity across both corrugated-to-concrete transitions and the additional compromised joint, without excavation or traffic disruption. This project demonstrated HydraTite®'s ability to adapt to complex transition geometries, manage dimensional variability, and deliver long-term performance using custom-engineered trenchless solutions.
