# INTERNAL PIPE HydraTite® JOINT SEAL

Exfiltration was discovered in a joint in a d-shaped pipe that ran between two tanks. Due to the depth of the pipe and its position between the tanks, a trenchless solution was needed. A repair was required before the erosion from the leak compromised the system further.

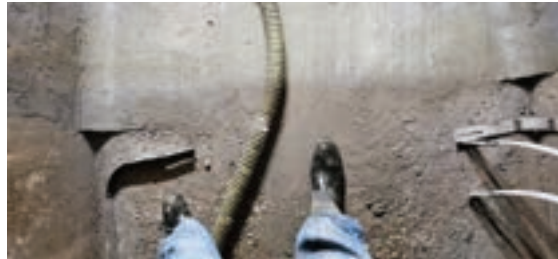
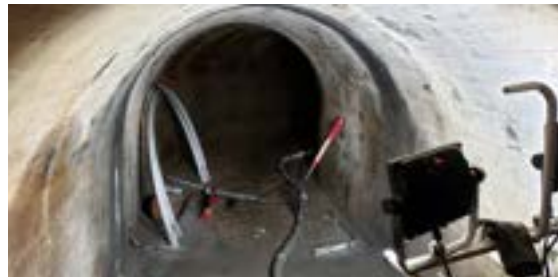
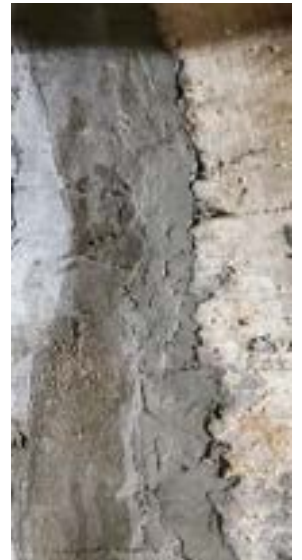
A crew of two people installed this custom-manufactured HydraTite seal in the pipe that was approximately 72" tall and wide. The rubber was positioned over the joint, and the stainless steel bands were then loosely placed over the rubber. Anchor holes were then drilled along the edge of the rubber on each flat portion of the pipe's interior surface. Anchors and hold-downs were then loosely positioned over the retaining bands. The retaining bands were expanded and locked in place. Then the hold-downs were tightened down onto the seal. Finally, The seal was air-tested to ensure that the leak had been eliminated. The entire process was completed in a single day.

An Extra-Wide HydraTite Seal with anchors was the chosen solution to eliminate the leak.

The repair was completed at a fraction of the cost associated with other options. The HydraTite seal eliminated the leak very quickly and the connected tanks were undisturbed during this process.
