INTERNAL PIPE

# HydraTite®

JOINT SEAL

A 66" corrugated metal pipe utilized as a dam overflow had developed a hole, which allowed water infiltration.

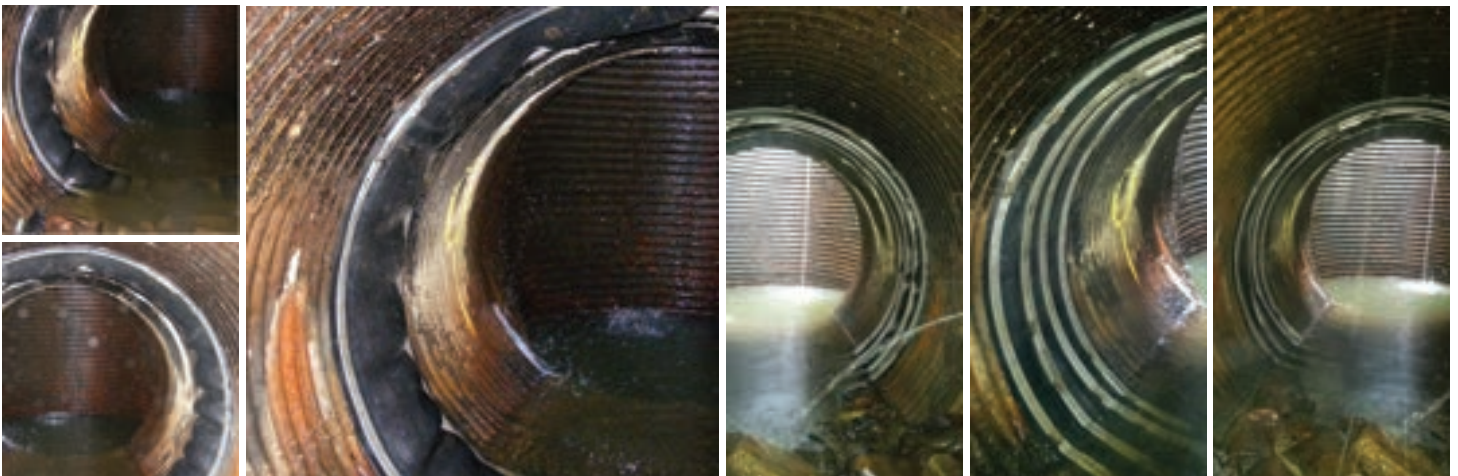
The surface of the pipe was prepared by filling in the valley of the corrugated metal to provide a smooth surface for the seal to be installed. HydraTite was then placed over the repair location and two retaining bands were installed in the rubber's channels. Then the seal was air tested. Finally, the two additional bands were installed. The entire repair was completed in just one day.

The HydraTite Internal Pipe Joint Seal proved an economical and practical way to stop infiltration through the hole in the corrugated pipe. This repair brought new life to the corrugated pipe that would have otherwise required replacement.
