# INTERNAL PIPE HydraTite® JOINT SEAL

An Ohio Department of Transportation (ODOT) inspection identified active infiltration at the crown of a stormwater pipe, concentrated at two transition points beneath a roadway. Each transition connected similar-sized corrugated metal pipe (CMP) to concrete pipe, creating imperfect connections that allowed groundwater to enter the system. ODOT required a trenchless repair solution capable of sealing these complex transition joints without excavation or disruption to traffic.

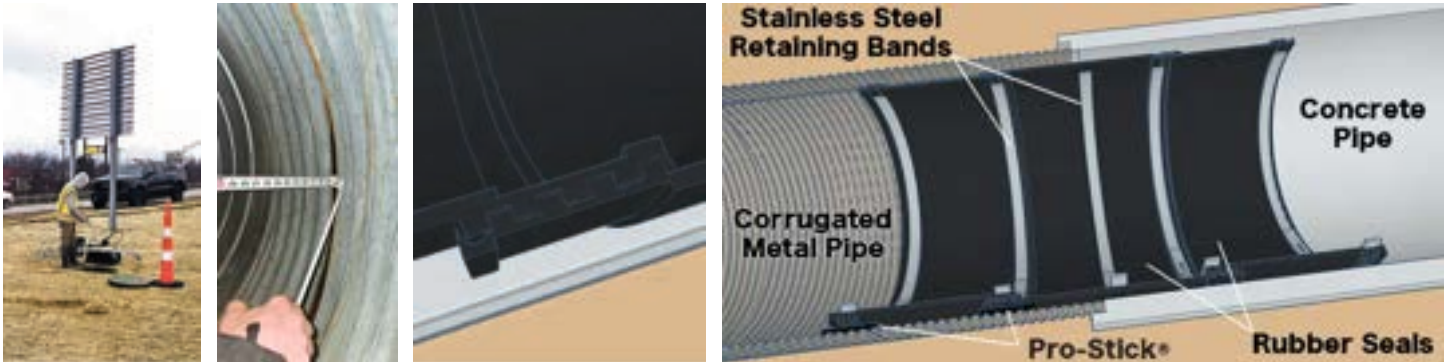
HydraTech engineered a custom HydraTite® Internal Pipe Joint Seal solution to accommodate the unique transition conditions. Each repair utilized interlocked seal sleeves, consisting of a double-wide (DW) inner rubber sleeve and a pair of extra-wide (EW) outer rubber sleeves.

The seals were equipped with five 4-piece stainless steel retaining bands, allowing greater adjustability and uniform compression across the transition. The outer EW rubber was manufactured 3/4 inch smaller in diameter to nest securely atop the DW seal, while one set of retaining bands was fabricated 1 inch smaller in diameter to ensure proper clamping over both overlapping layers.

HydraTech's two-person field crew installed the custom-manufactured, interlocking HydraTite® seal sleeves. On the corrugated side of each transition, Pro-Stick® was applied to fill corrugation valleys and create a unified sealing surface prior to installation. The extra-wide outer seals were installed with the rubber ribs facing the pipe wall, while the double-wide inner seal was inverted so its ribs faced outward toward the pipe interior. The opposing ribs were pressed together.

Retaining bands were expanded within all designated channels of the extra-wide rubber sleeves, with the final retaining band installed over the center of the double-wide seal. A single intruding bolt at one joint was safely cut back to allow proper seal placement.
