# HYDRAWRAP

STRUCTURAL COMPOSITE REPAIR SYSTEM

The challenge was to rehabilitate the deteriorated cooling water piping due to through wall leaks.

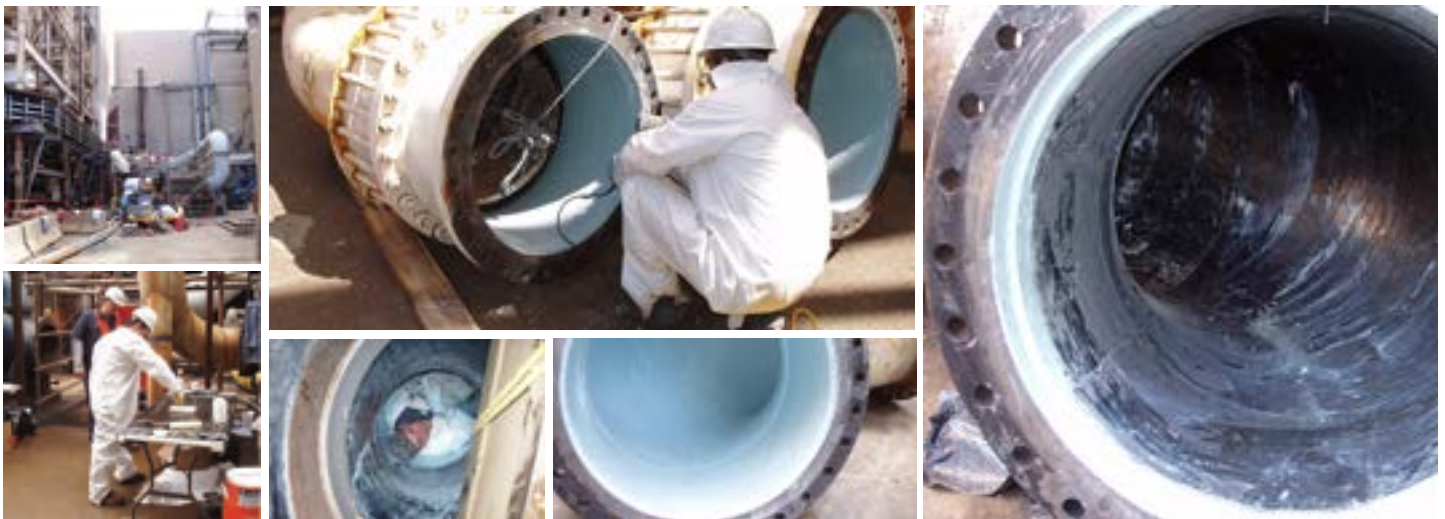
In 1987, sections of the cooling water pipe were replaced with carbon steel lined with Plastisol (plasticized PVC). Over the years, the liner disbonded from the substrate which subsequently resulted in numerous through wall leaks. These leaks and significant areas of corrosion resulted in poor system reliability and impacted the plant performance. Both the pump inlet and discharge pipe were affected by the deterioration.

The project required the removal of the sometimes tenacious existing coatings. Selected pipe spools were removed and other openings were provided to allow access into the piping. The substrate was prepared by grit blasting. The piping system was repaired by applying an epoxy primer, layers of carbon fiber, and a top coat. The entire process was completed in the allotted time frame and was a cost-effective repair option.
