# INTERNAL PIPE HydraTite® JOINT SEAL

**Market**  
*Water / Utilities*

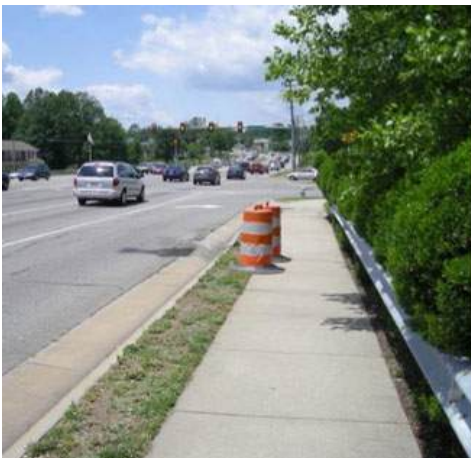
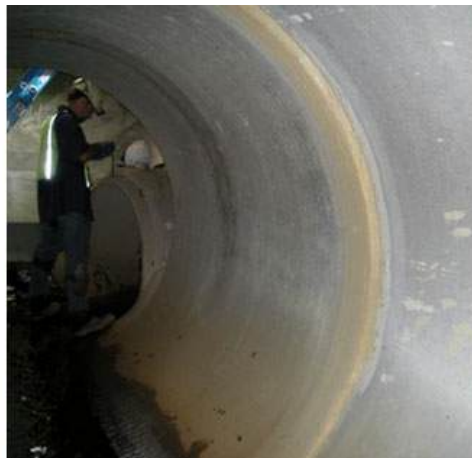
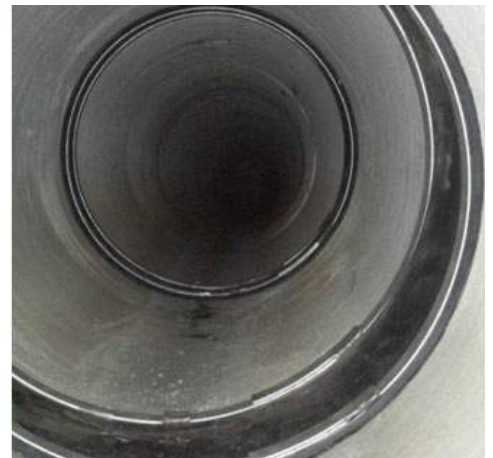
The challenge was to rehabilitate reinforced concrete storm drains under a major intersection. Inspection by engineers revealed that the 72-in pipe had opened up. In certain areas, the joints had failed and storm water had eroded the surrounding soil, producing sizable sink holes in the roadway and surrounding areas.

The crew and all materials entered through existing manholes. There was no above ground disruption to the traffic as the seals were installed. Installation of the HydraTite® seals eliminated infiltration and prevented any further sinkholes.
