# HydraTite®

JOINT SEAL

**Market**  
*DOT*

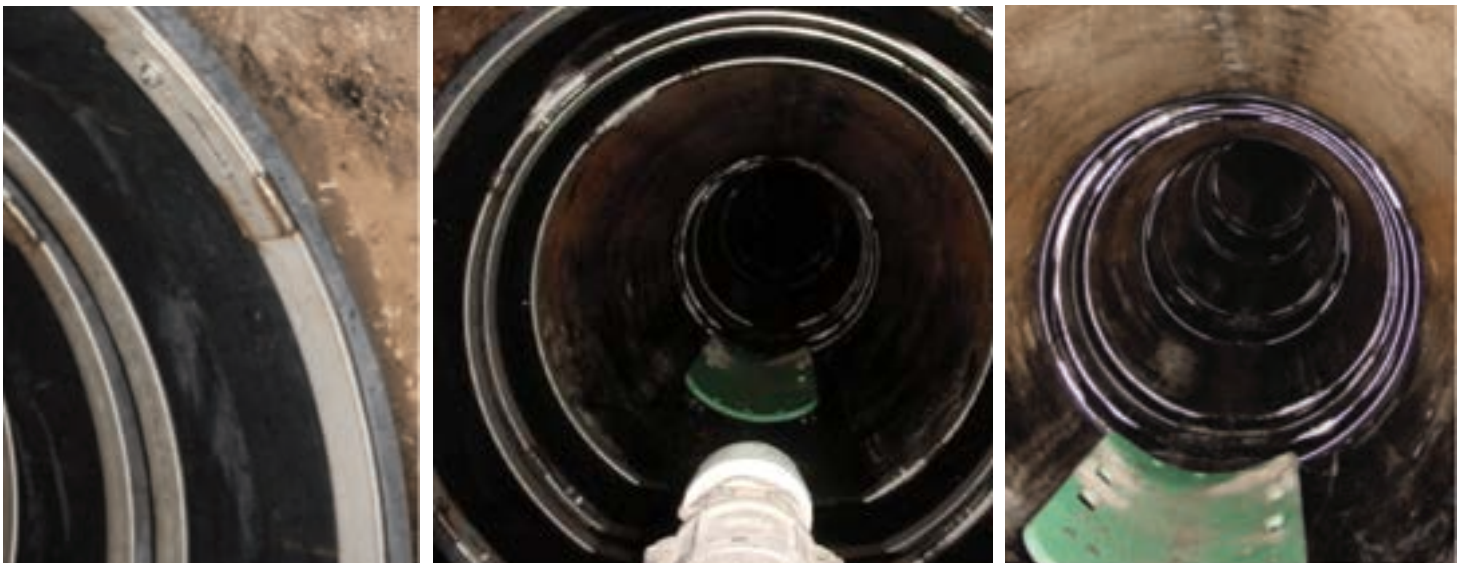
The Massachusetts Turnpike Authority, the predecessor of MassDOT, was reviewing its aging pipelines and during a video inspection of a 42" diameter gravity drain, cracks were discovered in the pipe. The joints had deteriorated as well. The affected area was found to be 120 feet long portion of reinforced concrete pipe that was servicing a water pump station.

All of the joints of concern and cracked portions of pipe were rehabilitated using the HydraTite seals. Some of the repair locations were so broad that HydraTite seals were installed in an interlocking sleeve.

A contractor suggested they install the HydraTite Internal Pipe Joint Seal. For these extensive repairs, it was decided that the Extra-Wide and Double-Wide seals would be installed.

HydraTite proved to be the best solution to rehabilitate a system with extensive signs of aging. These repairs will protect against leaks and will last longer than alternatives.
