# Putting a Round Plug in a Square Hole

*Capt. Travis M. Clower, MBA, PE, Owner of Integrity Aquatic, LLC*

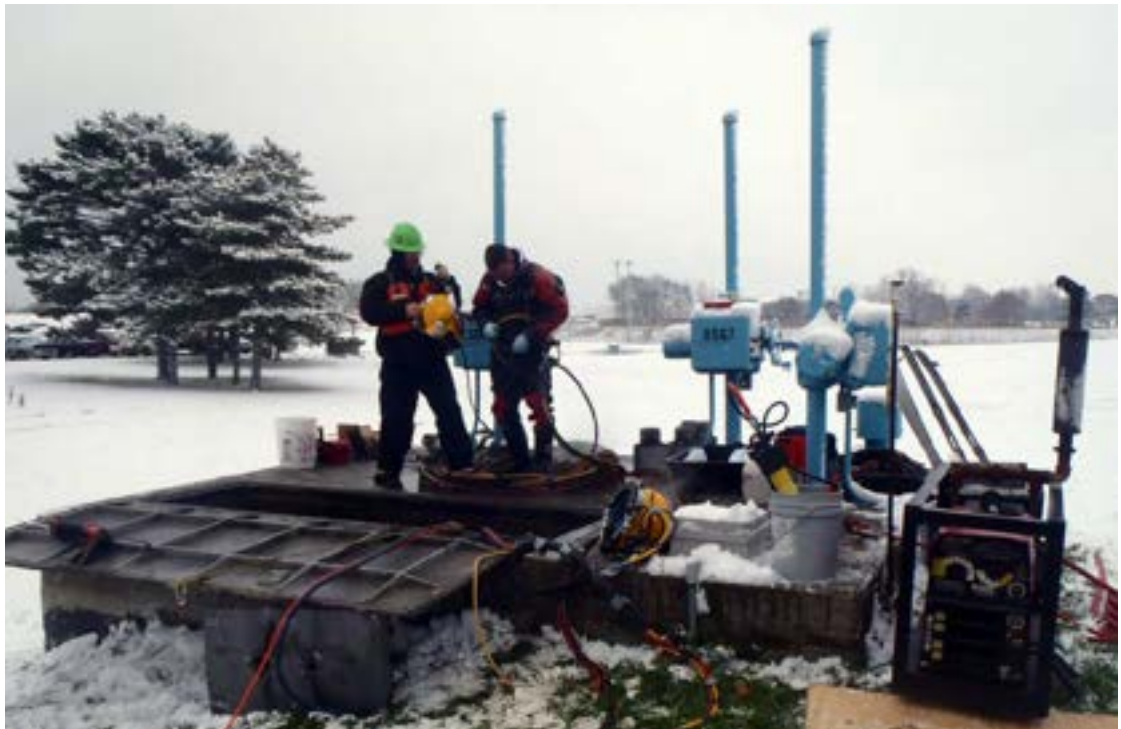
In the summer of 2013 after a few weeks on site and a couple of miles of swimming, five damaged leaking conduit joints were identified. Because it was potable water, everything to enter the water including the divers' drysuits and helmets needed to be cleaned and disinfected daily per AWWA C652-92. The quantity of finished water lost through these leaks, 24 hours a day, 7 days a week, year after year is staggering. In addition to the water leaking out, untreated ground water was leaking into two of the conduits. Repairs were needed to "stop the bleeding". Unfortunately whoever performed these repairs would need to do so while the conduits were filled with water. 40+ years ago water plants would typically drain the conduit and send some brave sole (the new

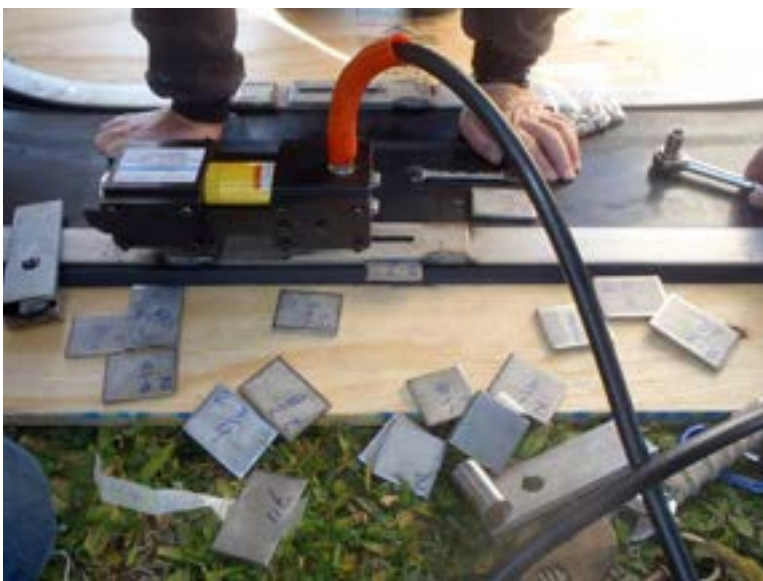
After the materials arrived, HydraTech's engineer provided onsite "dry run" training for my crew. A 54-inch plywood box was built to simulate the conduit. The photo taken during the training shows the simulated plywood conduit, the rubber seal, the stainless steel retaining bands, the wedges, and the hydraulic expander. As you can see, there were a lot of small light parts in the assembly process. That would come back to haunt us later on.

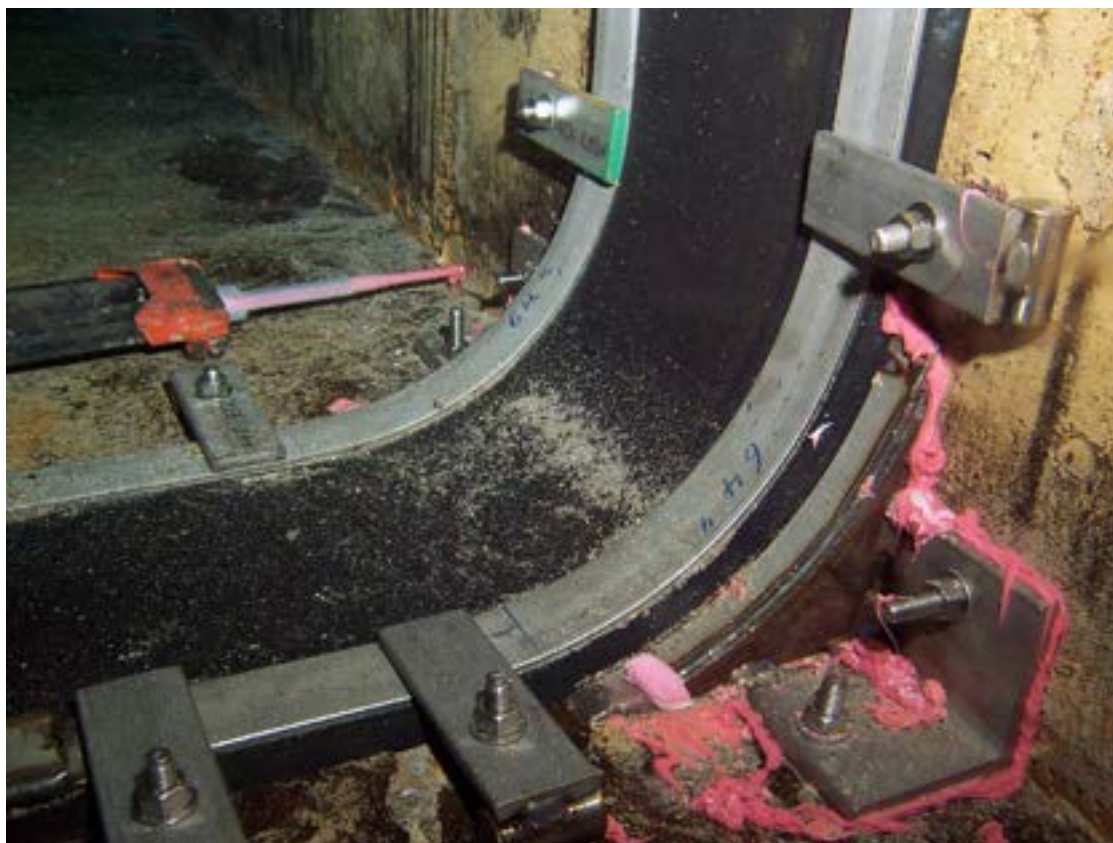
This would give the stainless steel bands a curved surface to press the rubber liner against creating a tight seal. A total of eight radiuses were needed for each liner, four on either side of the joint.

Working together we came up with installing HydraTite internal EPDM rubber joint seals made by HydroTech Engineered Products of Cincinnati, Ohio. These rubber seals are successfully used to cover leaking joints in cylindrical pipes. The rubber seal is compressed against the smooth, curved walls of the pipe using stainless steel retaining bands and a hydraulic expander. Once the retaining bands are expanded, wedges are installed in the gaps and bolts are tightened up to hold the assembly in place. Photos of all of these parts are attached. It sounds pretty straight forward and simple, right? What about the corners? In addition to the round pipes, the seals have been used above water in rectangular shaped culverts with 45-degree corners. In these cases additional anchor bolts were installed in the flat sections and the corners were rounded with epoxy or grout. This would be the “maiden voyage” for a square conduit with sharp corners installed completely underwater. The engineering firm again impressed me by suggesting the use of pre-fabricated stainless steel radiuses in the corners.

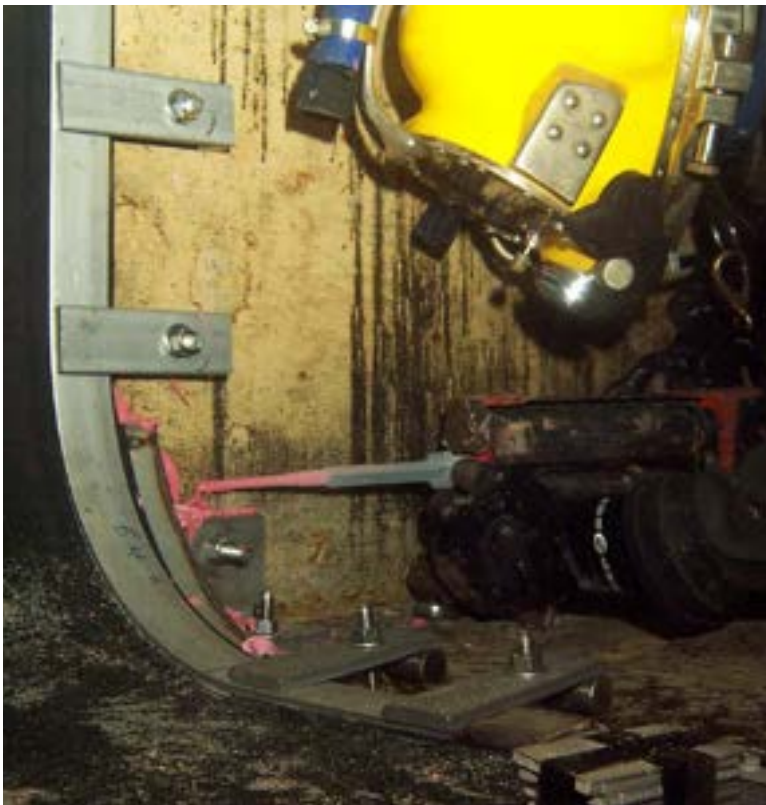
Fitting the radiuses in place proved to be difficult at some of the leaking joints. Several of the joints had up to a 1 inch concrete height mismatch. Also four of the radiuses were installed on a curved wall of the conduit. Both situations caused the sharp corners of the radiuses to rub the soft rubber seal potentially damaging it. After a little love with the underwater torch and a lot of concrete chipping, the tedious job of custom fitting the radiuses was complete. It took one day to attach the radiuses for each joint. The epoxy was then given all night to solidify. The following day was devoted to installing the HydraTite internal joint seal. Overall 56 anchor bolt holes were drilled at each leaking joint. The drill ran nonstop for almost 4 hours. While the first diver was drilling the holes on one side, the second diver worked on the opposite side assembling and expanding the stainless steel bands. Each of the two retaining bands had four locations that enabled the retaining bands to be expanded to compress the EPDM seal. Once expanded, wedges were installed locking the bands in place.

On November 10, 2014 the first pre-fabricated stainless steel radiuses were installed. A thick layer of Hilti RE-500 two part epoxy was applied underwater between the radiuses and the concrete corners. This epoxy filled imperfections in the concrete and helped secure the stainless radiuses to the conduit. Although the Hilti epoxy was not designed for this application, epoxies that can be applied underwater and that are NSF-61 approved for potable water are scarce. The Hilti epoxy worked well and came in an easy-to-use double barrel caulking gun. Stainless steel wedge anchor bolts were used to attach the radiuses and the stainless steel bands to the concrete.
